FACILITY CONDITION ASSESSMENT

Akins HS | February 2022

Executive Summary

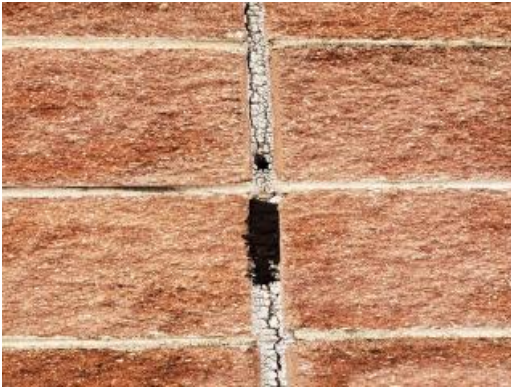
Cracked exterior brick

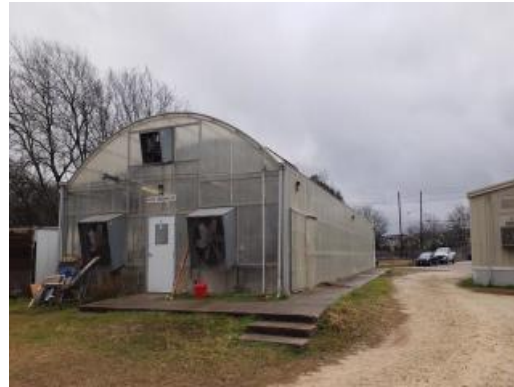
Deficiency	Category	Qty	UoM	Priority	Repair Cost	ID
Steel Column Replacement	Deferred Maintenance	80	LF	3	\$3,253	473
Note: 8 columns at 10' high each. Structural posts show extreme corrosion and water damage. In some cases the posts are completely corroded and do not touch the floor. Location: Greenhouse						
Sub Total for System		1 items			\$3,253

Corrosion on support beam of the greenhouse

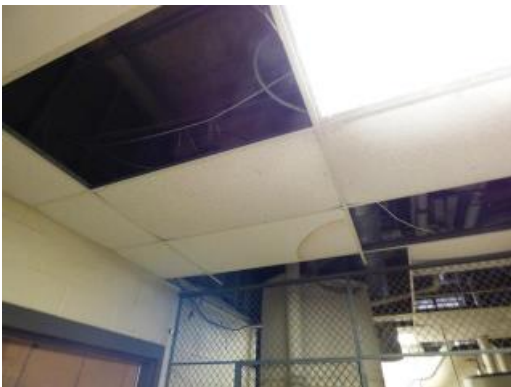
Missing acoustical ceiling tiles in the gym

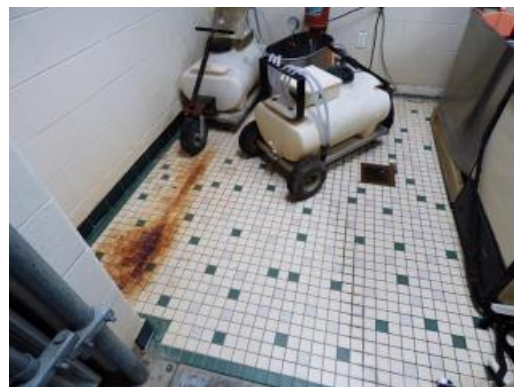
Damaged ceramic tile in the gym

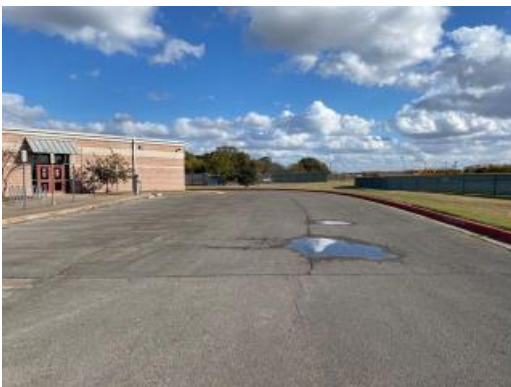
Asphalt pavement at end of life

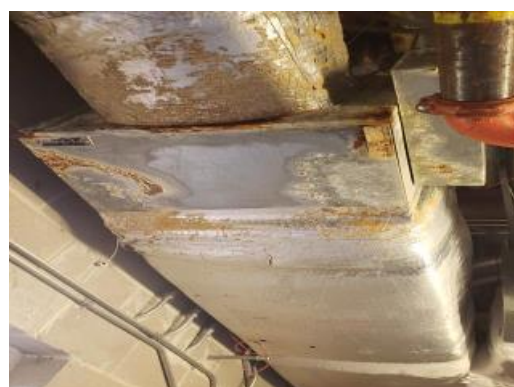
Classroom damaged variable air volume unit
