FACILITY CONDITION ASSESSMENT

Anderson HS | February 2022

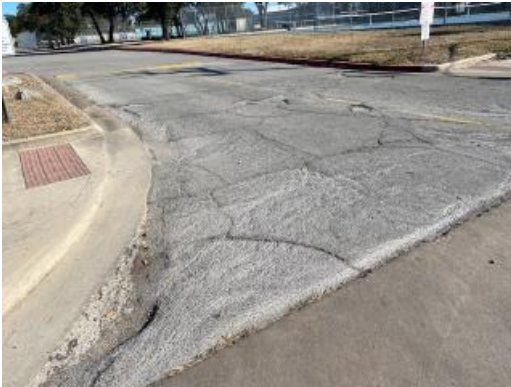
Damaged asphalt driveway

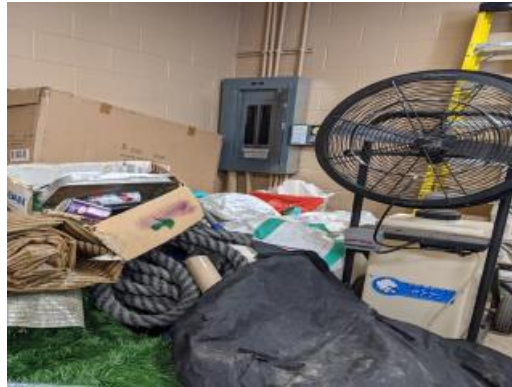
Obstructed electrical panel

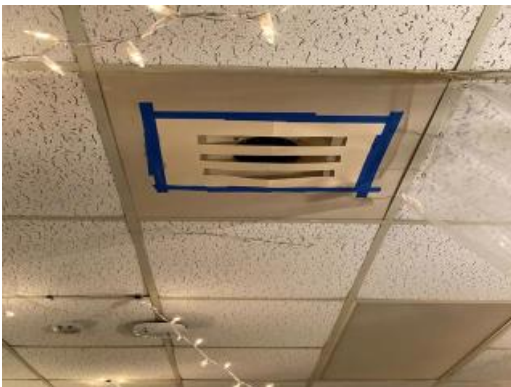
Cracked acoustical ceiling tile

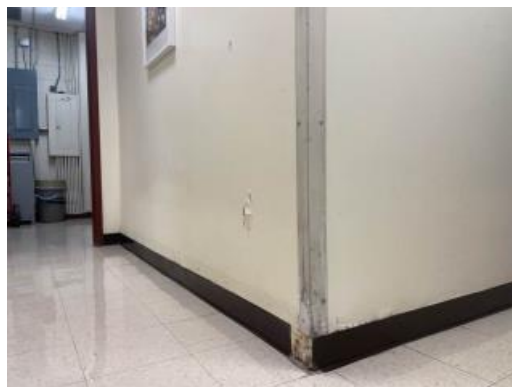
Administration wall finish damaged

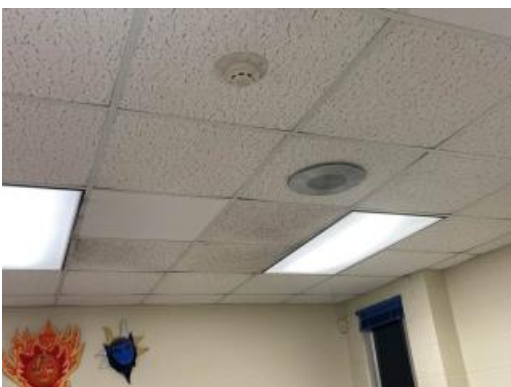
Acoustic ceiling and grid at end of life

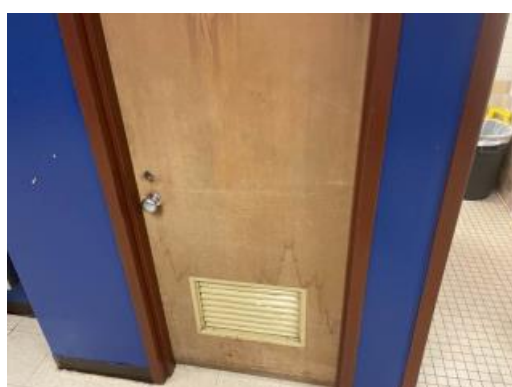
Water damage and bowing on wood doors

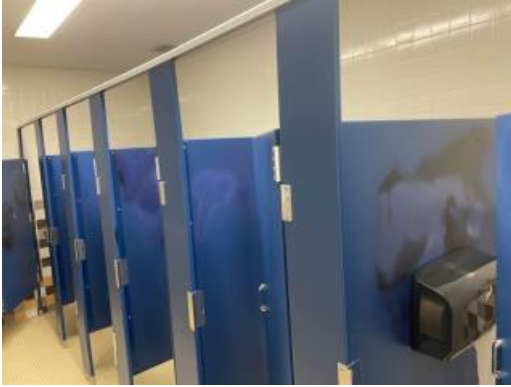
Restroom partitions at end of life

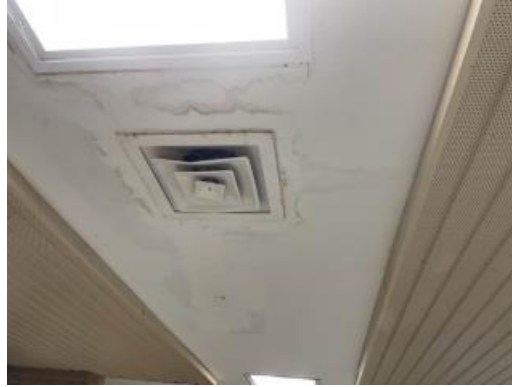
Stained cafeteria corridor ceiling

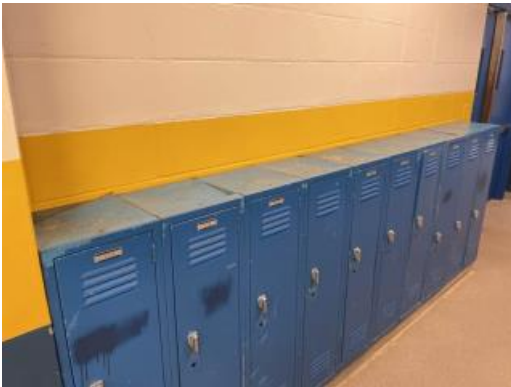
Metal lockers at end of life

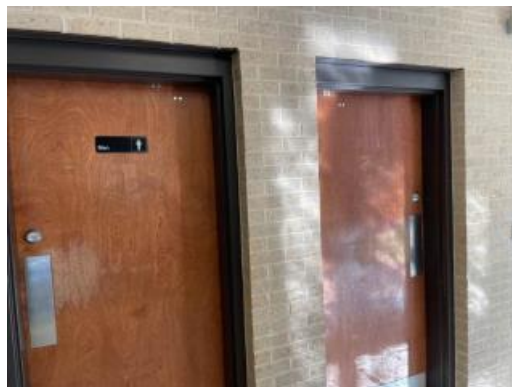
Wood doors at end of life

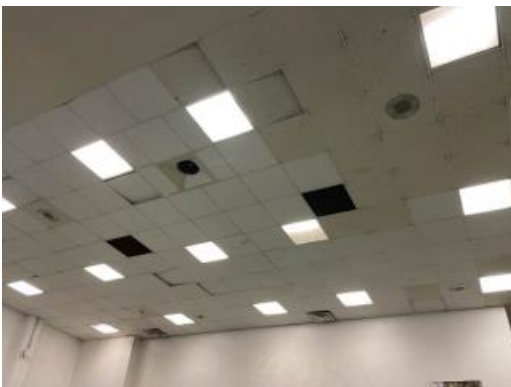
Acoustic ceiling tiles at end of life
