FACILITY CONDITION ASSESSMENT

Bailey MS | February 2022

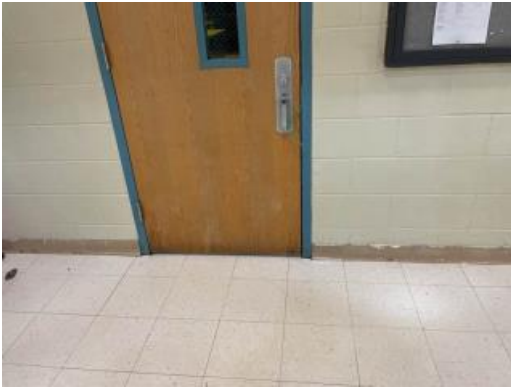
Sample Wood door delaminating at bottom and ends

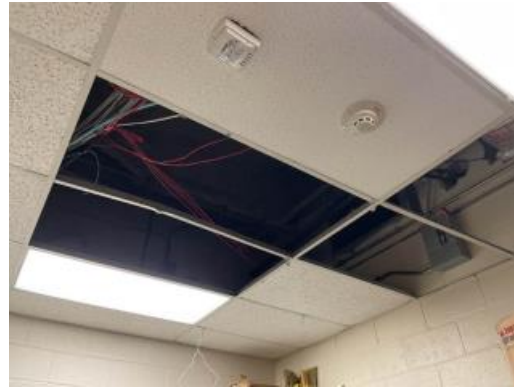
Acoustic ceiling tiles

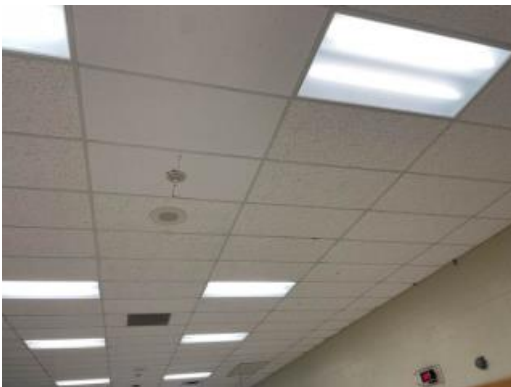
Sagging acoustic ceiling grid and tiles

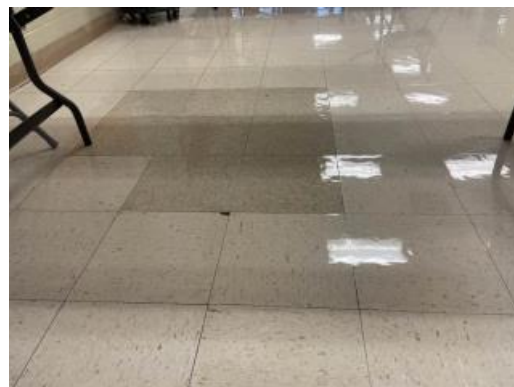
Vinyl composition tile flooring deficient

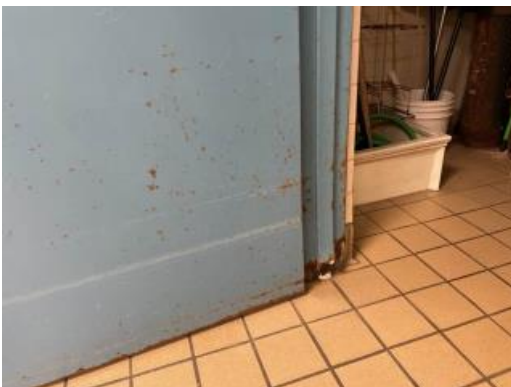
Steel door corrosion at bottom of door and frame

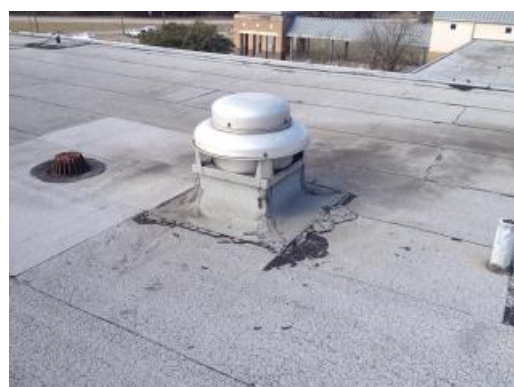
Damaged roof exhaust fan

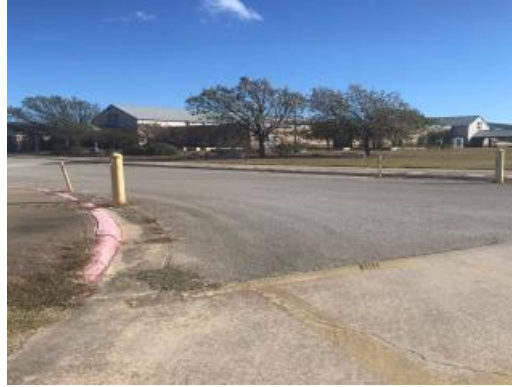
Cracked asphalt pavement

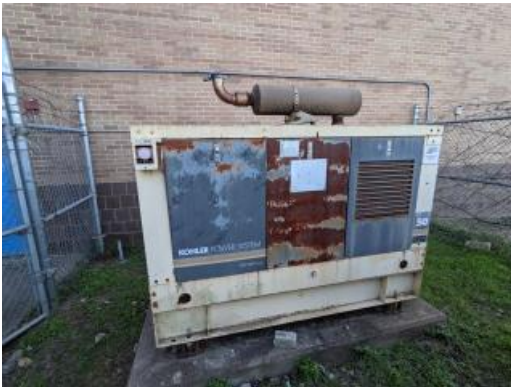
Corroded emergency generator
