FACILITY CONDITION ASSESSMENT

Barrington ES | February 2022

Barrington ES - Deficiency Summary

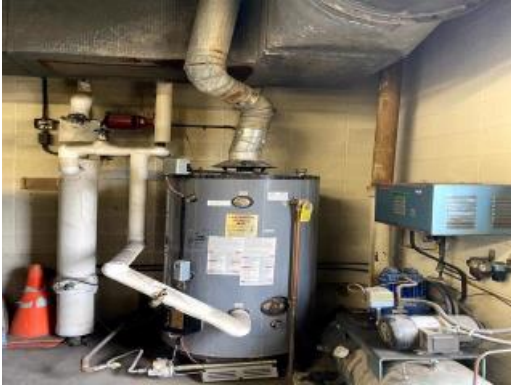
Rusted water heater piping

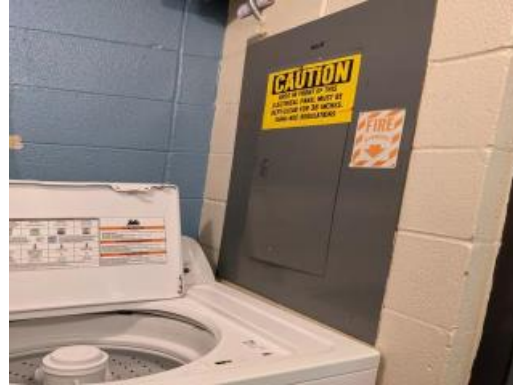
Obstructed electrical panel

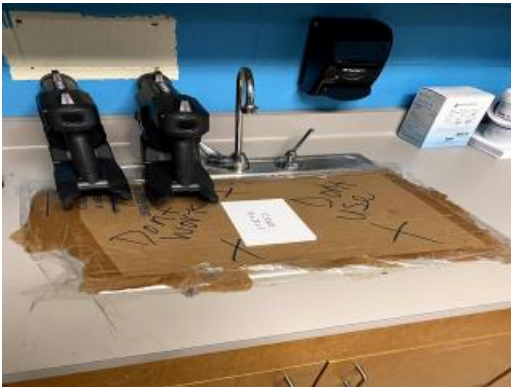
Classroom sink not working

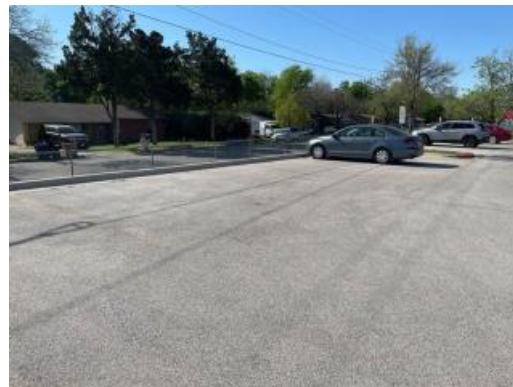
Parking lot missing striping

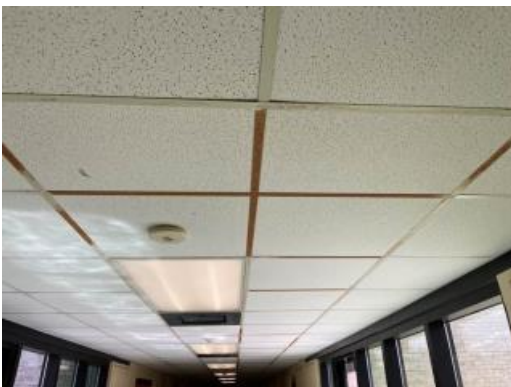
Ceiling grid corroded and damaged.

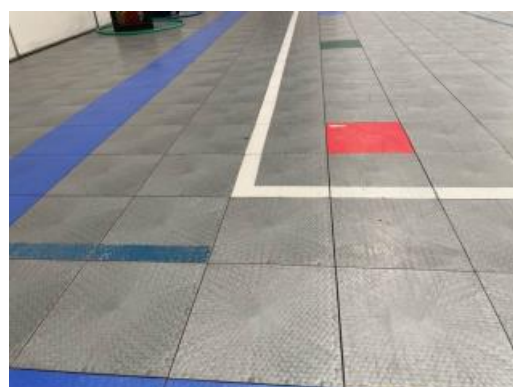
Gym flooring at end of life

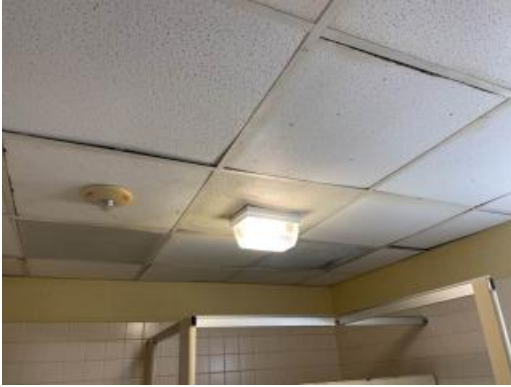
Restroom acoustic ceiling tiles past useful life

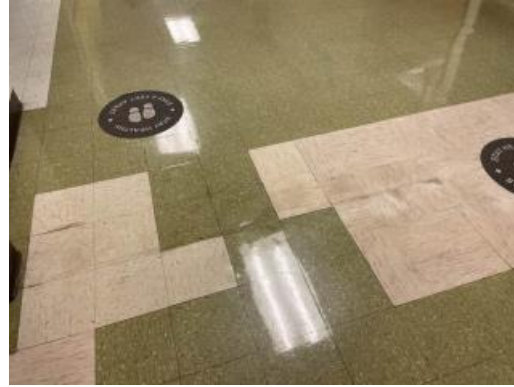
Vinyl composition tile flooring beyond useful life
