FACILITY CONDITION ASSESSMENT

Bear Creek ES | February 2022

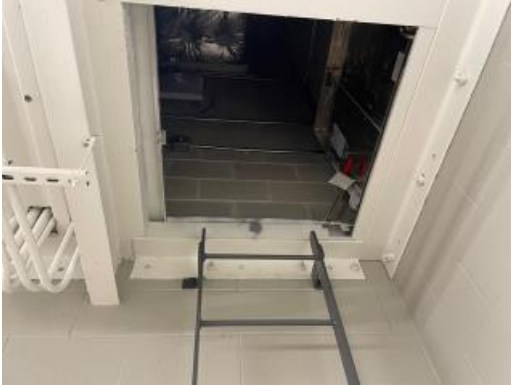
Note: Access ladder to mezzanine and HVAC Equipment is unsafe. Ladder does not extend to a level to allow a technician to safely access the mezzanine floor and exit the ladder.

Location: Room A-127A Cafe Chair Storage room

Ladder deficiency, cafeteria chair storage room.

Deficiency	Category	Qty	UoM	Priority	Repair Cost	ID
Permanent Roof Access Installation	Deferred Maintenance	1	Ea.	4	\$3,641	5908
