FACILITY CONDITION ASSESSMENT

Burger Athletic Complex | February 2022

Executive Summary

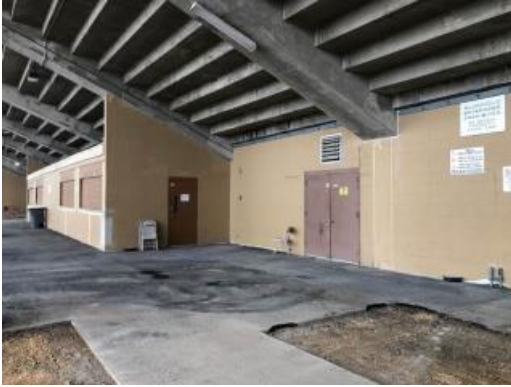
Well worn concrete slabs

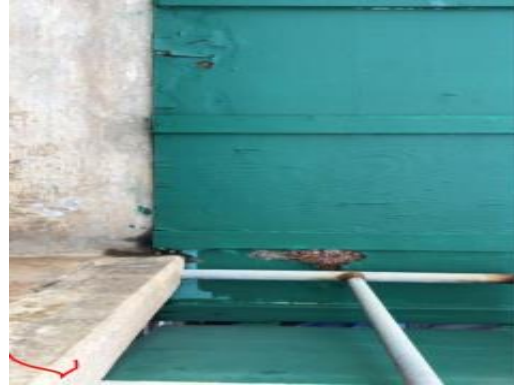
Damaged wood wall panels

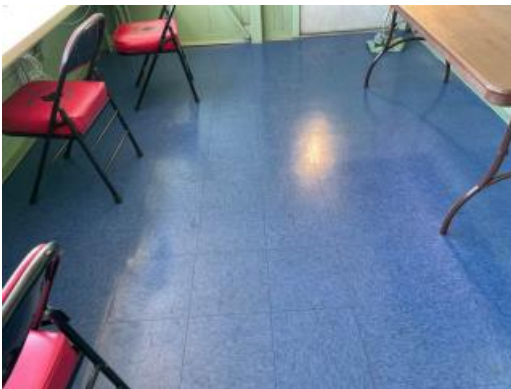
Aged vinyl composition tile flooring

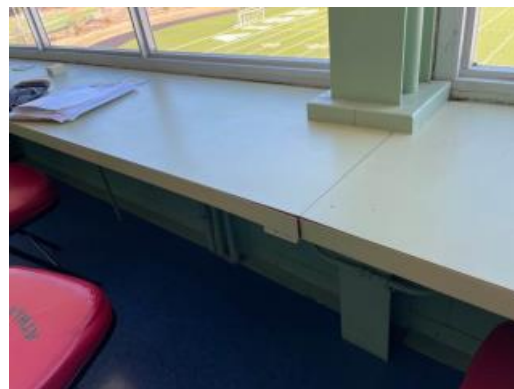
Fixed casework countertop delaminated

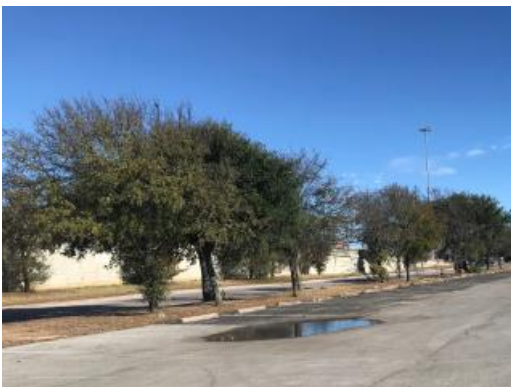
Potholes in parking lot

Deficiency	Category	Qty	UoM	Priority	Repair Cost	ID
Asphalt Driveway Replacement	Capital Renewal	26,118	SF	3	\$167,950	653
<p>Note: the areas with potholes need to be resurfaced soon; all parking lots and driveways need to be resurfaced within the next 5 years</p> <p>Location: east side of football stadium; large parking lot along jones road</p>						
Fencing Replacement (4' Chain Link Fence)	Capital Renewal	25	LF	4	\$1,180	652
<p>Note: Fence is damaged and bent, mostly due to overgrown weeds and vines. Portions should be replaced.</p> <p>Location: north property line (along drive between s lamar blvd and soccer field)</p>						
Fencing Replacement (4' Chain Link Fence)	Capital Renewal	25	LF	4	\$1,180	1195
<p>Location: north property line</p>						
Site Drainage Regrading	Deferred Maintenance	26,118	SF	4	\$37,555	655
<p>Note: ponding in several areas around site due to low points without drainage inlets</p> <p>Location: throughout site</p>
