FACILITY CONDITION ASSESSMENT

Casis ES | February 2022

Executive Summary

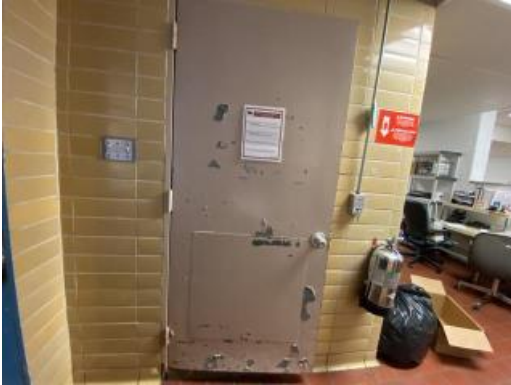
Damaged metal door

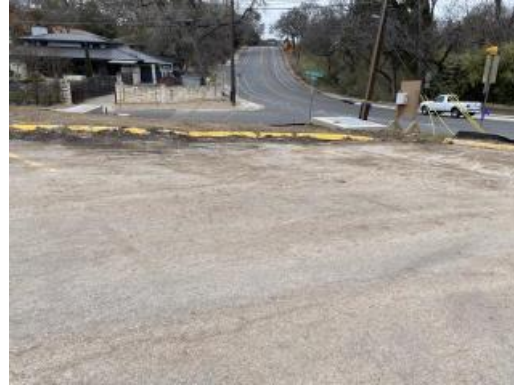
Aged asphalt pavement

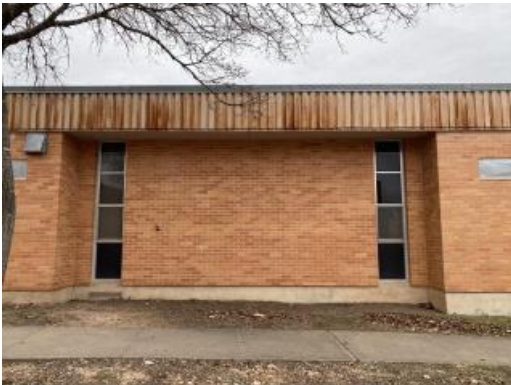
Rusted metal fascia

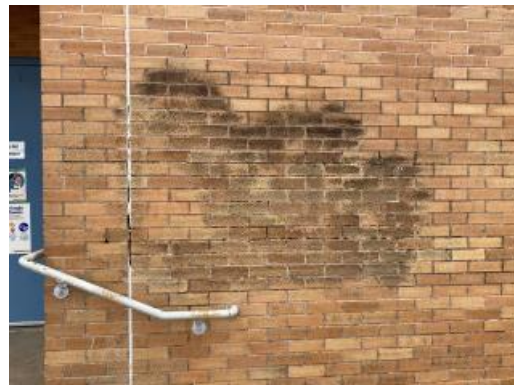
Stained exterior brick wall

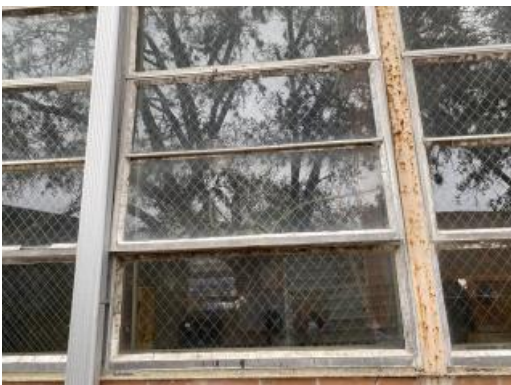
Aged exterior windows

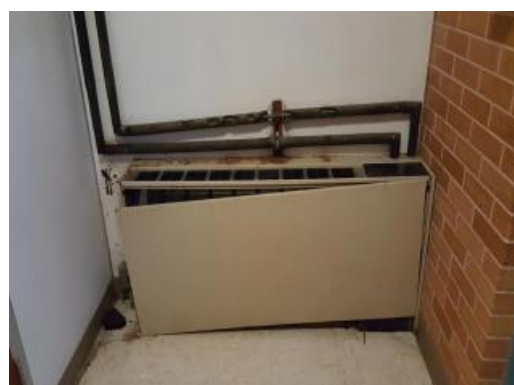
Damaged air conditioning unit

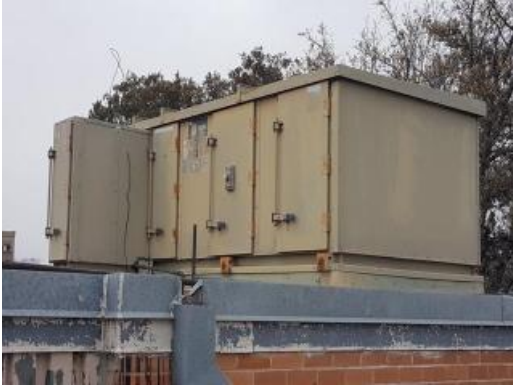
Corroded roof top unit

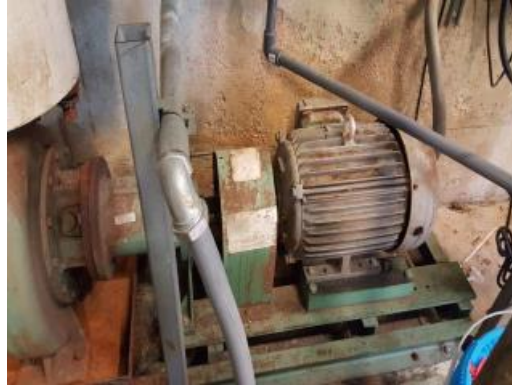
Aged pump
