# FACILITY CONDITION ASSESSMENT

*Cook ES* | February 2022

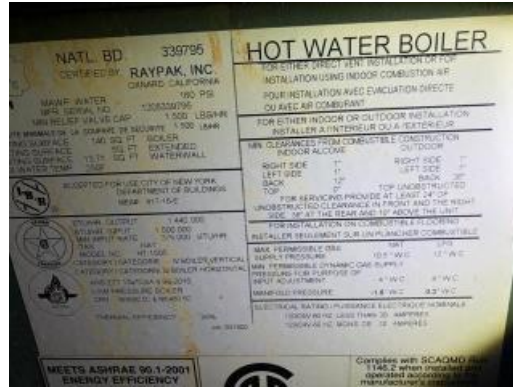
Hot water boiler beyond useful life

Deficiency	Category	Qty	UoM	Priority	Repair Cost	ID
Boiler Replacement	Capital Renewal	1	Ea.	2	\$54,285	4246
<b>Sub Total for System</b>		<b>1</b>	<b>items</b>		<b>\$54,285</b>

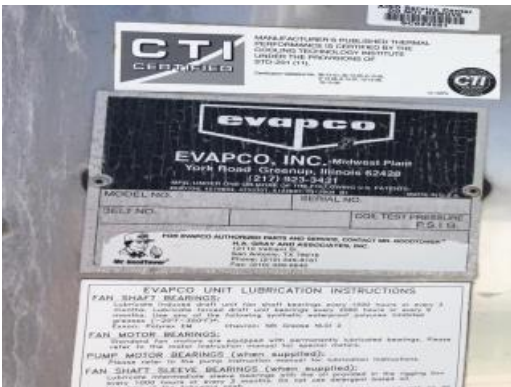
Cooling tower name plate

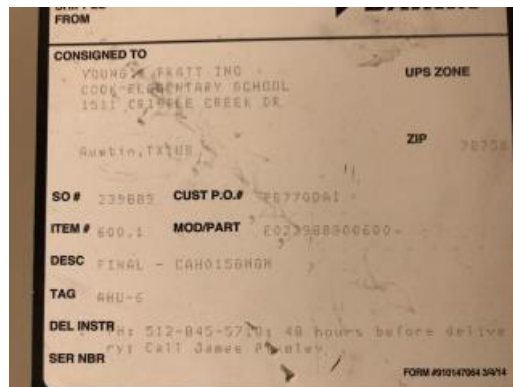
Air handling unit name plate

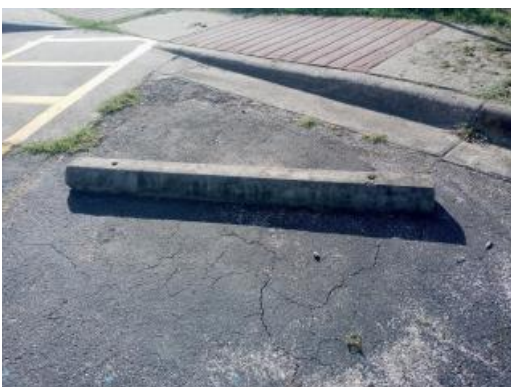
Paver marker is broken

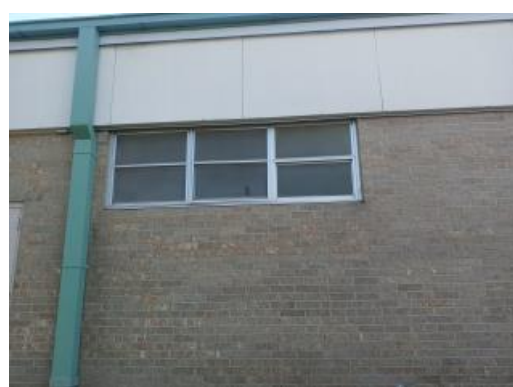
Exterior windows are beyond their useful life

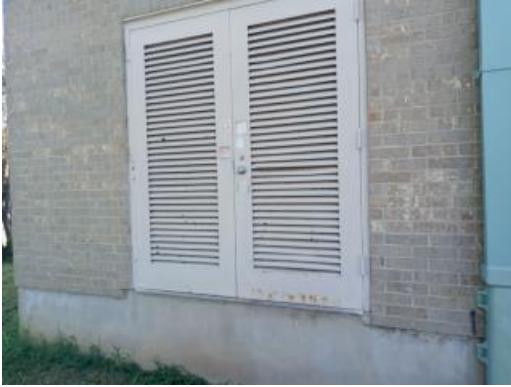
Exterior doorway is well worn

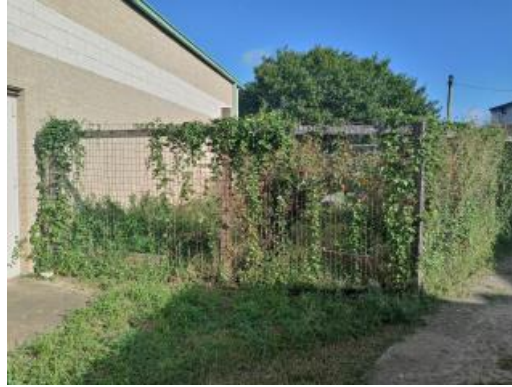
Fence is overgrown

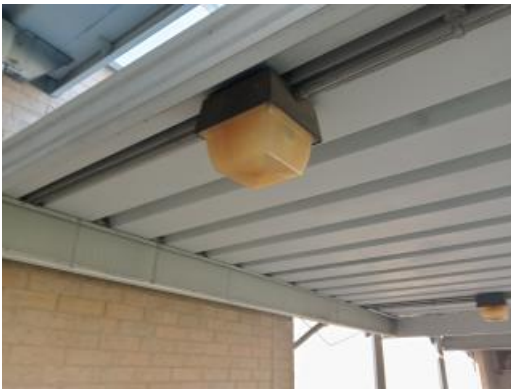
Light system is well used

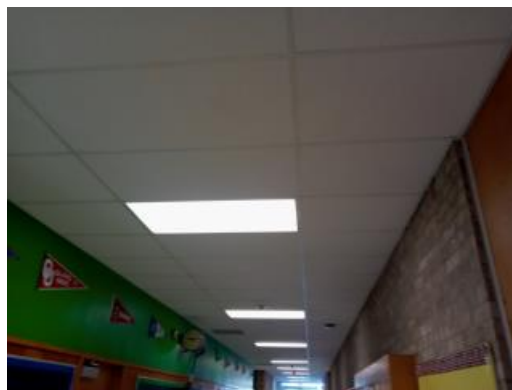
Acoustic ceiling tiles are well worn
