FACILITY CONDITION ASSESSMENT

Delco Activity Center | February 2022

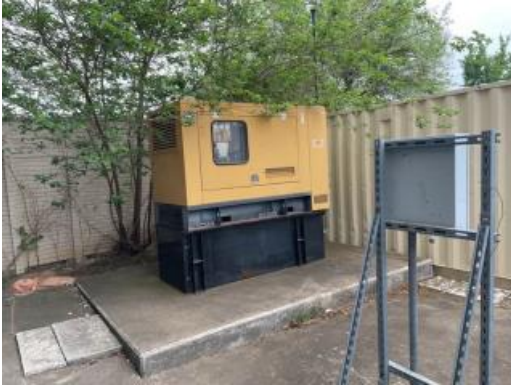
Deficiency	Category	Qty	UoM	Priority	Repair Cost	ID
Generator Replacement	Capital Renewal	1	Ea.	2	\$42,907	5063
Note: Generator is not functional per management						
Location: Exterior mechanical yard						
	Sub Total for System	1	items		\$42,907

Generator is not functional

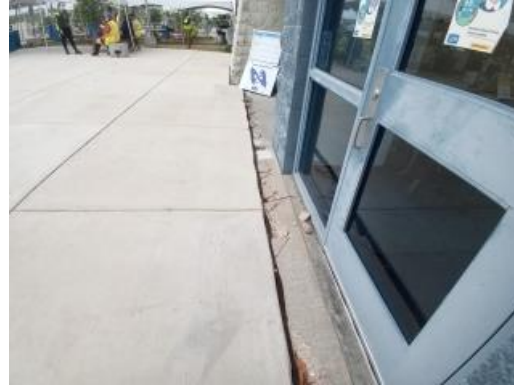
Exterior doors are worn

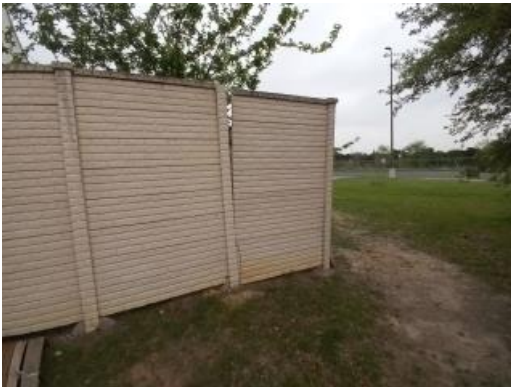
Deficiency	Category	Qty	UoM	Priority	Repair Cost	ID
Structural Study Recommended	Deferred Maintenance	1	Job	1	\$6,455	5126
Note: Cracking on CMU Wall and Fondation is sinking						
Location: Southend of Building						
Structural Study Recommended	Deferred Maintenance	1	Job	1	\$6,455	6965
Note: Structural study to detail scope of work based on the 2017 crawlspace deficiencies provided by AISD						
	Sub Total for System	2	items		\$12,910	
	Sub Total for School and Site Level	7	items		\$237,386

Exterior enclosure wall shows differential movement.

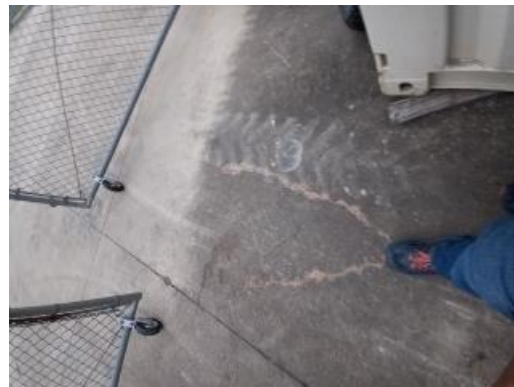
Concrete pavement is stained

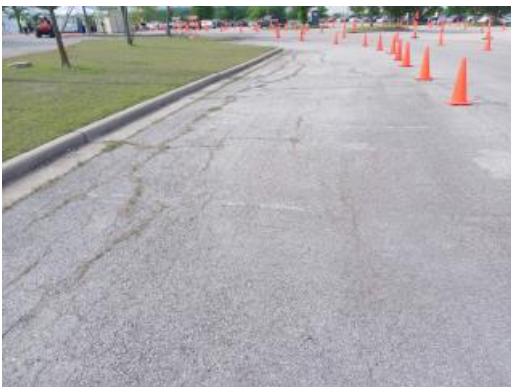
Asphalt pavement cracked and has vegetation growth
