FACILITY CONDITION ASSESSMENT

Hart ES | February 2022

Executive Summary

Hart ES is located at 8301 Furness Dr in Austin, Texas. The oldest building is 22 years old (at time of 2020 assessment). It comprises 81,042 gross square feet.

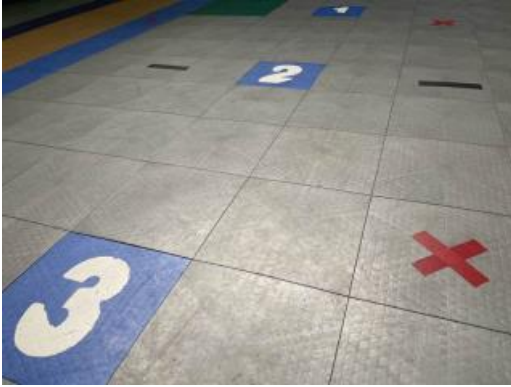
Deficiency	Category	Qty	UoM	Priority	Repair Cost	ID
Athletic Sport Flooring Replacement Note: corners lifting, traction eroding	Capital Renewal	3,494	SF	3	\$53,603	5430
Interior Door Hardware Replacement Note: to be replaced with new door install	Capital Renewal	44	Door	3	\$65,323	5435
Interior Door Replacement Note: end of life Location: classrooms restrooms	Capital Renewal	28	Door	3	\$52,517	5433
Metal Interior Door Replacement Note: end of life Location: mechanical rooms	Capital Renewal	4	Door	4	\$11,575	5432
Vinyl Composition Tile Replacement Note: cracked, end of life Location: numerous	Capital Renewal	13,977	SF	4	\$114,300	5431
Interior Door Repainting Note: end of life Location: classrooms, restrooms	Deferred Maintenance	12	Door	5	\$535	5434
Interior Wall Repainting Note: missing chipped stained Location: various	Deferred Maintenance	13,450	SF Wall	5	\$30,212	5429
	Sub Total for System	7	items		\$328,065

Corners are lifting and tiles have lost slip resistant texture on gym floor

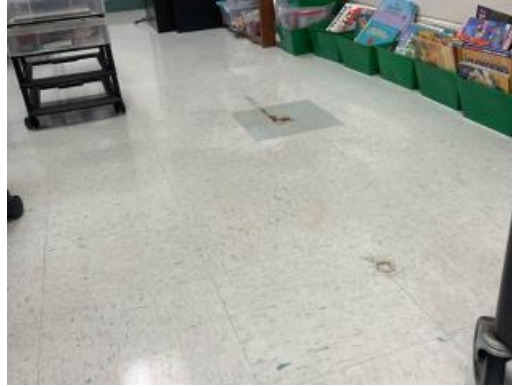
Stained and damaged classroom vinyl composition tile flooring

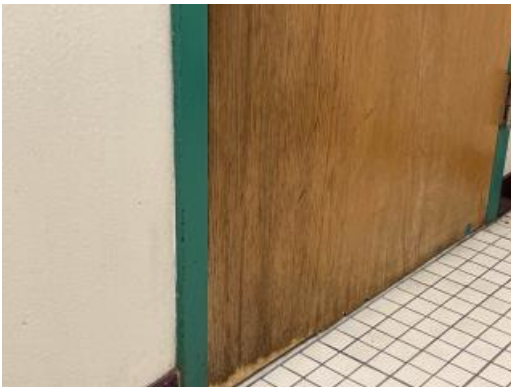
Damaged wood restroom door

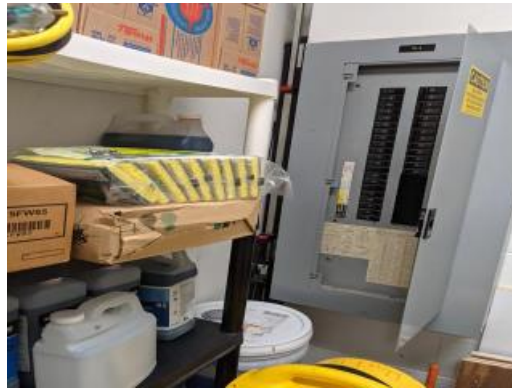
Uniformat Description	LC Type Description	Qty	UoM	Repair Cost	Remaining Life
Power Distribution	Panelboard - 120/208 225A	11	Ea.	\$60,495	8
	Note: Panel in the admin area have exposure due to missing breachers, electrical gear does not have NEC safety PPE/ARC flas labelling, and installations do not comply with NEC clean space requirements				
Power Distribution	Panelboard - 120/208 125A	7	Ea.	\$10,212	8
Power Distribution	Panelboard - 120/208 400A	2	Ea.	\$24,683	8
	Sub Total for System	5	items	\$212,873

Obstructed electrical panel
