FACILITY CONDITION ASSESSMENT

House Park | February 2022

Executive Summary

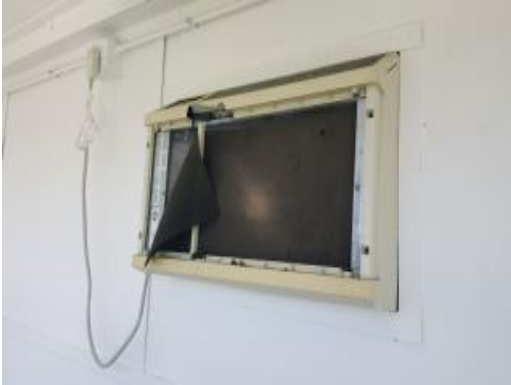
Window unit is beyond service life.

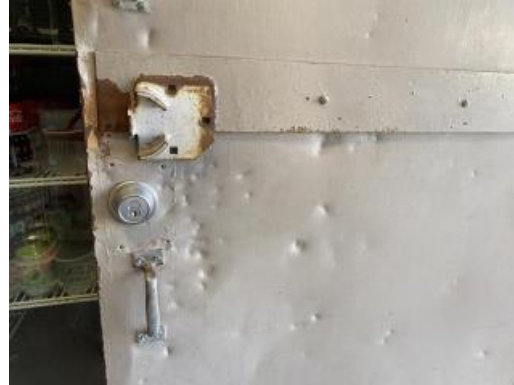
Metal door is rusted and damaged.

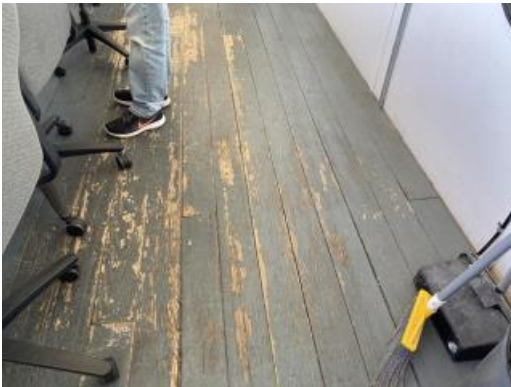
Wood floor is damaged, worn, and paint is flaking.

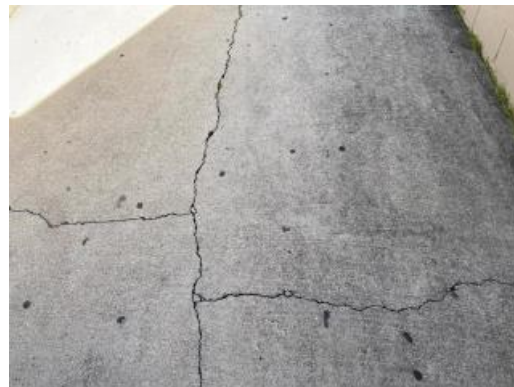
Asphalt pavement is cracked.
