# FACILITY CONDITION ASSESSMENT

*Lamar MS* | February 2022

Lamar MS is located at 6201 Wynona Ave in Austin, Texas. The oldest building is 65 years old (at time of 2020 assessment). It comprises 121,594 gross square feet.

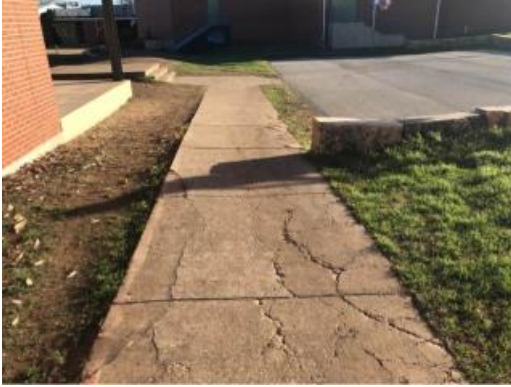
Damaged east side sidewalk

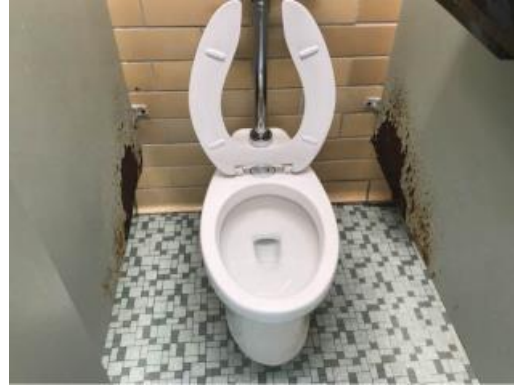
Boys Restroom partitions rusted and beyond service life

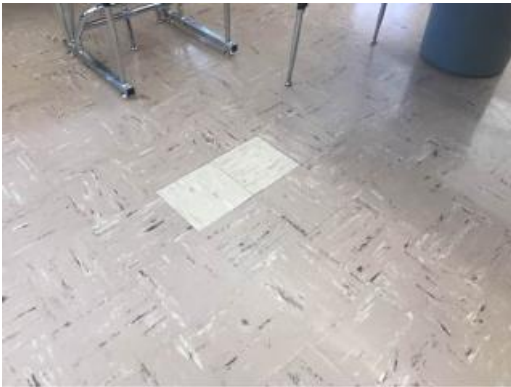
Deficient classroom floors

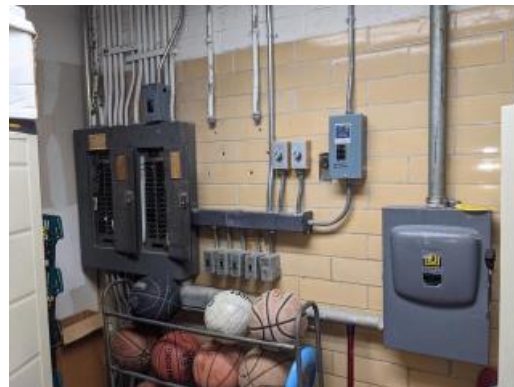
Obstructed electrical panels
