FACILITY CONDITION ASSESSMENT

Nelson Field Bus Terminal | February 2022

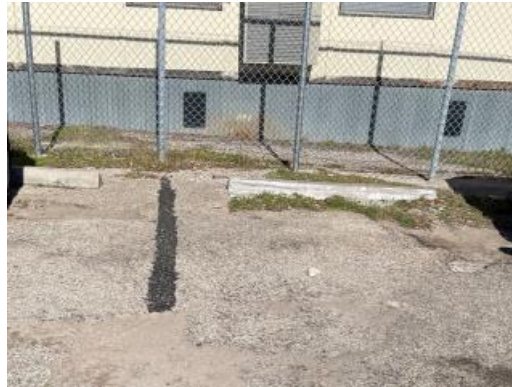
Parking spaces are worn

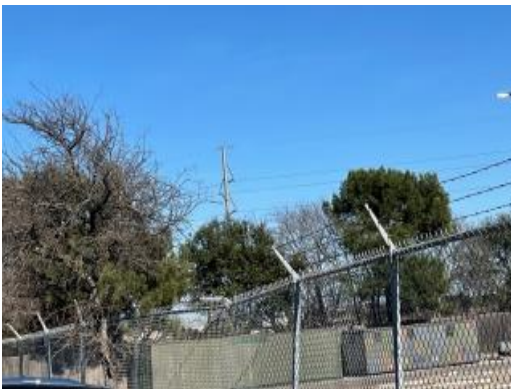
Metal fence is bent
