# FACILITY CONDITION ASSESSMENT

*Palm ES* | February 2022

Palm ES is located at 7601 Dixie Dr in Austin, Texas. The oldest building is 33 years old (at time of 2020 assessment). It comprises 79,082 gross square feet.

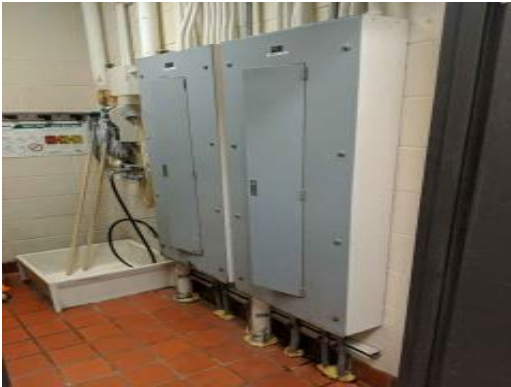
Typical electrical distribution panels

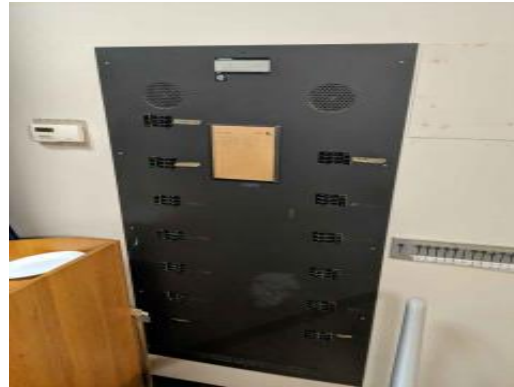
Stage sound system

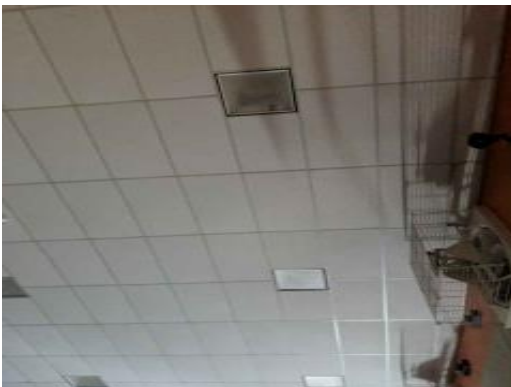
Typical accoustical ceiling

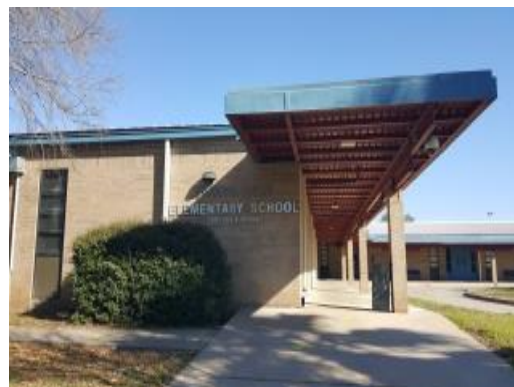
Covered Walkway to School Entrance

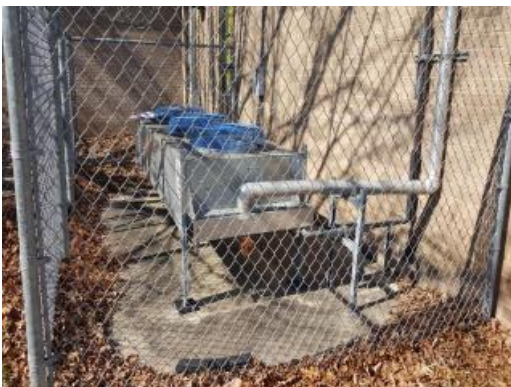
HVAC Condensing unit

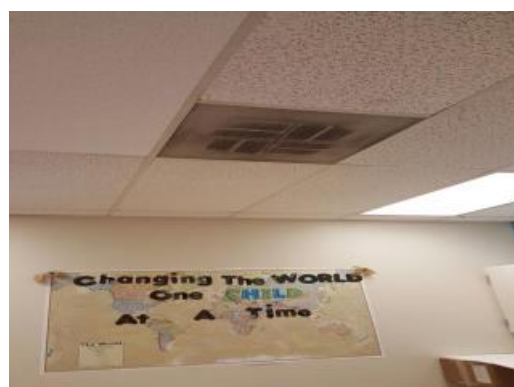
Worn vent

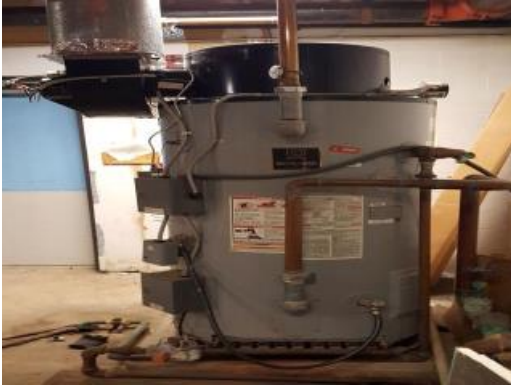
Corroding water heater pipes

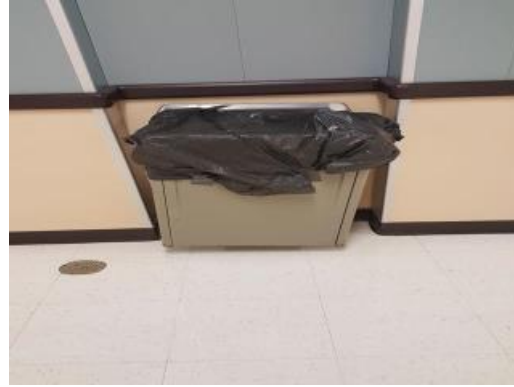
Drinking fountain not working
