FACILITY CONDITION ASSESSMENT

Reilly ES | February 2022

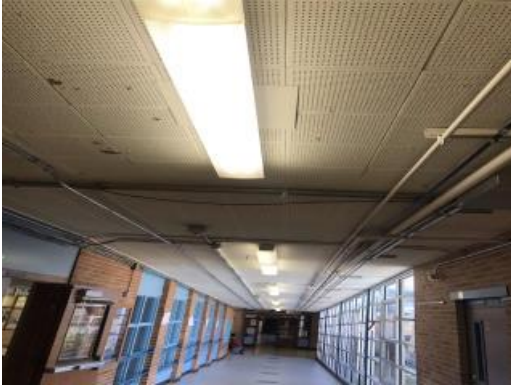
Typical Hallway Finishes

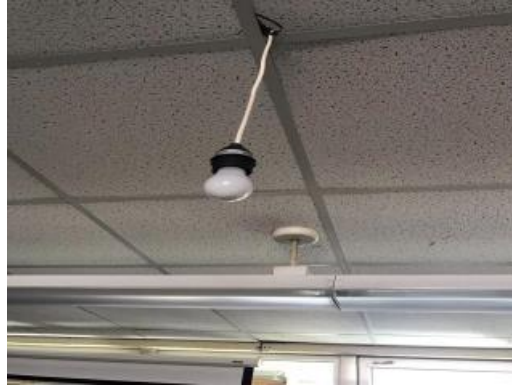
Interior lighting

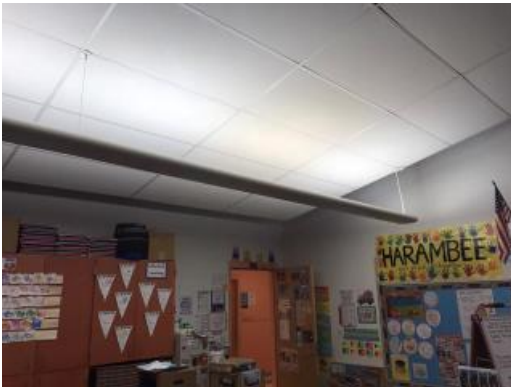
Typical classroom finishes

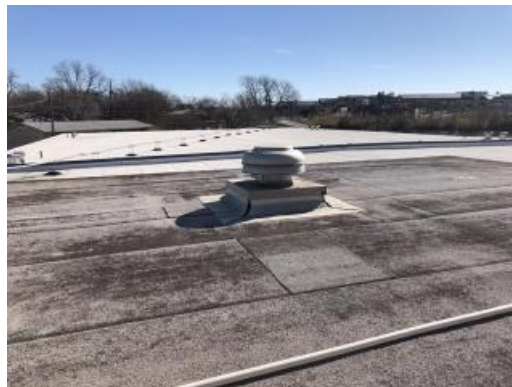
Roof Exhaust

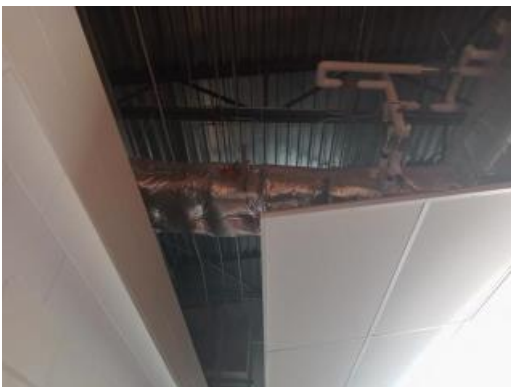
Ductwork exposed

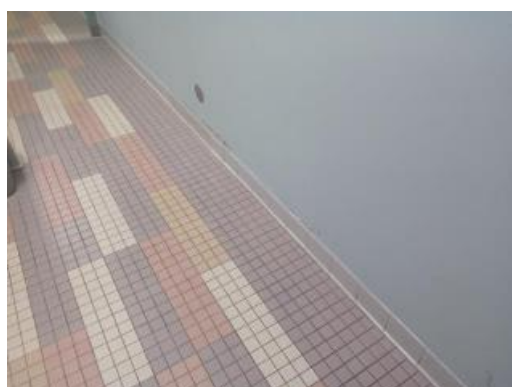
Damaged baseboard and bathroom tile

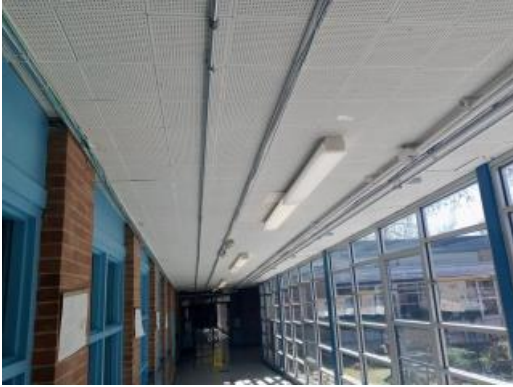
Typical Hallway Finishes
