FACILITY CONDITION ASSESSMENT

Ridgetop ES | February 2022

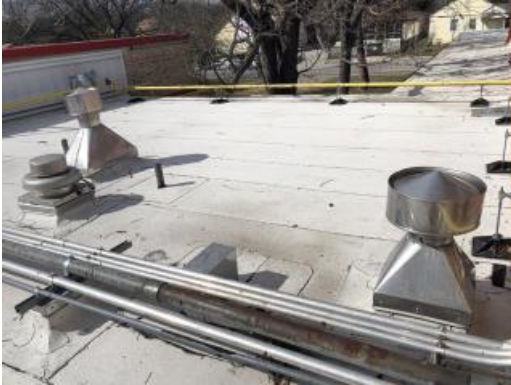
Roof exhausts discolored

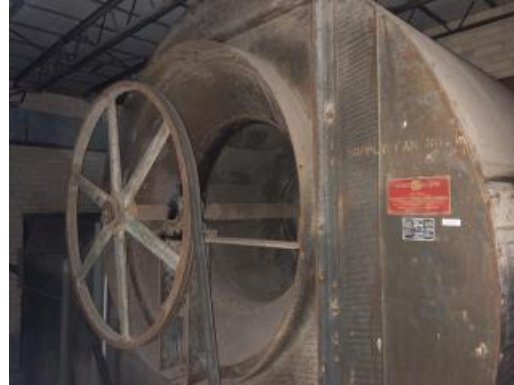
Aged and rusted supply fan

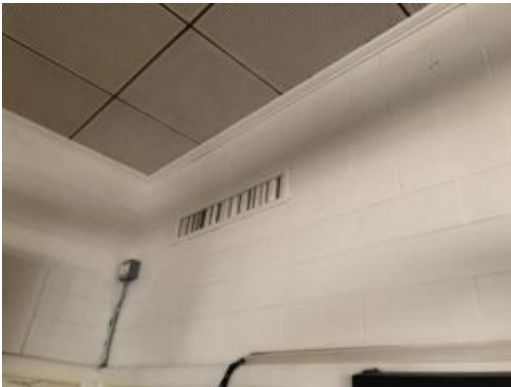
Painted glazed structural tile

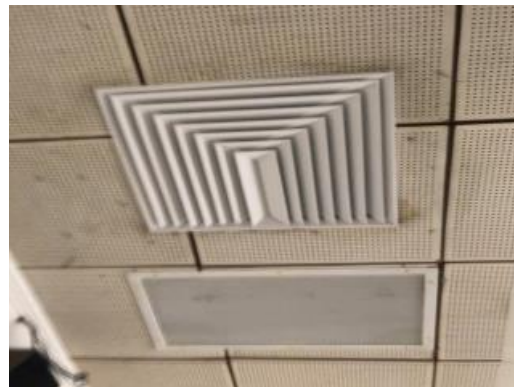
Damaged ceiling tiles

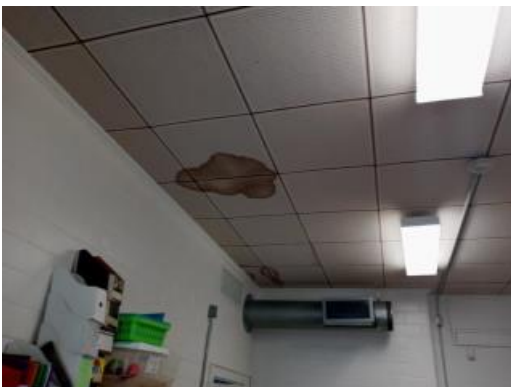
Damaged ceiling tiles
