FACILITY CONDITION ASSESSMENT

Williams ES | February 2022

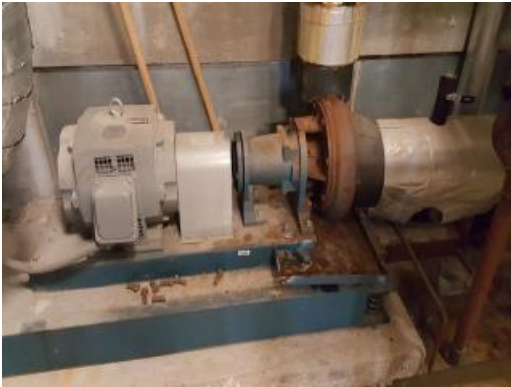
Rusted pipes

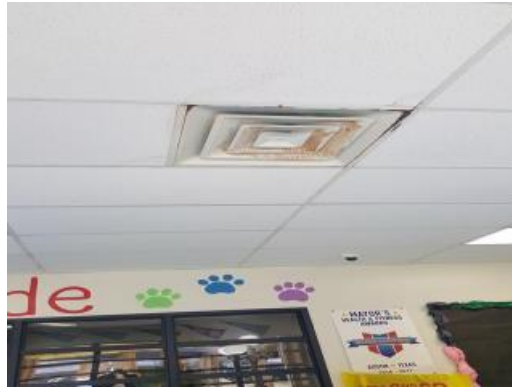
Damaged ceiling diffuser

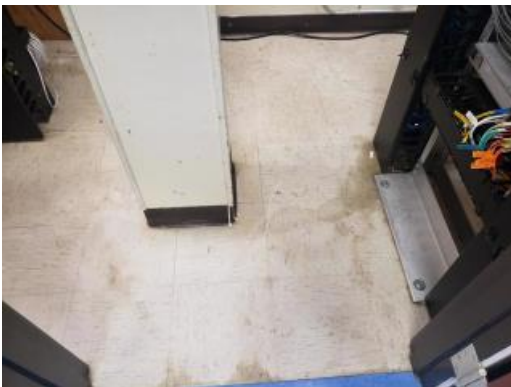
Stained vinyl composite tile

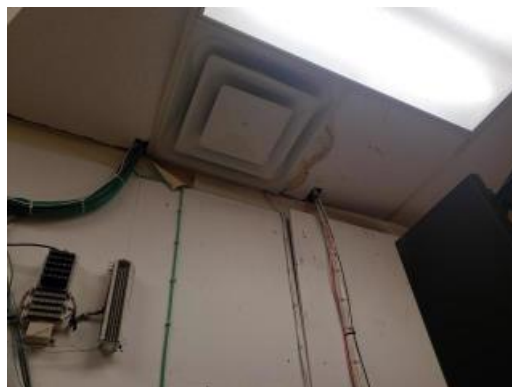
Damaged ceiling diffuser and acoustical ceiling tile

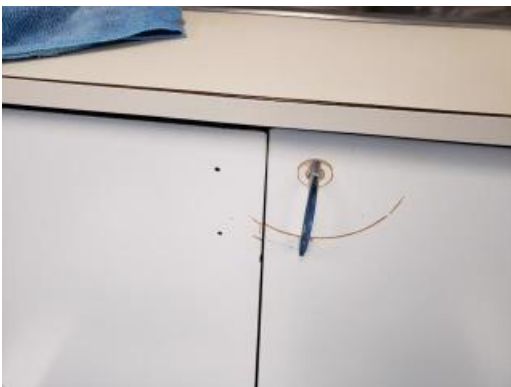
Damaged Casework

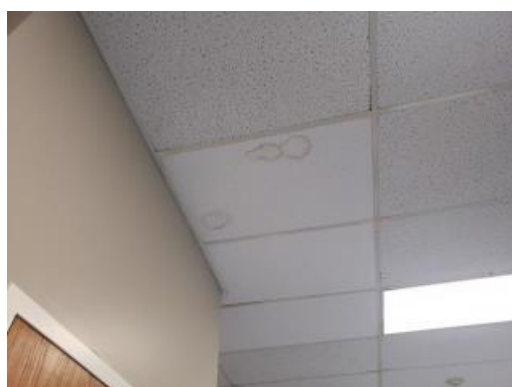
Stained acoustical ceiling tiles

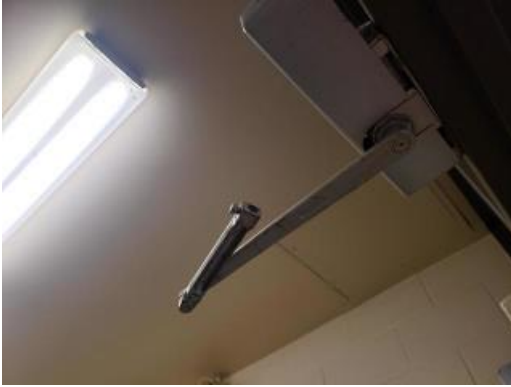
Damaged hardware
