FACILITY CONDITION ASSESSMENT

Wooten ES | February 2022

Building: 144A - Main building includes Administration Offices, Classrooms, Cafeteria, & Gym.

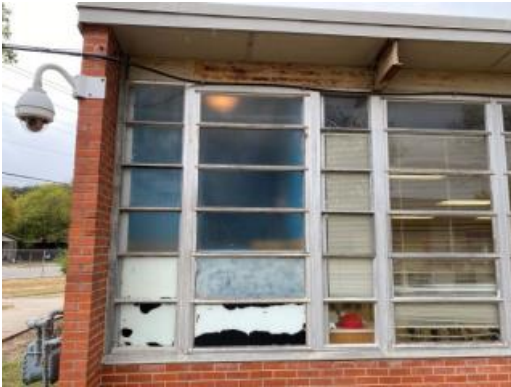
Exterior windows are beyond their expected life.

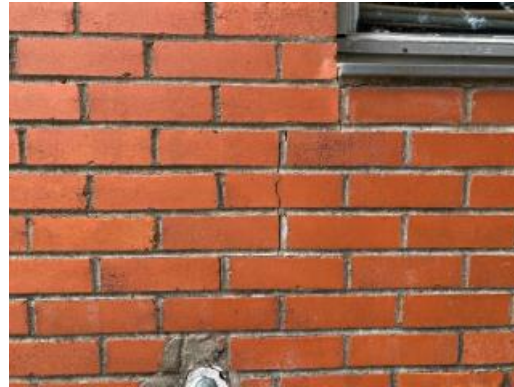
The exterior brick veneer presents cracking.

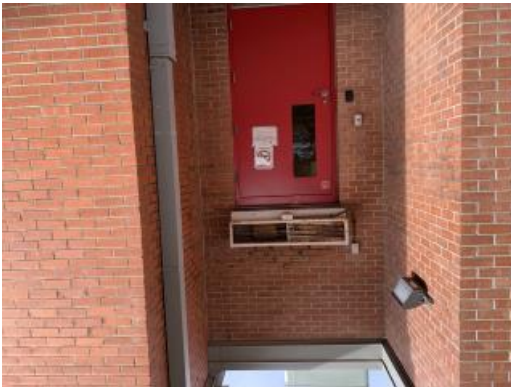
The air curtain is not operating.

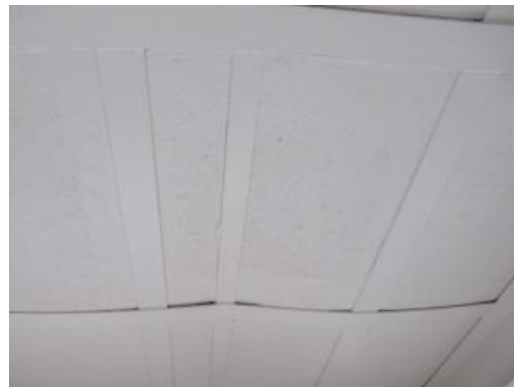
The ceiling grid is bowing and beyond useful life.
