FACILITY CONDITION ASSESSMENT

Zilker ES | February 2022

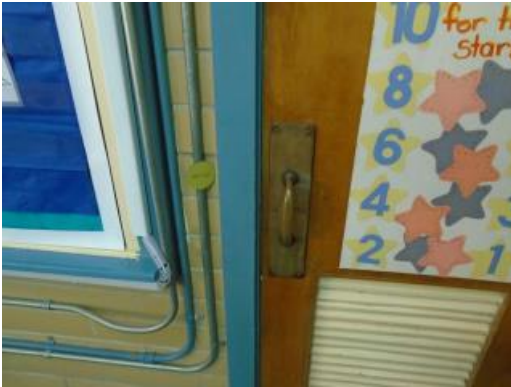
Classroom Doors are dated

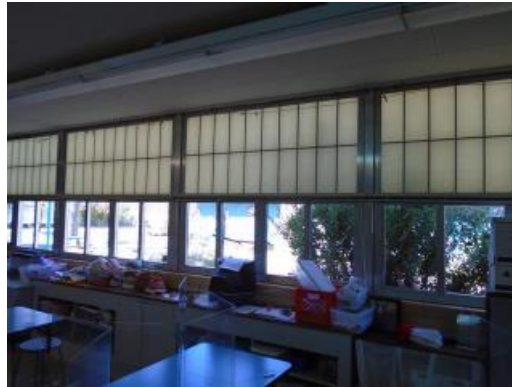
Classroom Windows are beyond their useful life

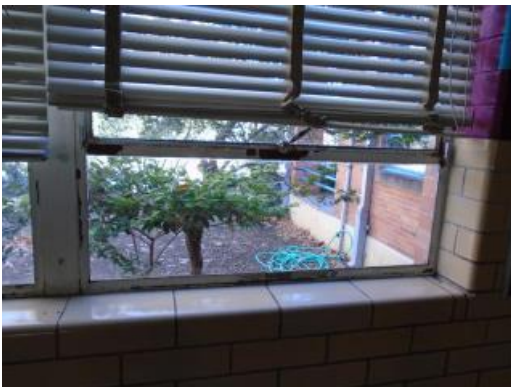
Window Frames are aged and beyond their useful life

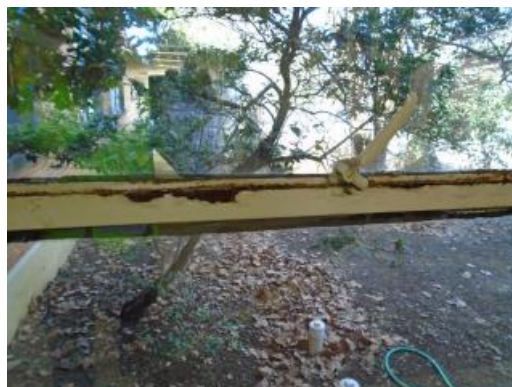
Rusted Window Latch

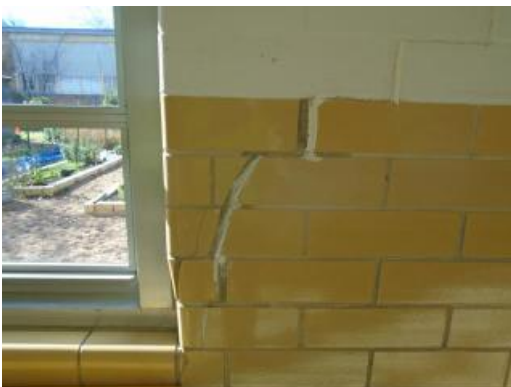
Cracked Brick Wall

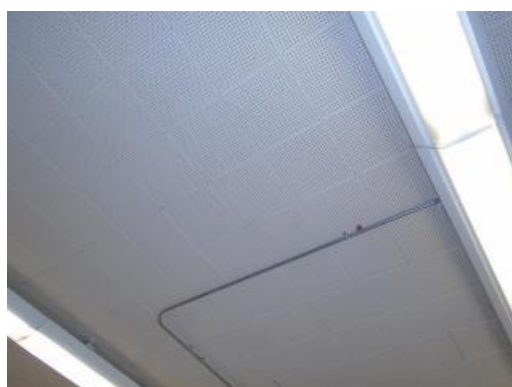
Glued on ceiling is beyond its useful life
