FACILITY CONDITION ASSESSMENT

Central Warehouse | February 2022

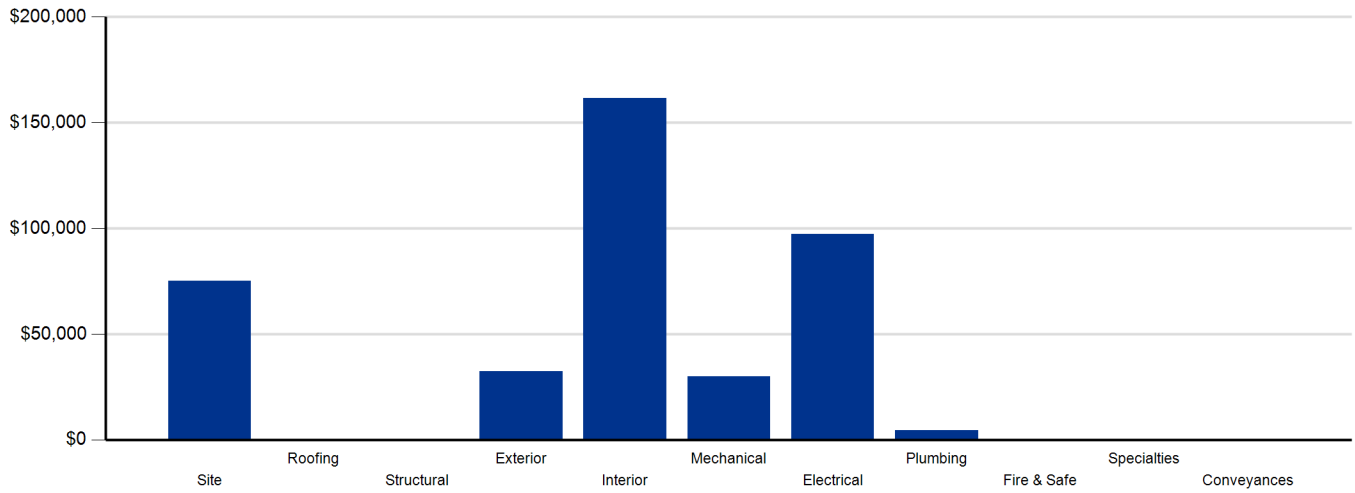
Figure 1: System Deficiencies

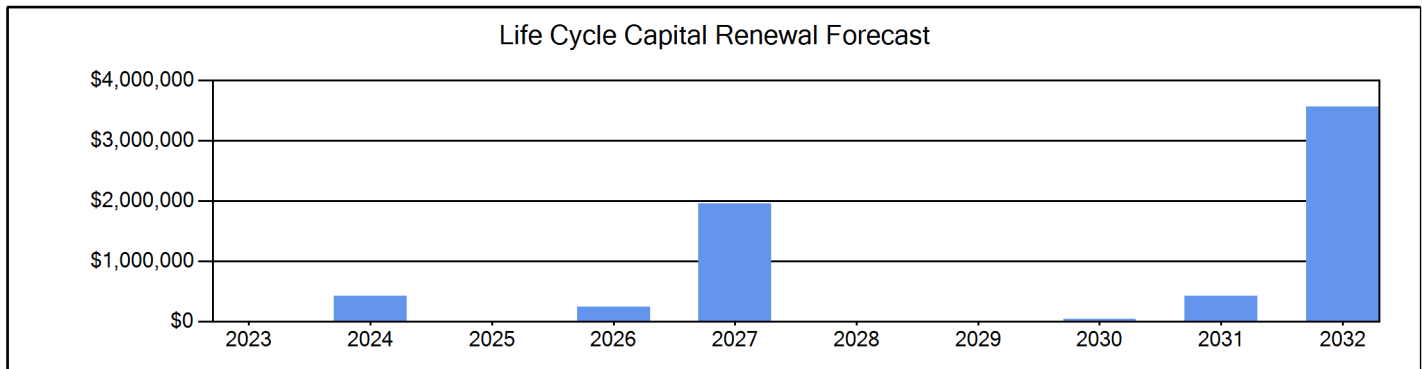
Figure 2: Ten Year Capital Renewal Forecast

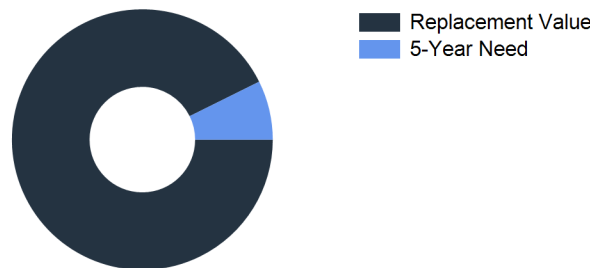
Figure 3: 5-Year FCA

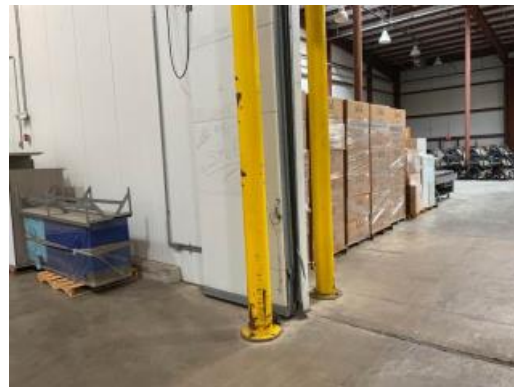
Damaged insulated sliding door

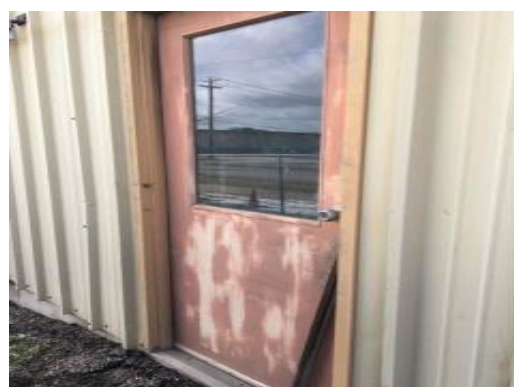
Steel doors are beyond useful life.

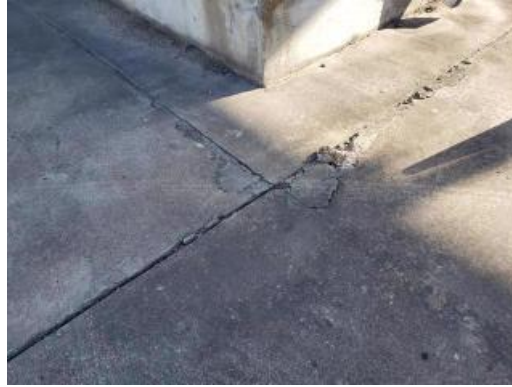
Cracked concrete pavement.
