The Educational Suitability Assessment of Akins Early College High School earned a 59% overall score and places the campus in a category of Average. The assessment consists of seven General Building categories and eight Academic categories to determine areas that need more attention.

Austin ISD Educational Suitability Assessment Criteria

Akins Early College High School

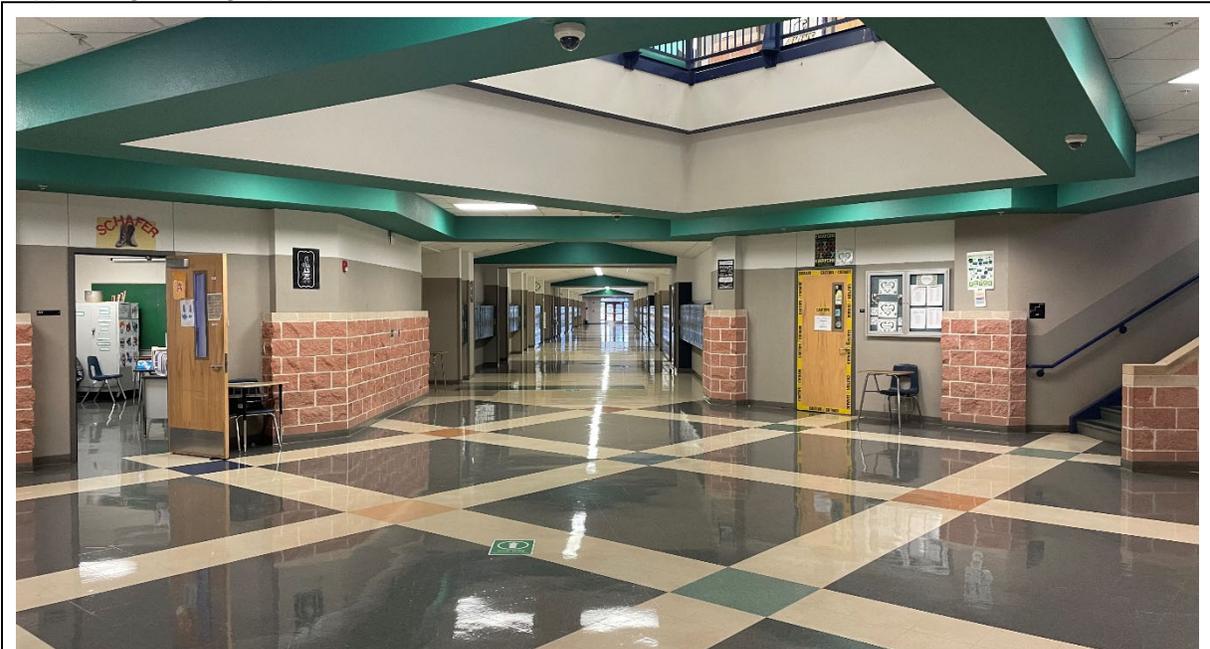
Main corridors and circulations in main studio building. Corridors are wide and have natural daylight.

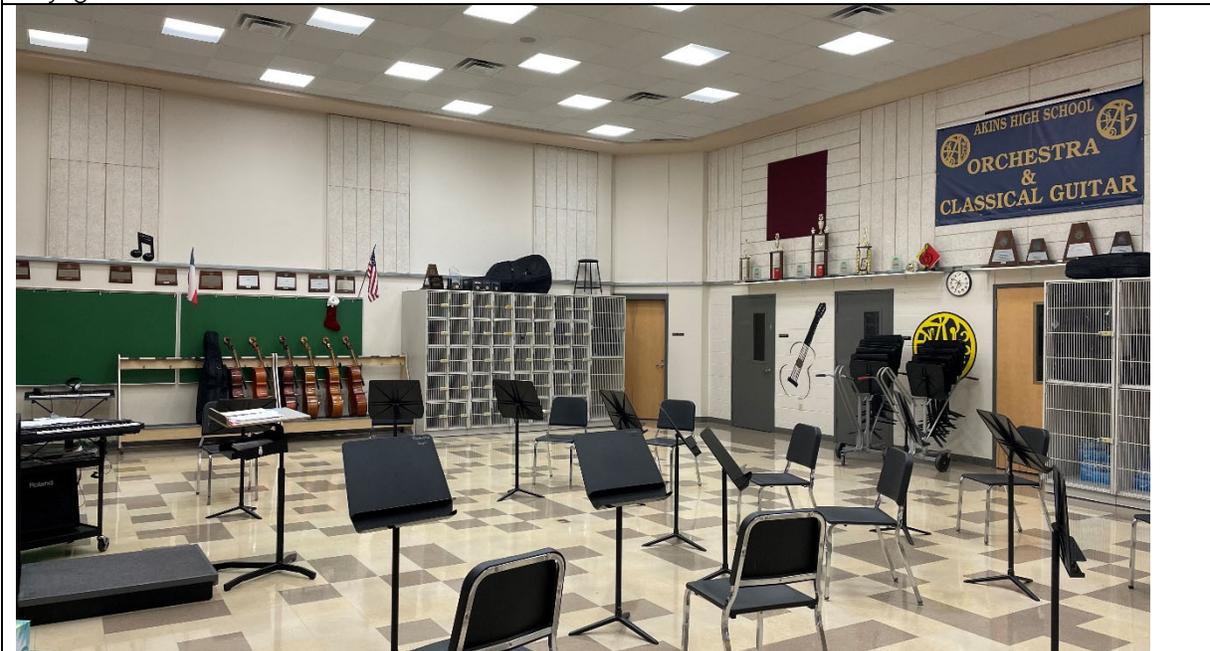
Fine Arts: Orchestra room is under-sized. Band, orchestra, choir all have limited practice rooms and current practice rooms are being used as storage.

10.3	Are orchestra and support spaces appropriately configured per the ed spec?			3				Comments	1.00	3.00	
1 Very unsatisfactory - Too small, missing program spaces 2 Unsatisfactory - Too small, poor condition 3 Neutral - Adequate size, adequate condition, needs updates or renovations to function well. 4 Satisfactory - Good size, good condition 5 Very Satisfactory - Generous size, excellent condition N/A Does not apply		Orchestra and Guitar shard a room, Room 109, which is labeled as Choir. Has practice room uniform storage aux classroom where guitar is taught.

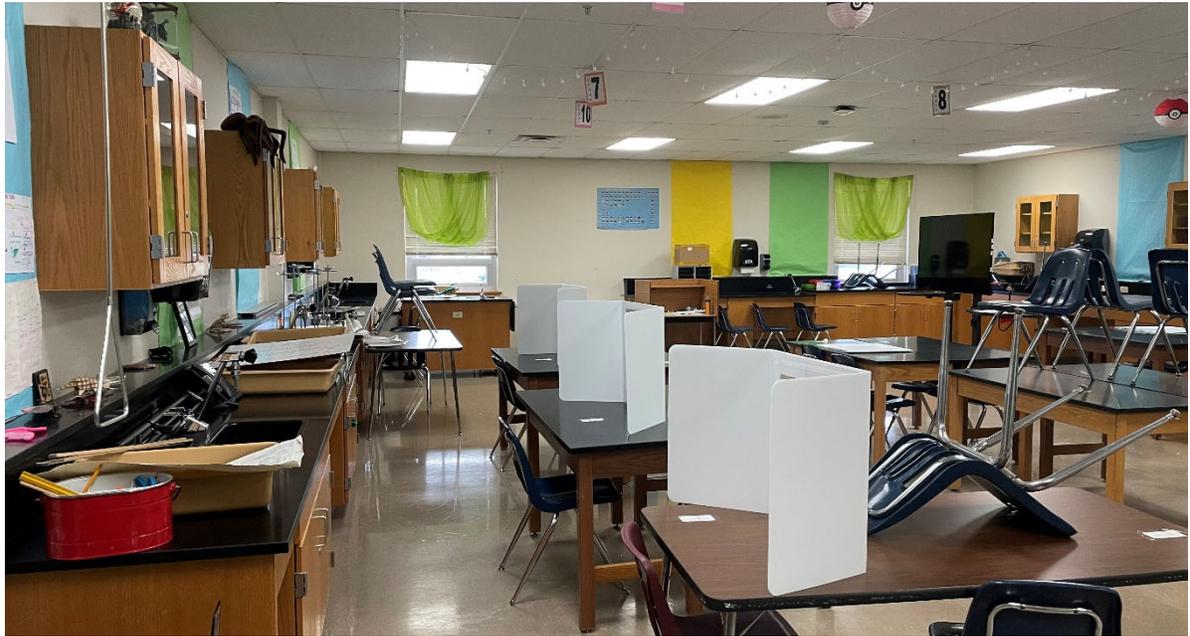
Academics and Learning: Science room are in adequate shape with flexible seating arrangements and sink areas along the edge.

N/A	Does not apply									
8.4	Are Science Labs and support spaces appropriately configured per the ed spec?			3				Comments	1.00 3.00	
1	Very unsatisfactory - No dedicated science room							Adequate size but prep rooms used as storage in main building. New tech building has two science labs on second floor that are adequate.		
2	Unsatisfactory - Too small, poor condition, no connected support space									
3	Average - Adequate size, adequate condition, needs some renovations or updates to function well									
4	Satisfactory - Good size, good condition, connected support spaces									
5	Very Satisfactory - Generous size, excellent condition, connected support spaces									
N/A	Does not apply

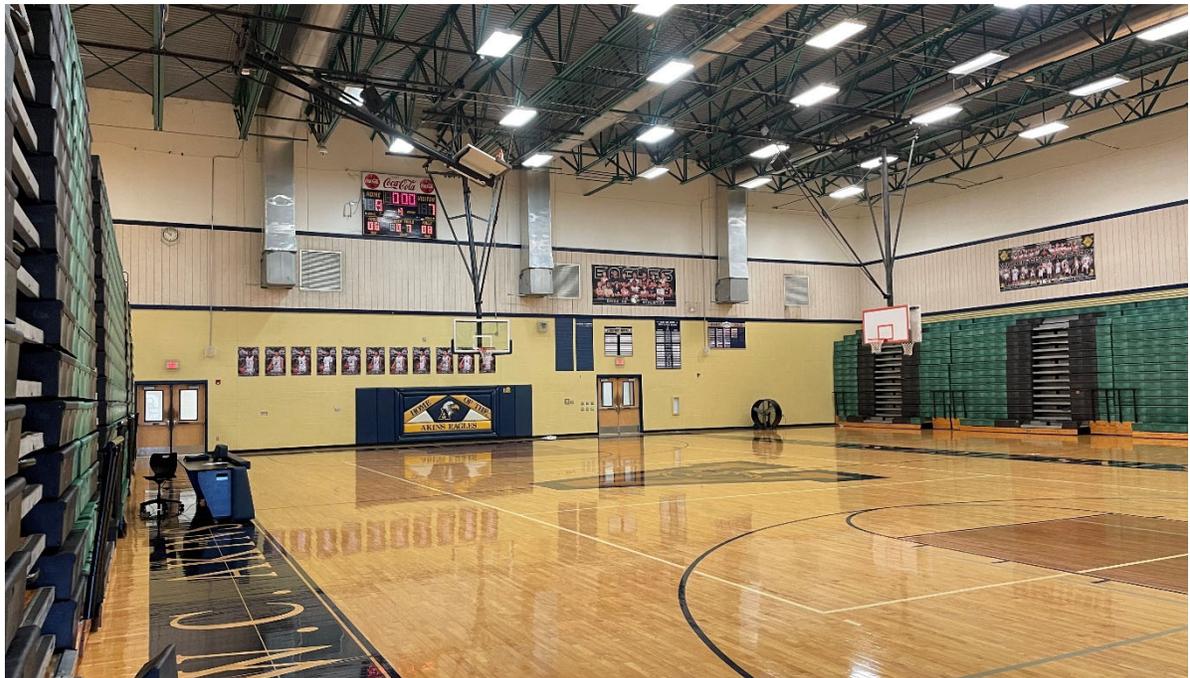
Athletics and Wellness: Large gymnasium space for basketball and volleyball is adequately sized.

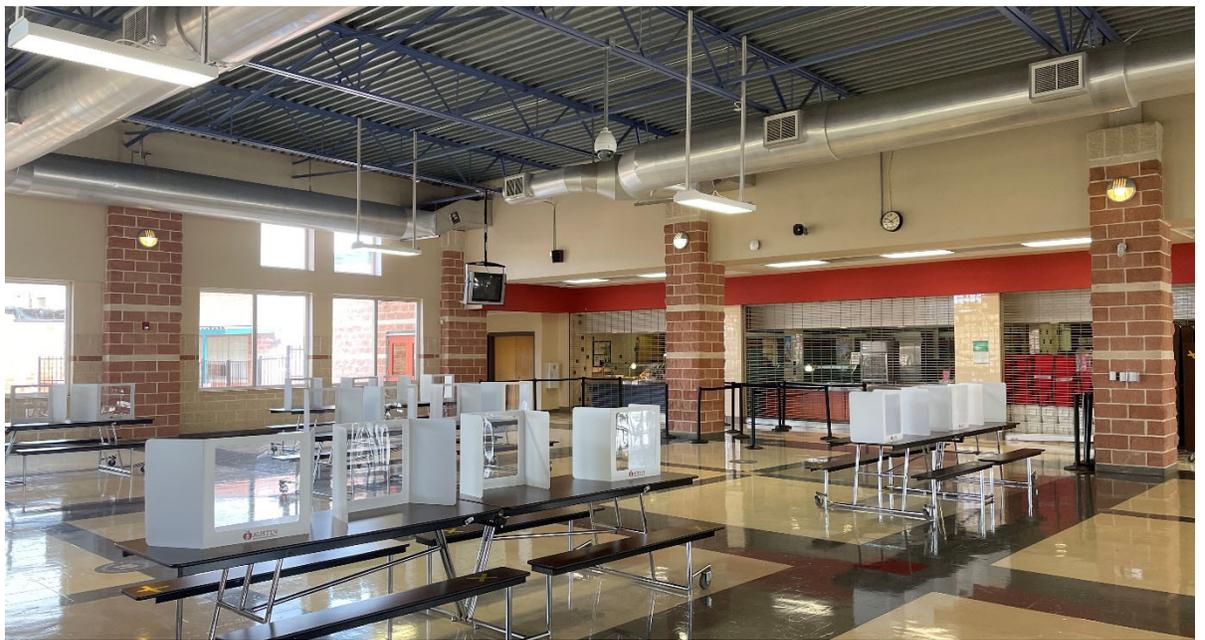
Food Service: Cafeteria located in a separate building. It is undersized for the current student enrollment.

12 - Food Services										10.00	40%	
12.1	Is the Dining Commons appropriately configured per the ed spec?		2							Comments	1.00	2.00
1	Very unsatisfactory - Too small, missing program spaces	Too small for current student enrollment. Current size ~11,000 SF. Should be 16,000 SF for 2,800 students. Connected to small outdoor area.										
2	Unsatisfactory - Too small, poor condition, only one option for eating space provided, inadequate circulation											
3	Average - Adequate size and condition, needs updates or renovations to function well											
4	Satisfactory - Good size and condition, good circulation, multiple options for eating space (ex: connection to outdoor eating space)											
5	Very Satisfactory - Generous size, excellent condition and circulation, multiple options for eating space (ex: connection to outdoor eating space)											
N/A	Does not apply

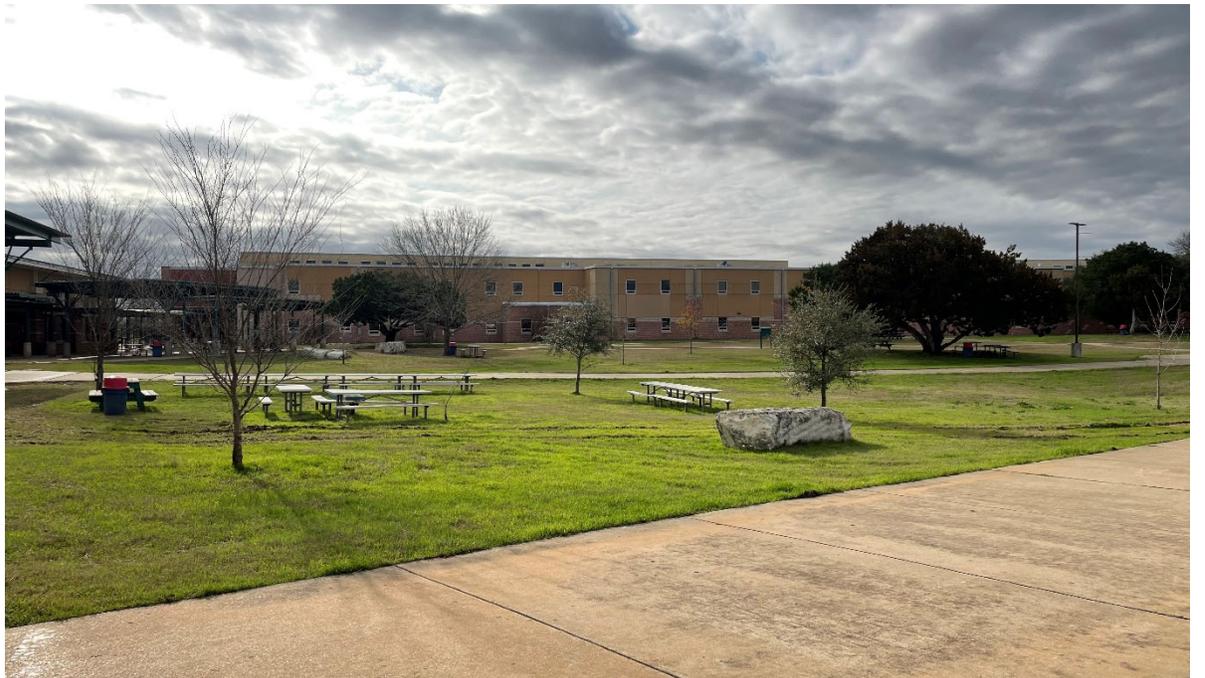
Outdoor Learning and Activity: Center courtyard space needs upgrades to landscaping and furniture to function as outdoor studios or collaboration space.

2.1	Are outdoor studios and support spaces appropriately configured per the ed spec?	1						Comments	1.00 1.00
1	Very unsatisfactory - No dedicated outdoor studios								No currently outdoor studios. Courtyard space has tables, but requires upgrades to function as an outdoor studio.
2	Unsatisfactory - Too small, poor condition, disconnected from learning spaces, no flexibility, no shade provided								
3	Average - Adequate size, adequate condition, needs some renovations or updates to function well, 50% or less shade coverage over studio area								
4	Satisfactory - Good size, good condition, connected to learning spaces, good flexibility, more than 50% shade coverage over studio area								
5	Very satisfactory - Generous size, excellent condition, connected to learning spaces, excellent flexibility, full shade coverage over studio area								
N/A	Does not apply

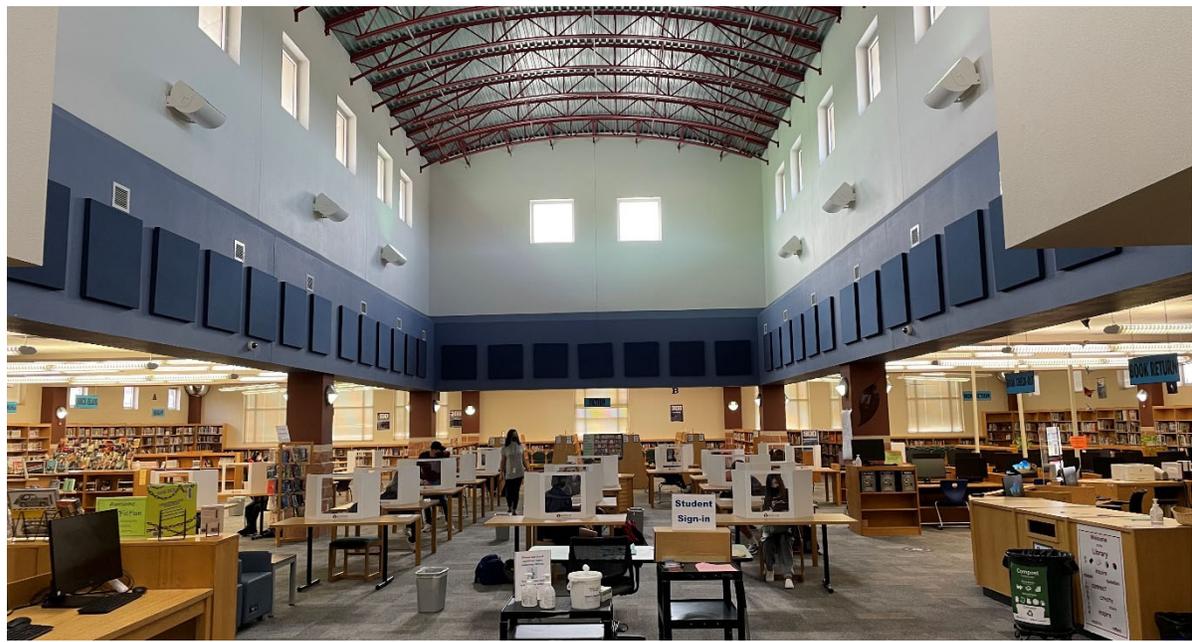
Media Resources: Open-concept library with computer stations.

13 - Media Resources - Continued		1	2	3	4	5	N/A				
13.2	How well does the Library/Media Center support quiet study?		2						Comments	1.00	2.00
1	Very unsatisfactory - No quiet study spaces							One large open space. No breakout spaces for quiet study.			
2	Unsatisfactory - One area in poor condition, poor acoustic privacy										
3	Average - One or more areas provided, needing updates or renovations to function well										
4	Satisfactory - Clusters or small rooms adjacent to media center, good condition, good acoustic privacy										
5	Very Satisfactory - Multiple clusters or small rooms adjacent to media center, excellent condition, excellent acoustic privacy										
N/A	Does not apply

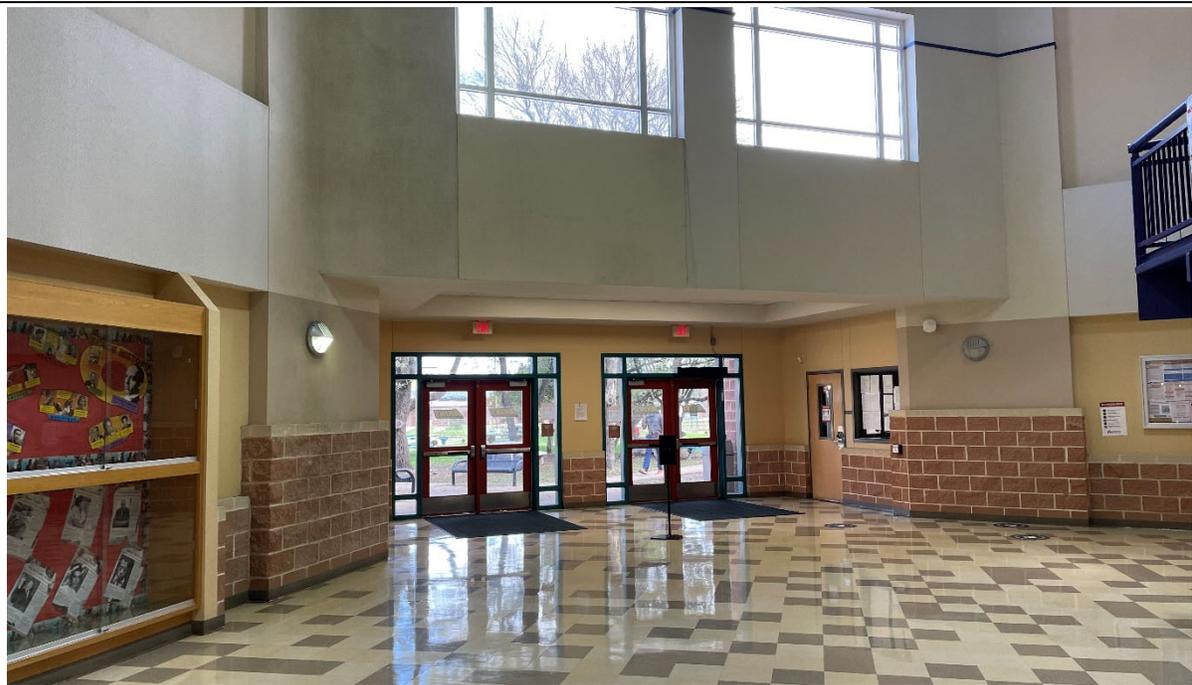
View of exits to central courtyard space from main building.

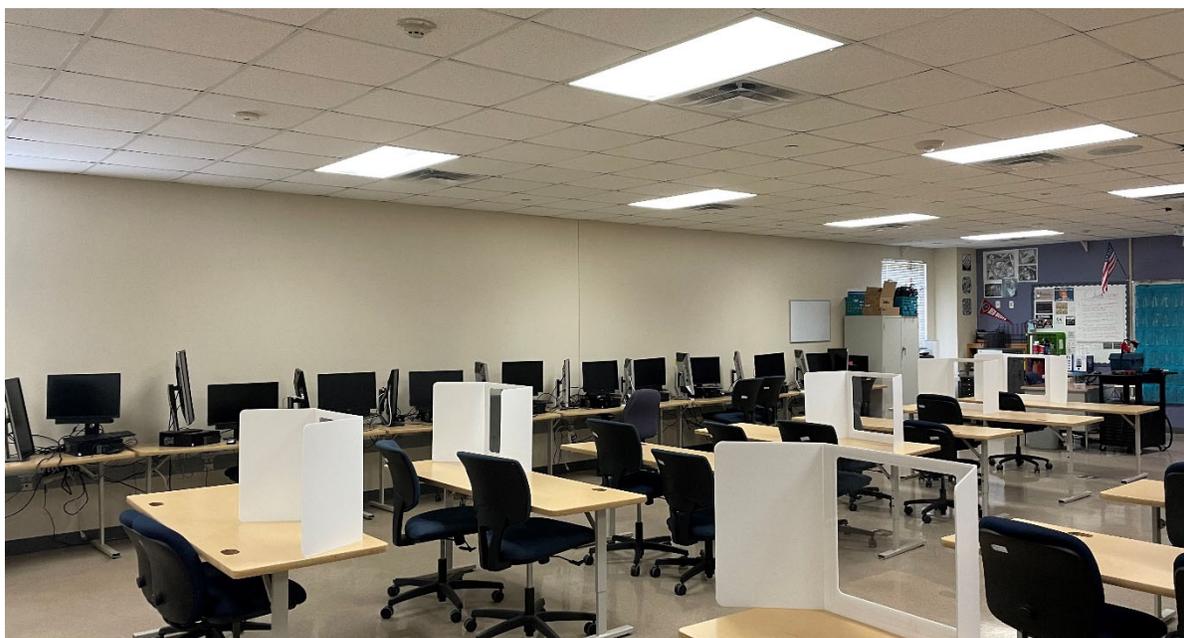
Computer lab studio in tech building is adequately sized, but there is no power for center tables.

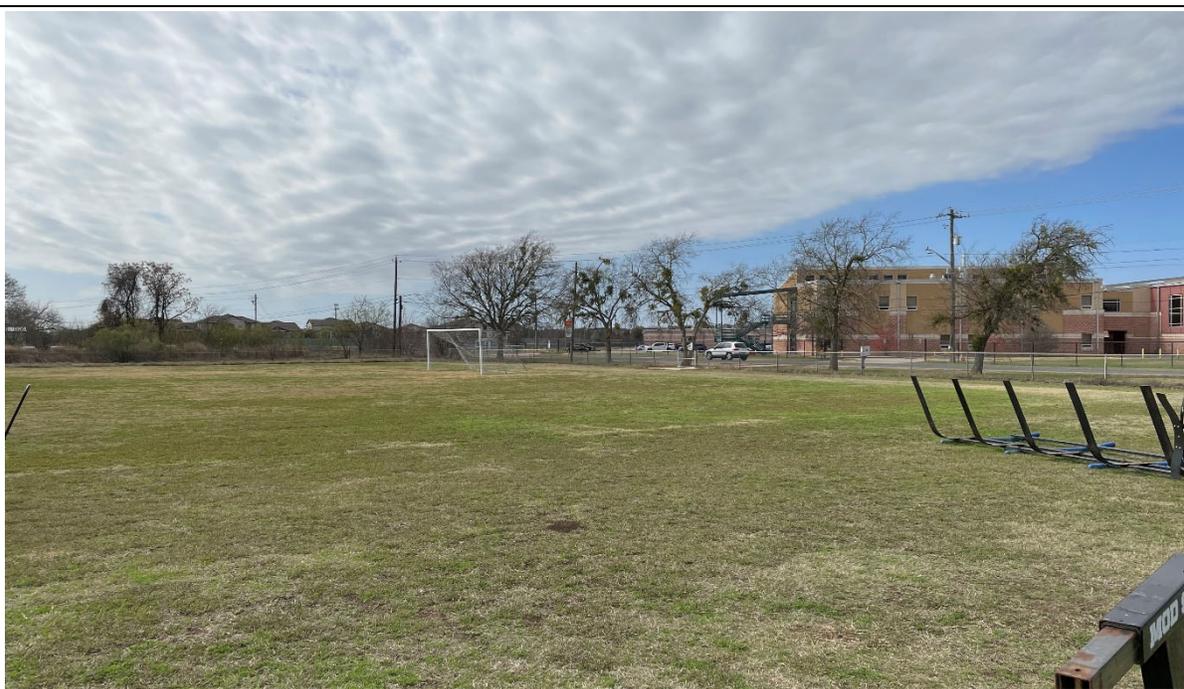
Athletics: Condition of fields could use improvement. No site lighting is provided at the fields.

11.18	How do the athletics fields align with FMP Campus Improvements? Turf Field, Parking lot lighting, ADA accessible amenities (high School only)	1						Comments	0.00	0.00
	1 Very unsatisfactory - No turf, inaccessible, no site lighting 2 Unsatisfactory - No turf/field in poor condition, some accessibility concerns, poor site lighting 3 Average - Field in adequate condition, needs some updates or renovations to function well 4 Satisfactory - Turf field in good condition, good ADA access and site lighting 5 Very Satisfactory - Turf field with excellent maintenance, excellent ADA access for spectators and athletes, excellent site lighting N/A Does not apply.	Monitoring answer, but doesn't affect overall score.
