Educational Suitability Summary Report

Lively Middle School

Date: 01/21/2021

Score 55% Average

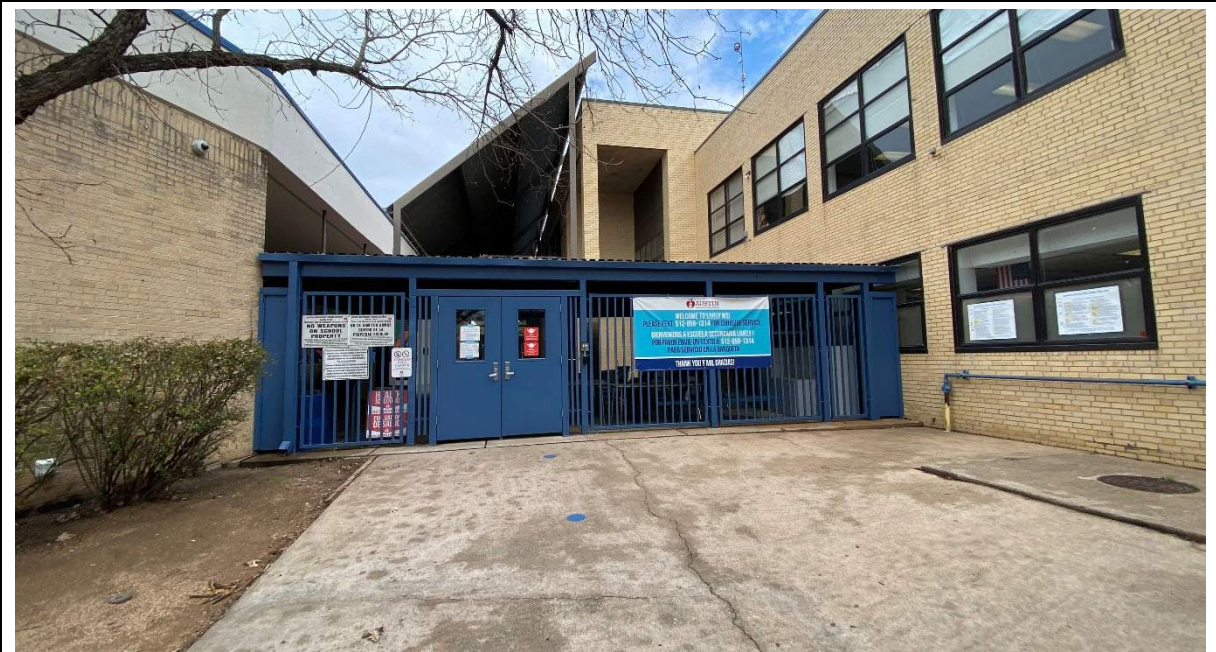
Main Entrance: Lack of signage and wayfinding make it difficult to understand this is the main entrance. Additional signage has been posted since this photo was taken; however, additional signage is still needed.

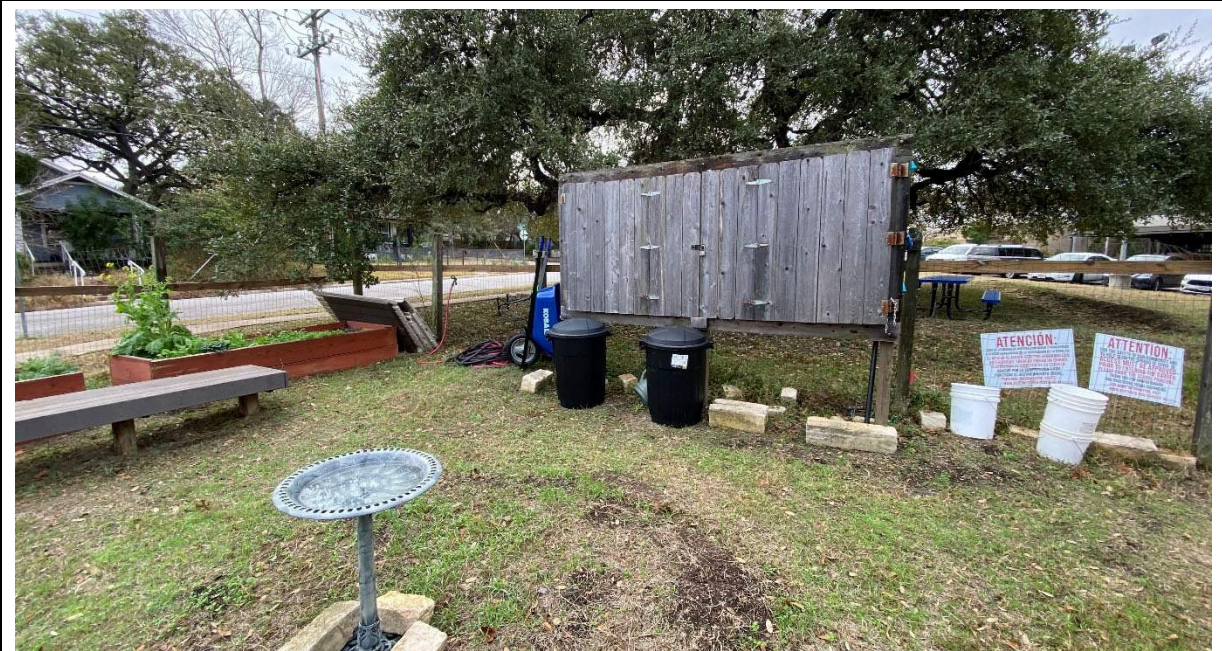
Outdoor Learning and Activity: A space set up with seating and a whiteboard for outdoor learning adjacent to the outdoor learning gardens.

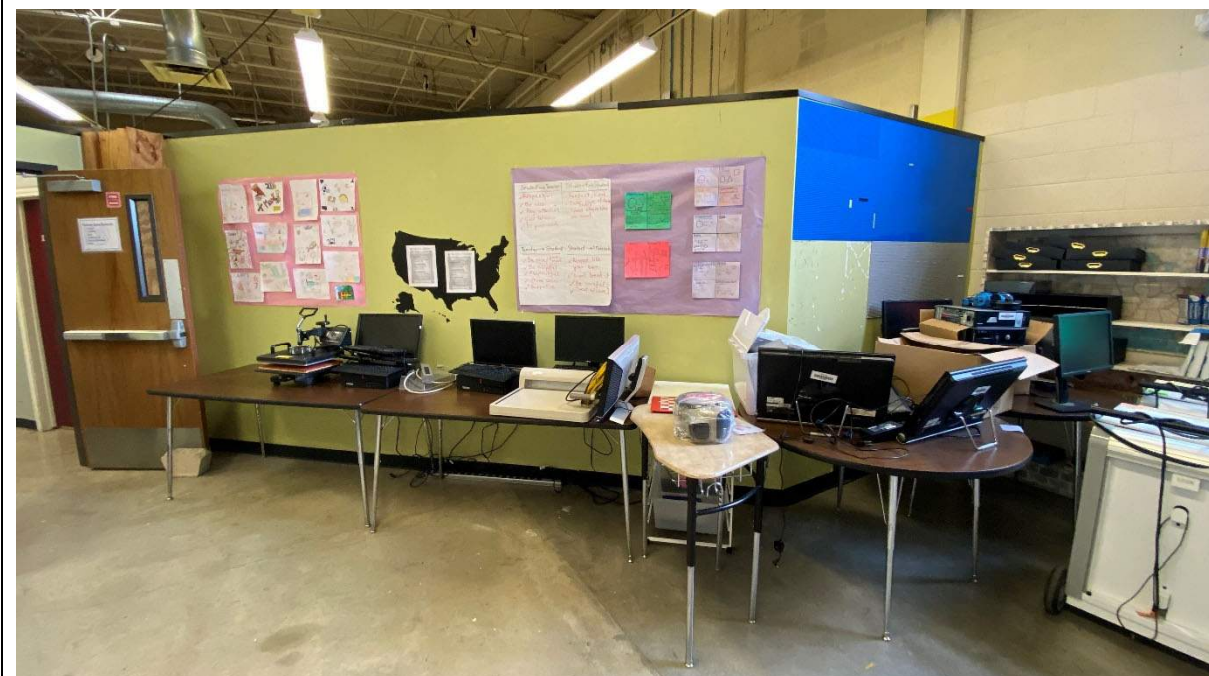
Maker Space: Maker space is in area without full-height walls, near family support and Communities in Schools. Not currently in use due to COVID-19 protocols.

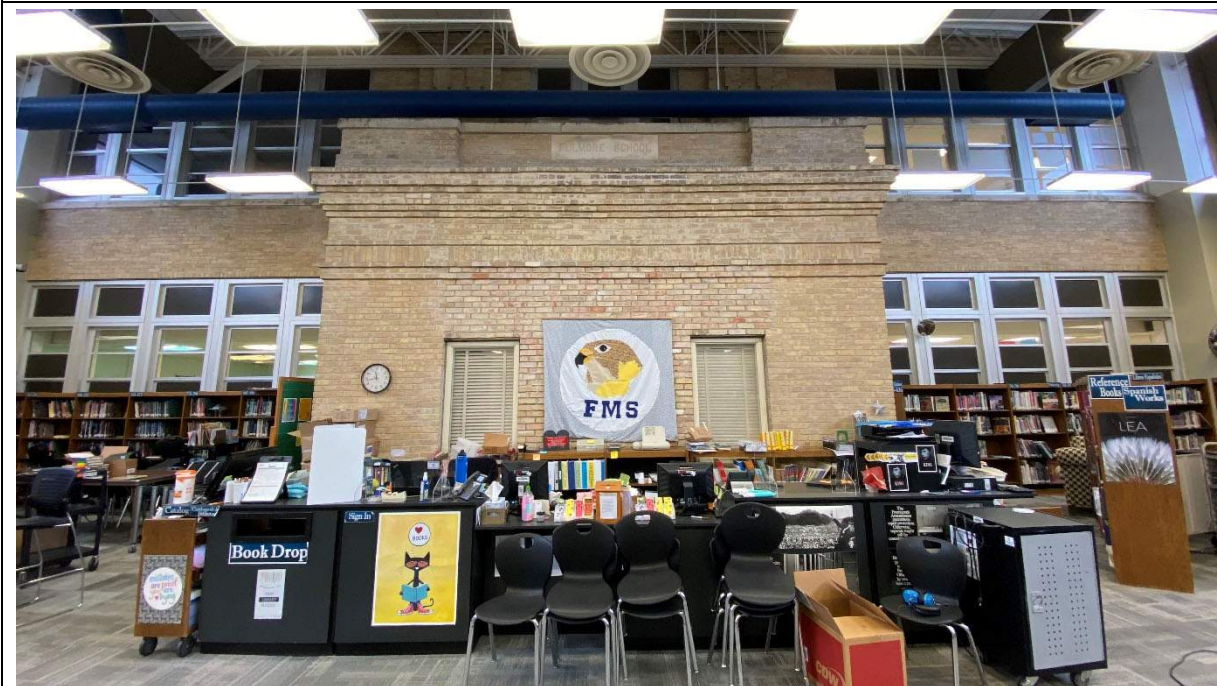
Media Resources: The library contains the historic façade of the original building and is a feature the campus really likes.

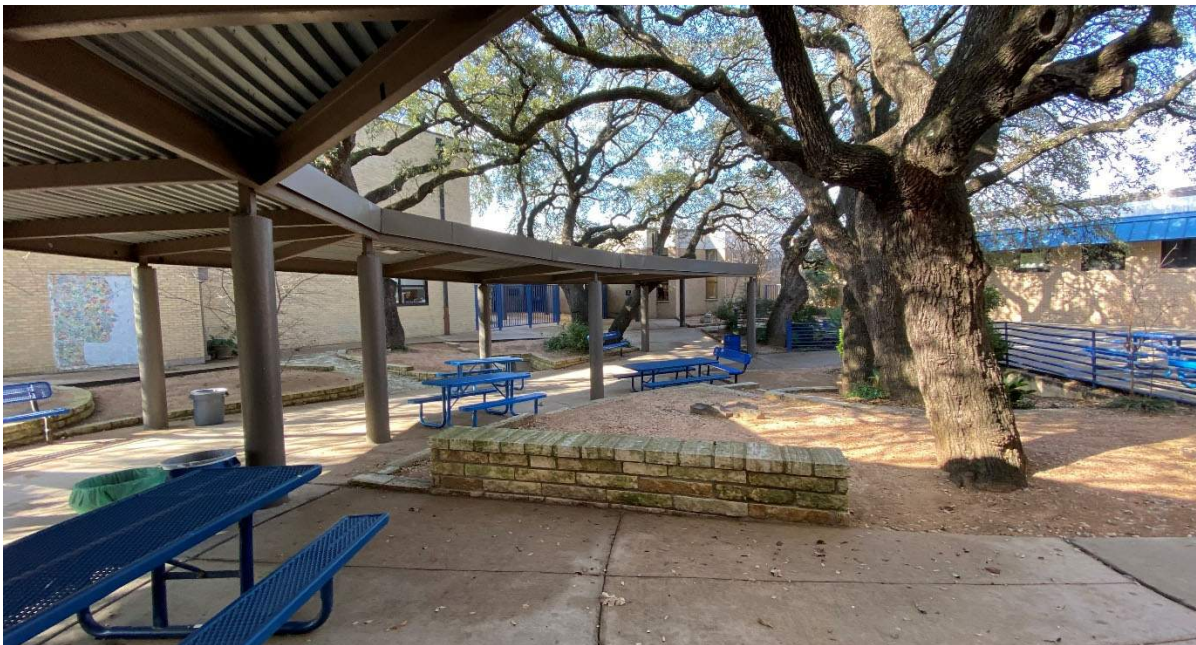
Internal Courtyard: Mature trees provide shade for outdoor seating. There is a covered walkway between buildings. During rain events, drainage issues and standing water (mosquito issues) occur.

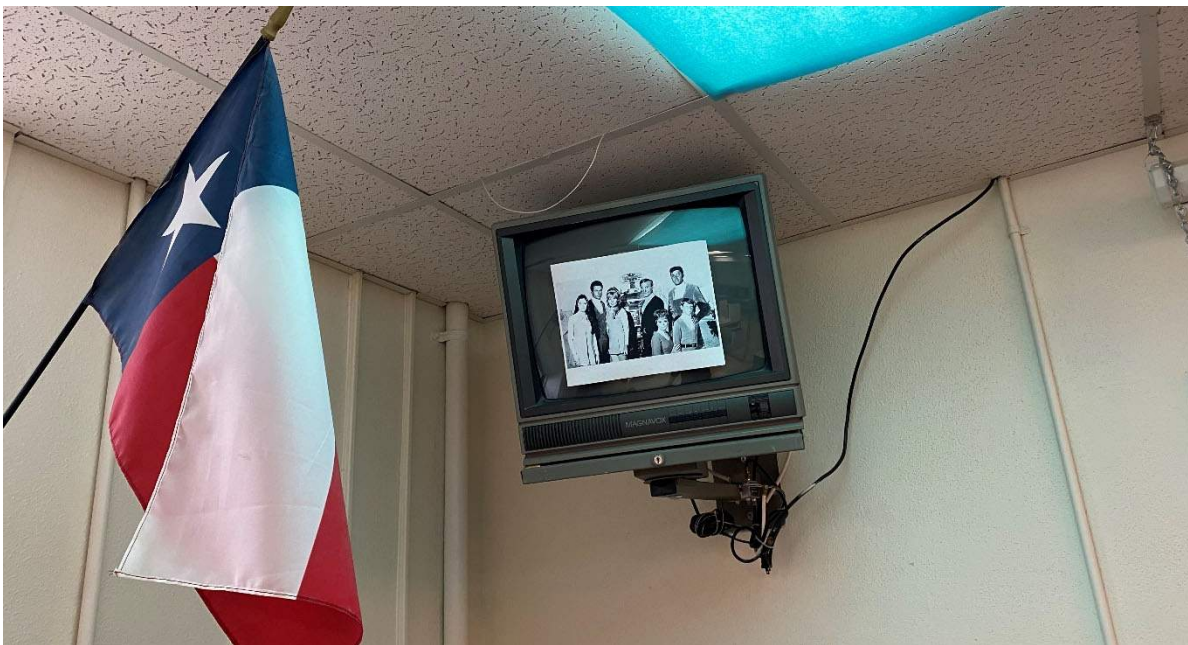
Technology: Antiquated technology is still present in many of the learning spaces.

Studios lack an appropriate number of outlets and charging locations. Additional outlets are needed and have appropriate capacity for higher voltage. A/V in the gym and cafeteria is dated and needs to be replaced. There are mobile screens available throughout the campus. Old wall mounted TVs

are still present in many studios. The school has requested their removal.

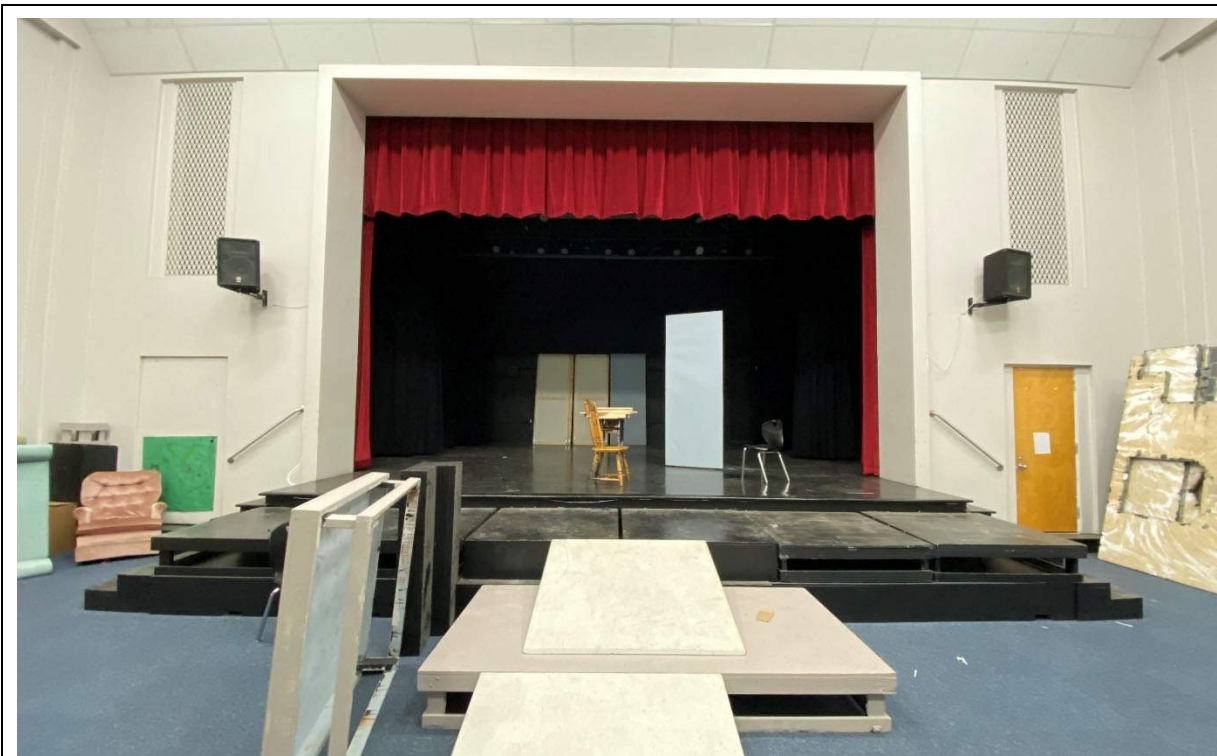
Visual and Performing Arts: Auditorium is in older part of building and works well as a drama room but does not accommodate enough people to function well as an auditorium. It does not have fixed auditorium seating and only has a flat floor for chairs.
