Educational Suitability Summary Report

Zavala Elementary School

Date: 01/04/2021

Score 49% Unsatisfactory

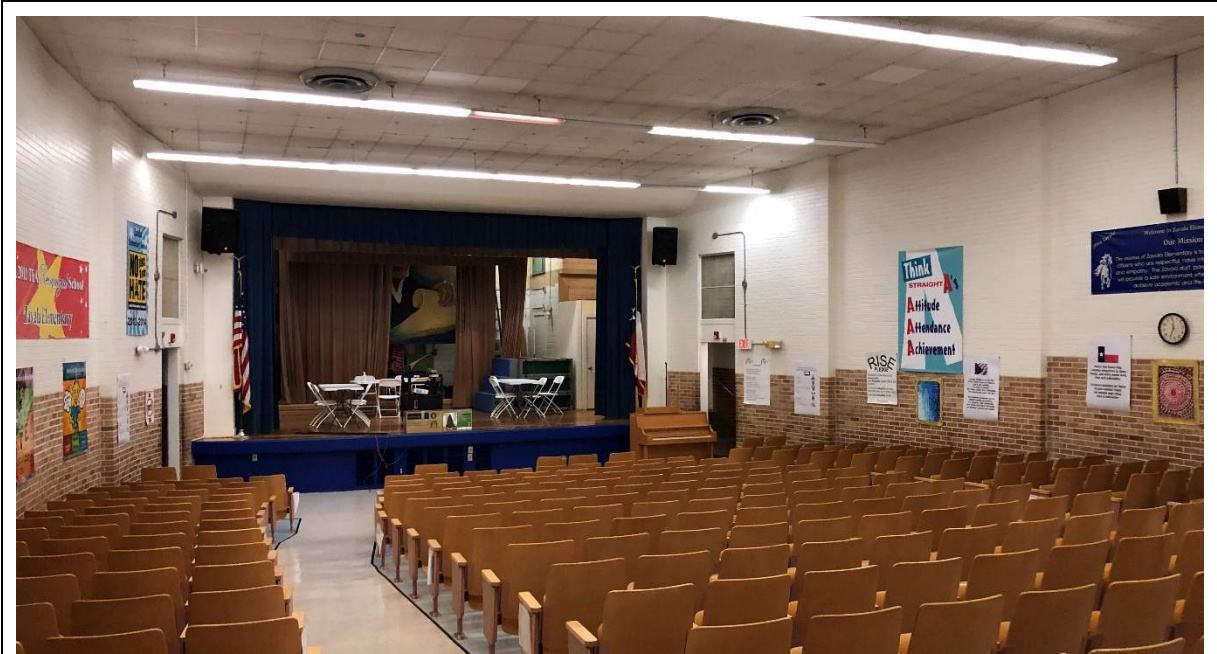
Dedicated auditorium accommodates evening functions but is dated and needs some improvements to function better.

Campus has an auditorium for performances in the original part of the building. The school reports the seats have been replaced. The auditorium is dated and needs some updates to function better, including HVAC upgrades.

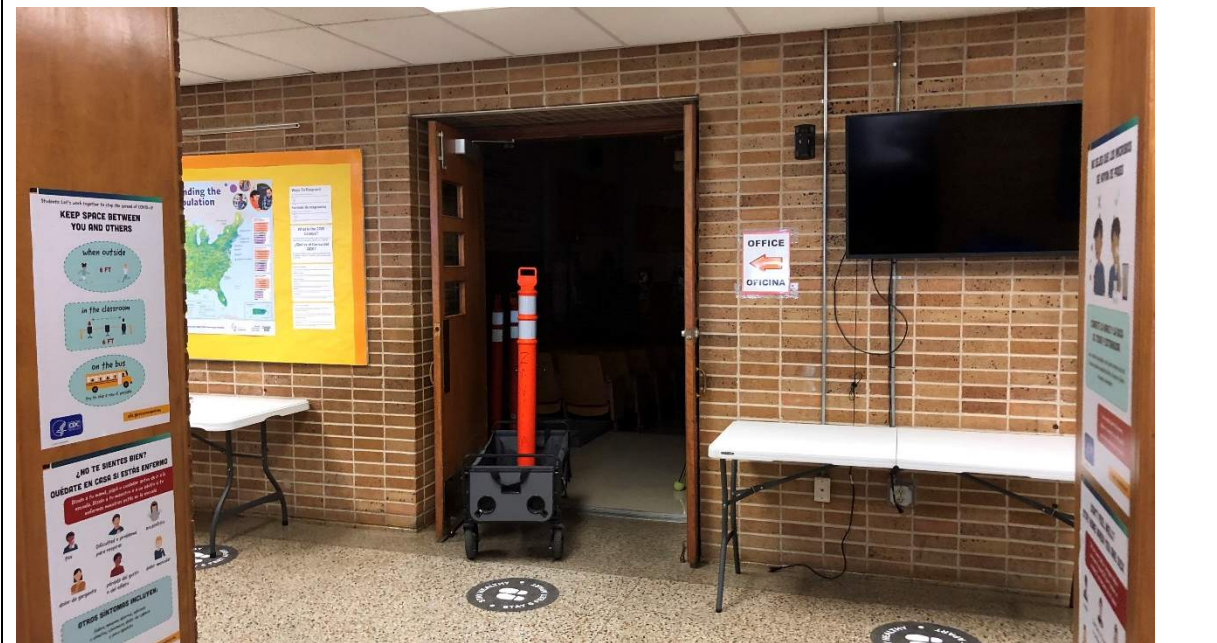
Front entry of campus [redacted] is just outside auditorium with sign direction to main office.

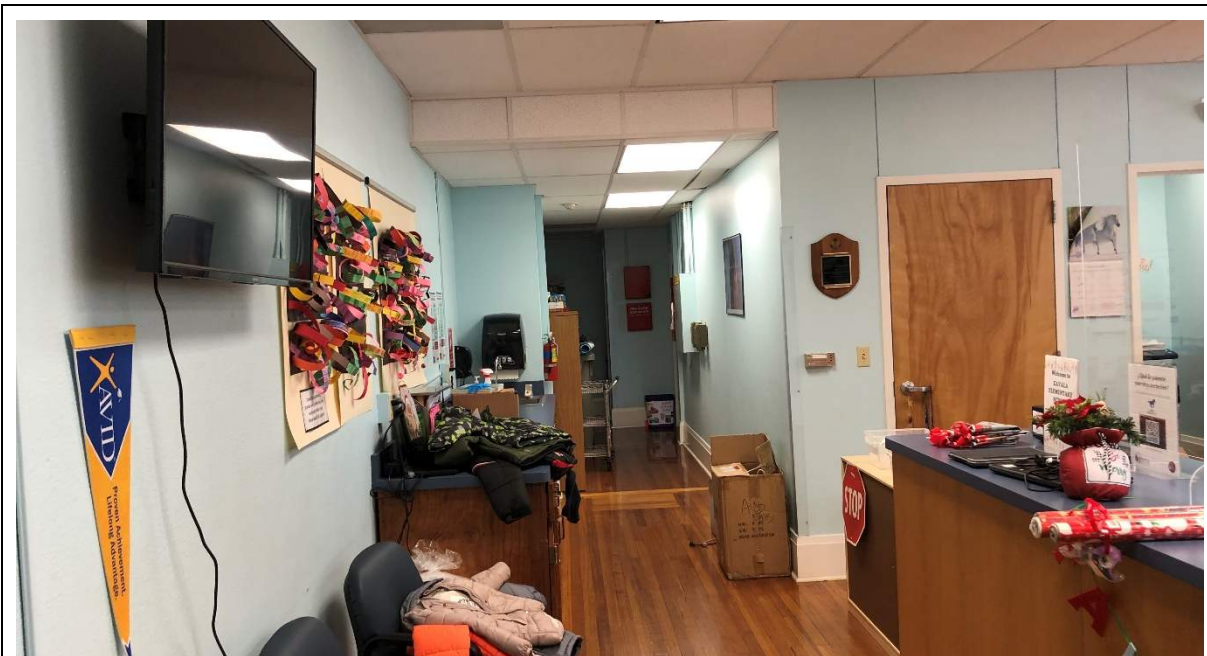
Main office front desk checkpoint is small and has limited seating area.

The checkpoint at the reception area is small and not in good condition and does not feel very welcoming with minimal furniture. Acoustics among the spaces in the administration are not good and conversations can easily be heard between the office spaces. The school reports that this is not an issue.

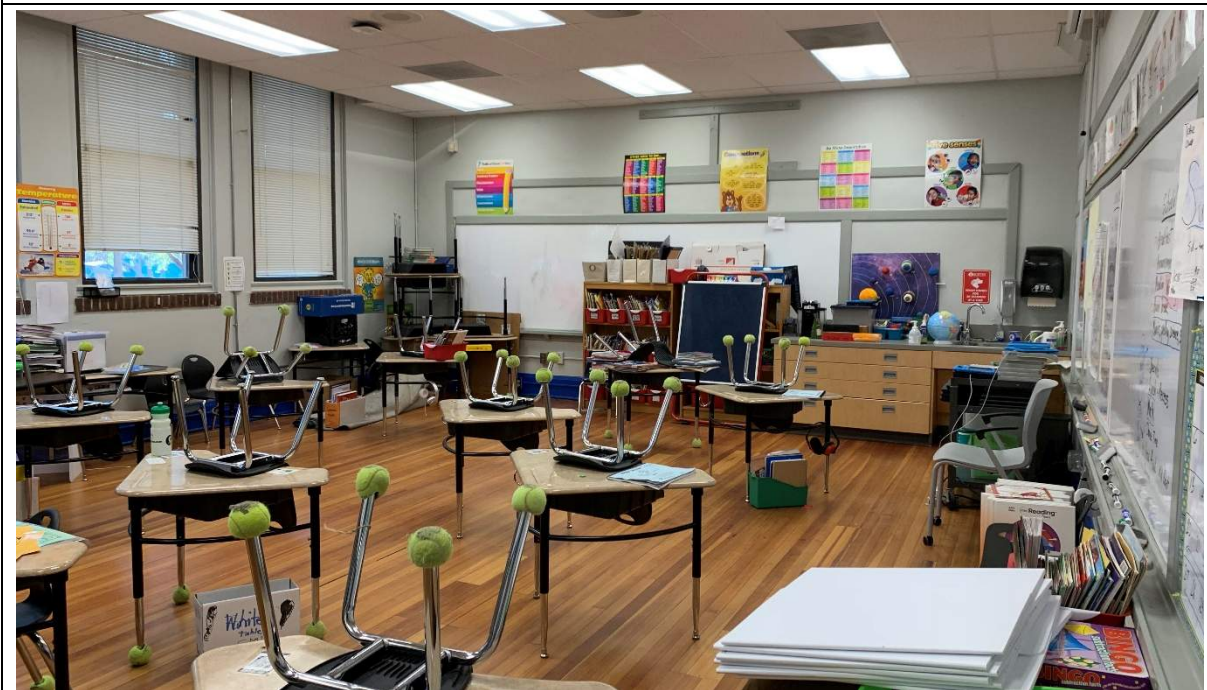
Studio in original building built in 1937. Original hardwood floors in good condition. Furniture is 3 years old and is in good condition and able to reconfigure.

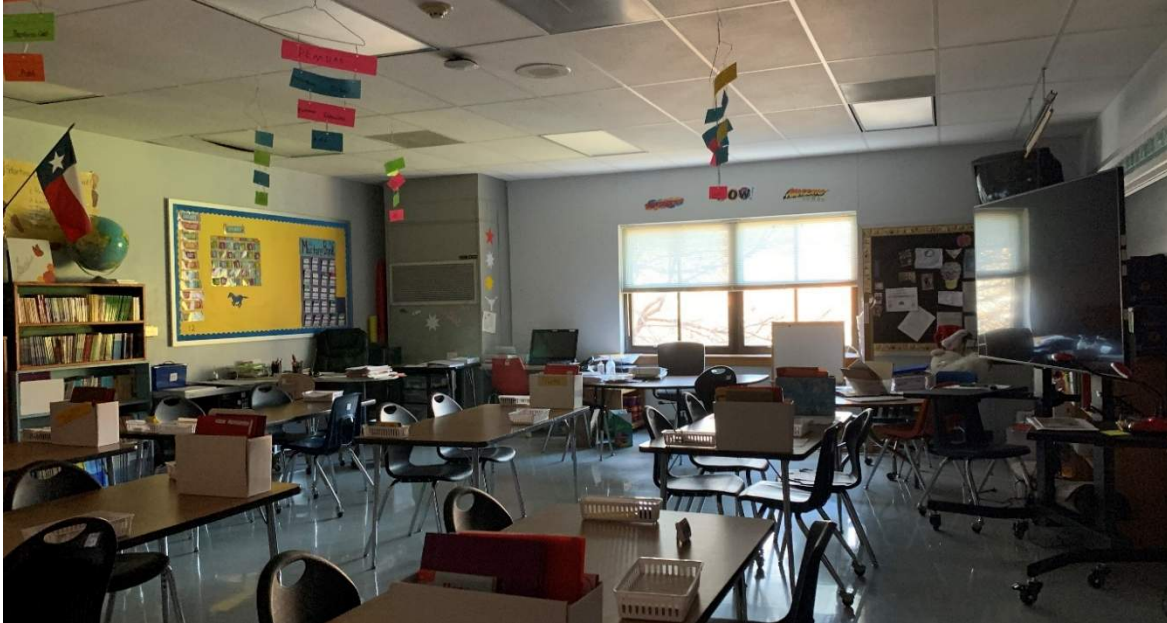
Newer studio with less flexible furniture with larger tables and loose chairs. School notes teacher chose this furniture configuration.

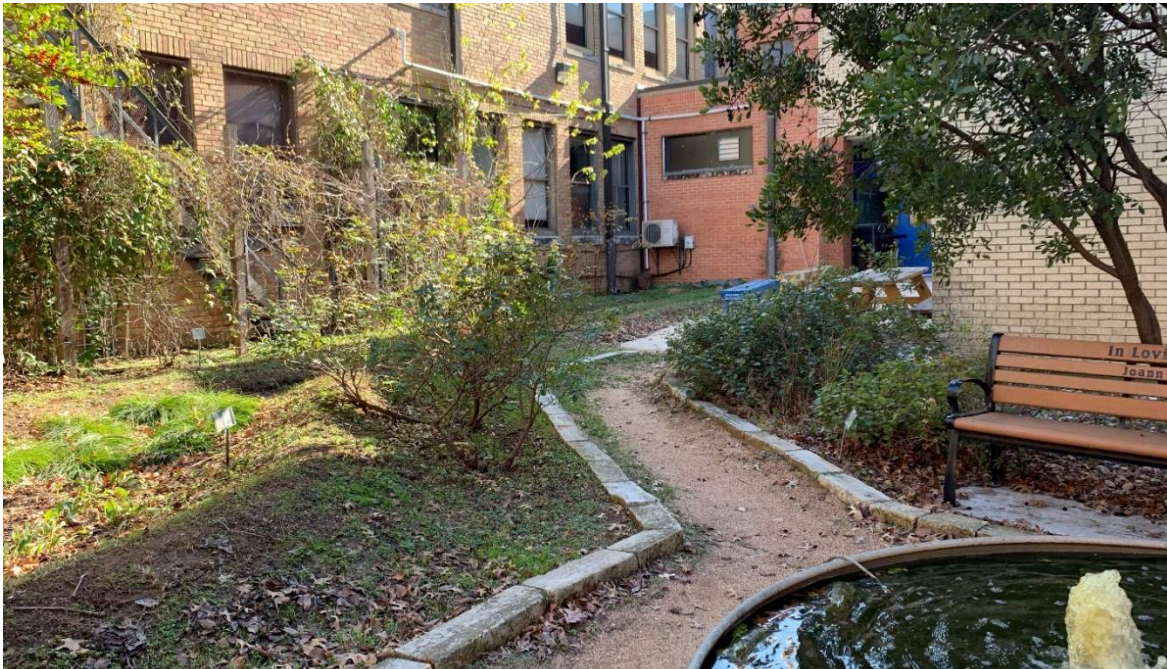
Courtyard as outdoor learning studio with learning pond located centrally to the campus. Water in pond needs maintaining and overall space needs some updates to function well. School reports they have not had their upkeep days due to Covid.

Courtyard space is located centrally and has access to water with a learning pond. Pan American Neighborhood Park has equipment in good condition and an outdoor stage.

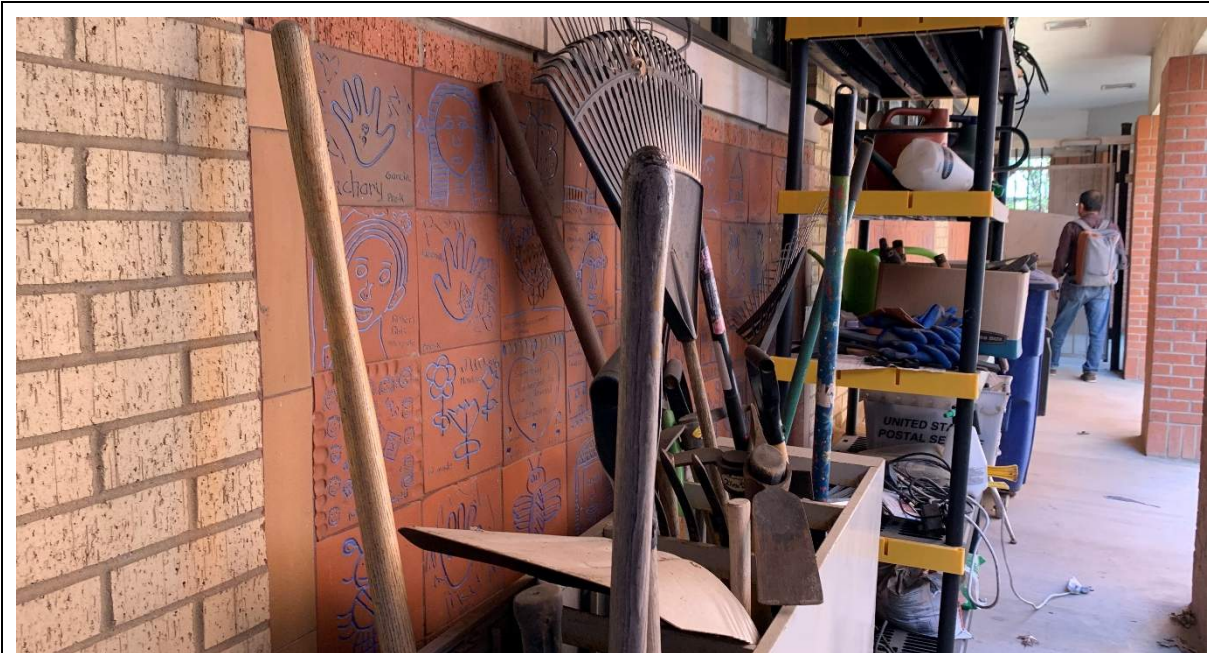
Storage outside library for gardening equipment. More storage needed for outdoor learning areas.

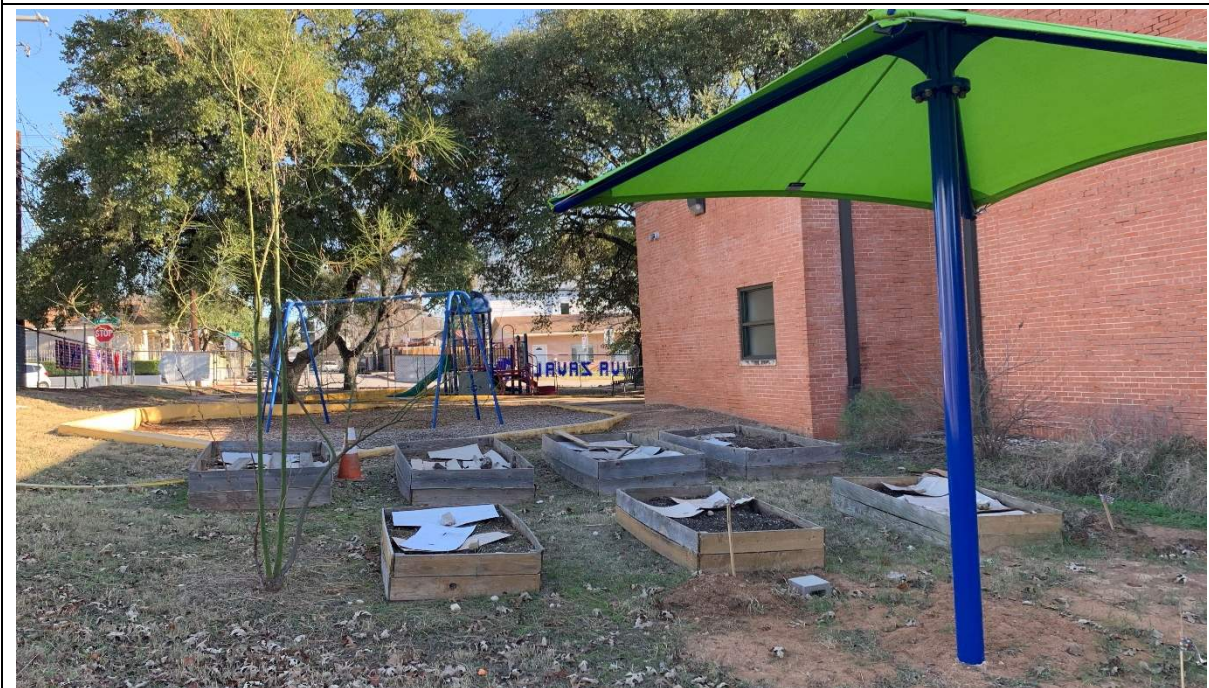
Outdoor garden space with small shade structure and no furniture. Beyond is the small playground on campus. Campus is adjacent to a public park, Pan American Neighborhood Park.

The campus loves their exterior spaces at the school. There could be some improvements to help them function better. A central courtyard has adequate space but lacks enough shade and furniture to function well. There are large sitting stones at the front of the campus, but the space is not well-developed and would need some maintenance to serve as an outdoor studio. This space has some natural shade with the large trees but would benefit from a canopy shade structure.

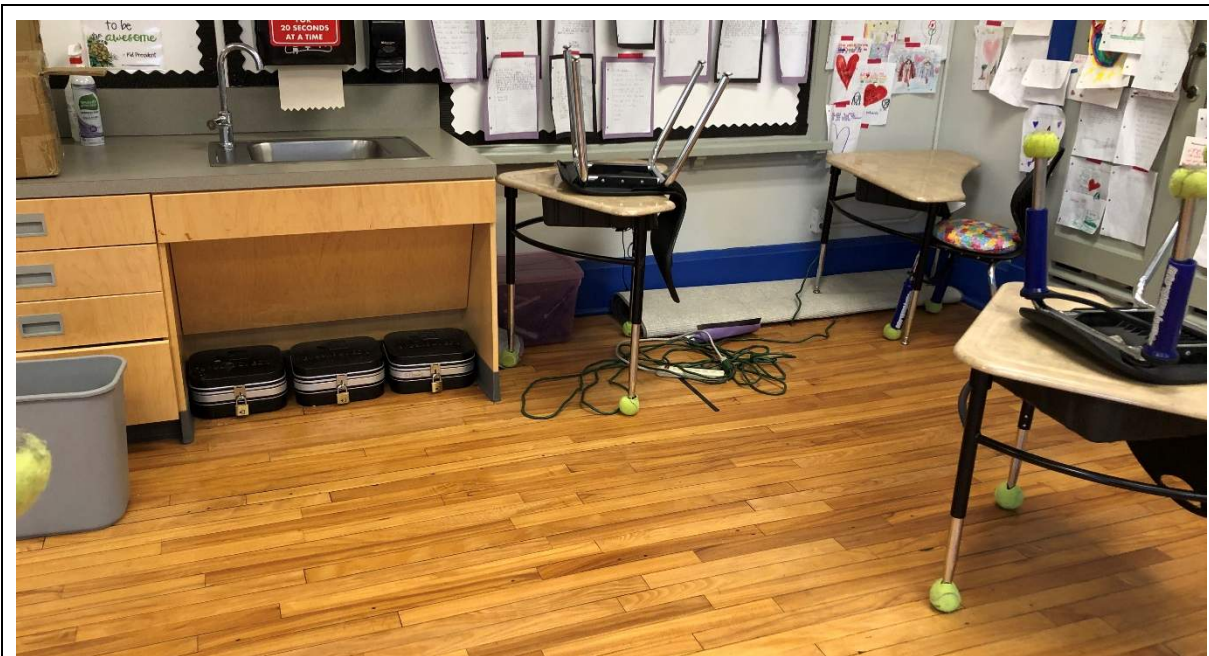
Use of extension cables and power strips in typical studios from limited outlets.

Due to the age of the main building, there is a lack of power and data outlets in the learning spaces. The studios do not have centralized charging locations and use extension cords throughout the campus.

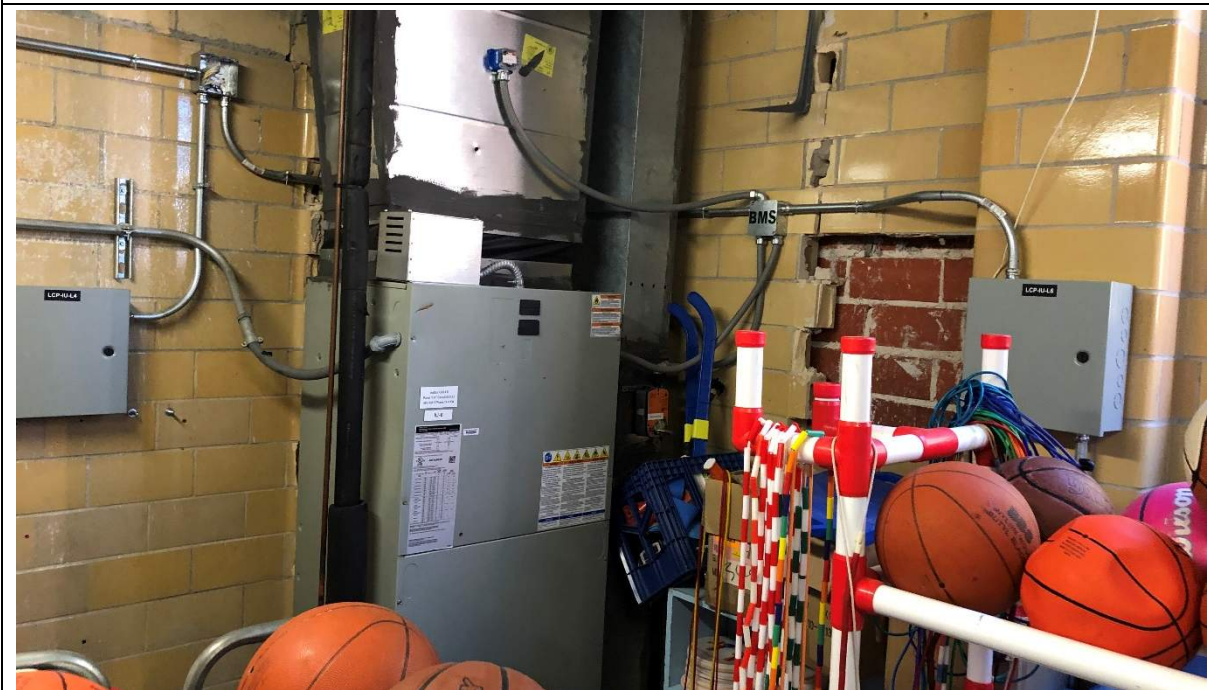
Storage for gym equipment shared with mechanical and electrical room.

Gym is dated with old equipment and is undersized at 2,500 SF. The campus only has one small playground in the front. The campus typically uses the adjacent public park, which was recently redone with a grant from Dell Children's Hospital. The storage is mixed in with large HVAC equipment.
