Educational Suitability Summary Report

Zilker Elementary School

Date: 12/10/2020

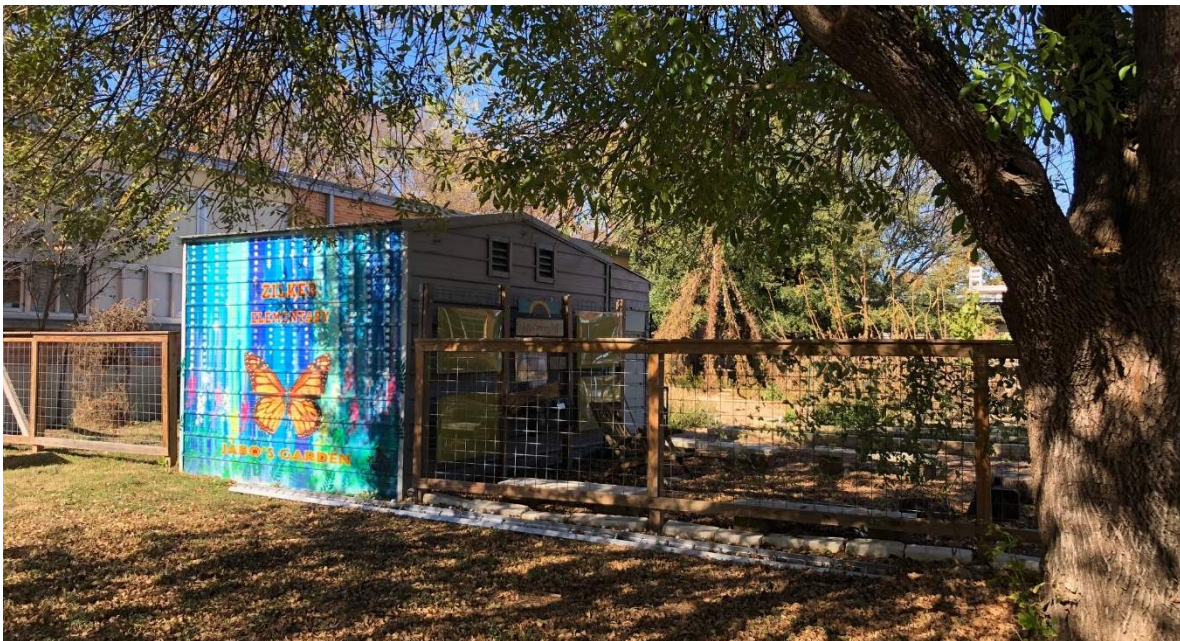
Outdoor Gardens: Well-tended and source of pride for the school.

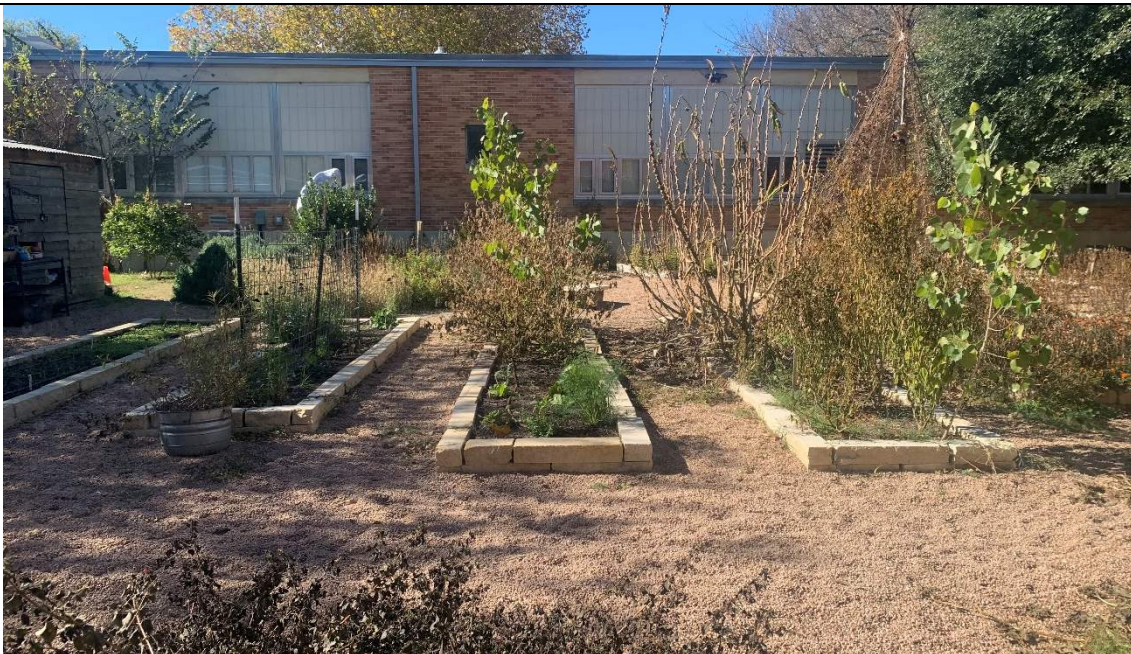
Outdoor Gardens and Husbandry: Chicken coop in the same area.

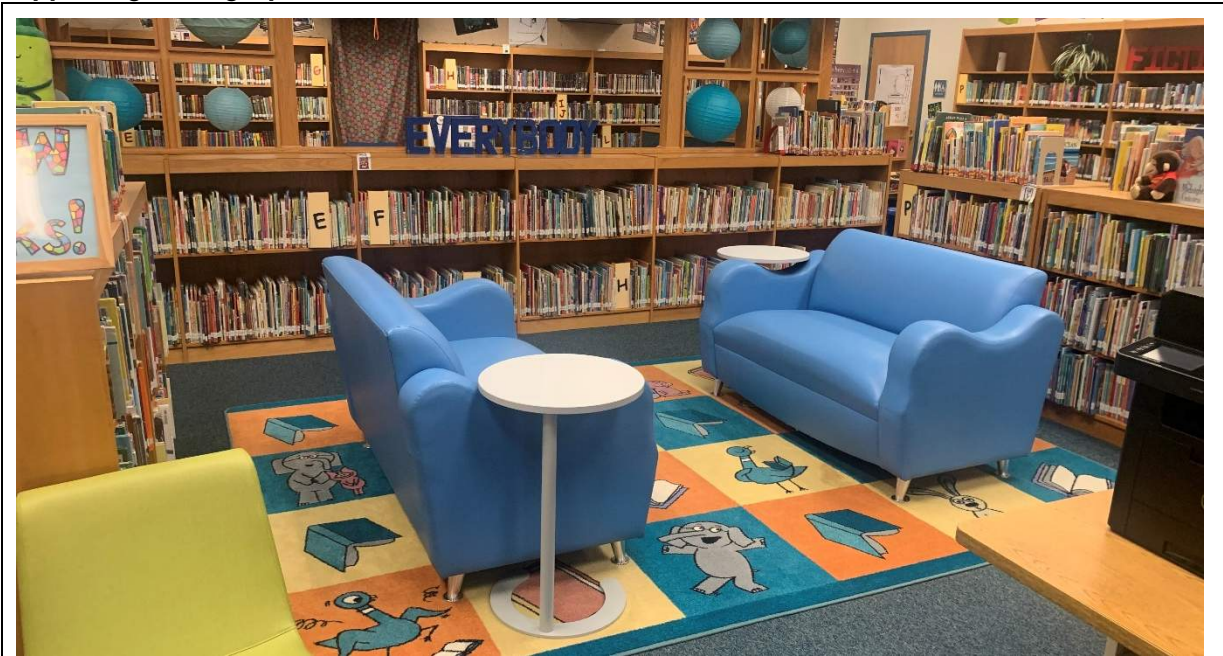
Media Center: Provides different seating areas.

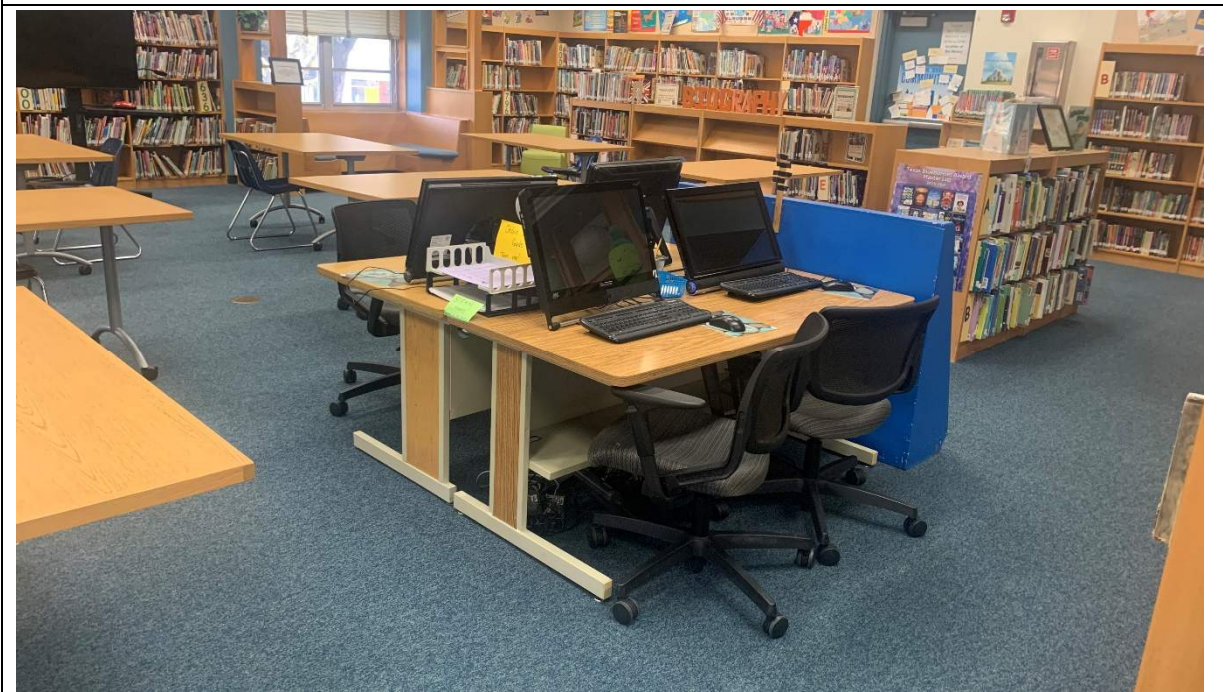
Media Center: Access to technology and multiple seating options.

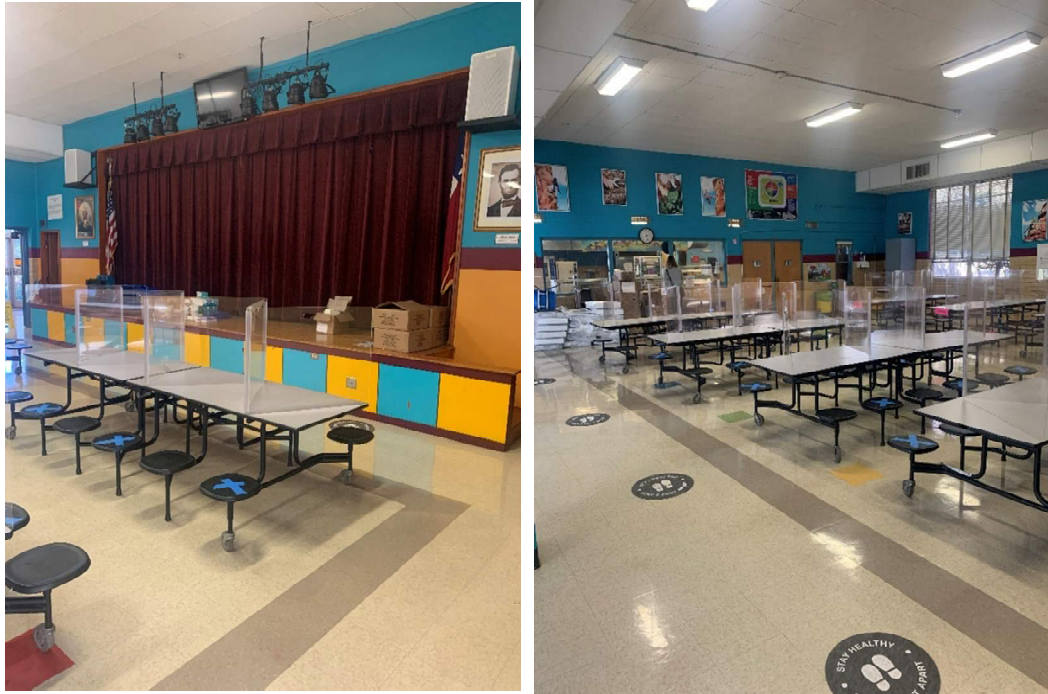
Stage and A/V in poor condition. Cafeteria SF accommodates 1/3 of learning population but is dated and doesn't function well in hosting events. School doesn't have storage available for adult-sized chairs.

11.1	Is the Dining Commons appropriately configured per the ed spec?		2					Comments	1.00 2.00	
1	Very unsatisfactory - Too small, missing program spaces								Cafeteria accommodates 1/3 of learner population at 17 SF/person but is in poor condition.	
2	Unsatisfactory - Too small, poor condition, only one option for eating space provided, inadequate circulation									
3	Average - Adequate size and condition, needs updates or renovations to function well									
4	Satisfactory - Good size and condition, good circulation, multiple options for eating space (ex: connection to outdoor eating space)									
5	Very Satisfactory - Generous size, excellent condition and circulation, multiple options for eating space (ex: connection to outdoor eating space)									
N/A	Does not apply

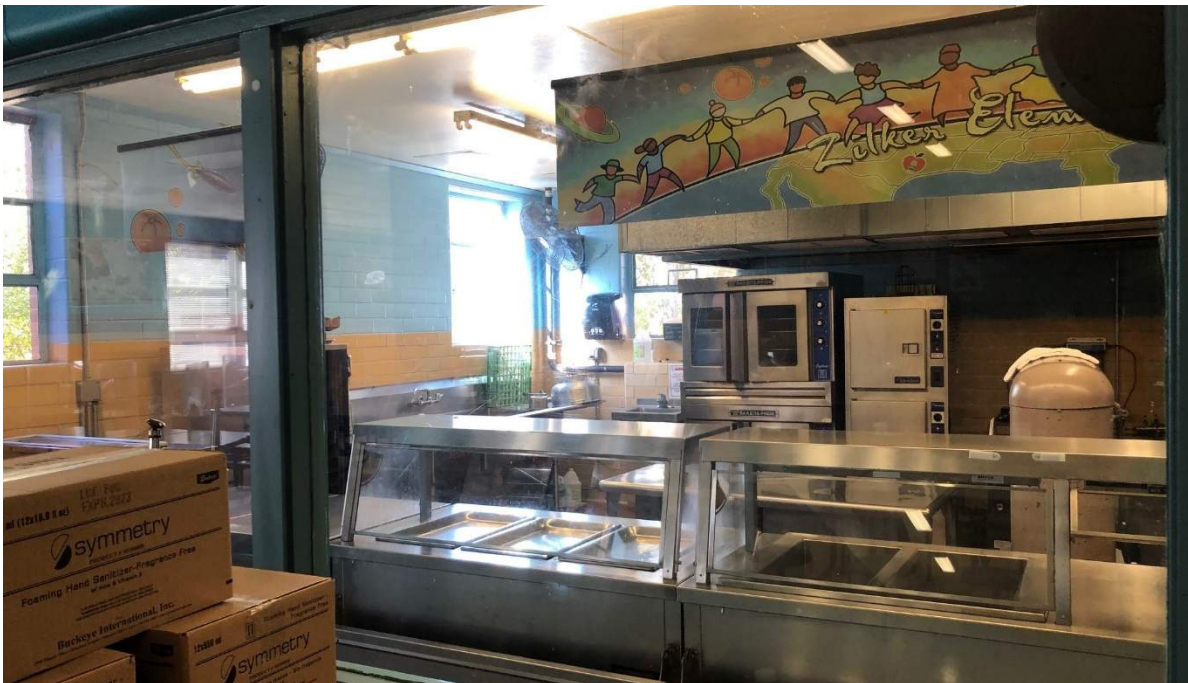
Kitchen/servery is undersized and does not meet current Ed Spec standards.

11.2	Are the Food Services support spaces appropriately configured per the ed spec?		2					Comments	1.00 2.00	
1	Very unsatisfactory - None provided								Kitchen/servery is very undersized at 1,300 SF. No storage for chairs/stage. Stage is adequate size but chair lift takes up a lot of space.	
2	Unsatisfactory - Too small, disconnected, poor condition									
3	Neutral - Adequate size, average condition, needs updates or renovations to function well									
4	Satisfactory - Good size, connected, good condition									
5	Very Satisfactory - Generous size, connected, excellent condition									
N/A	Does not apply

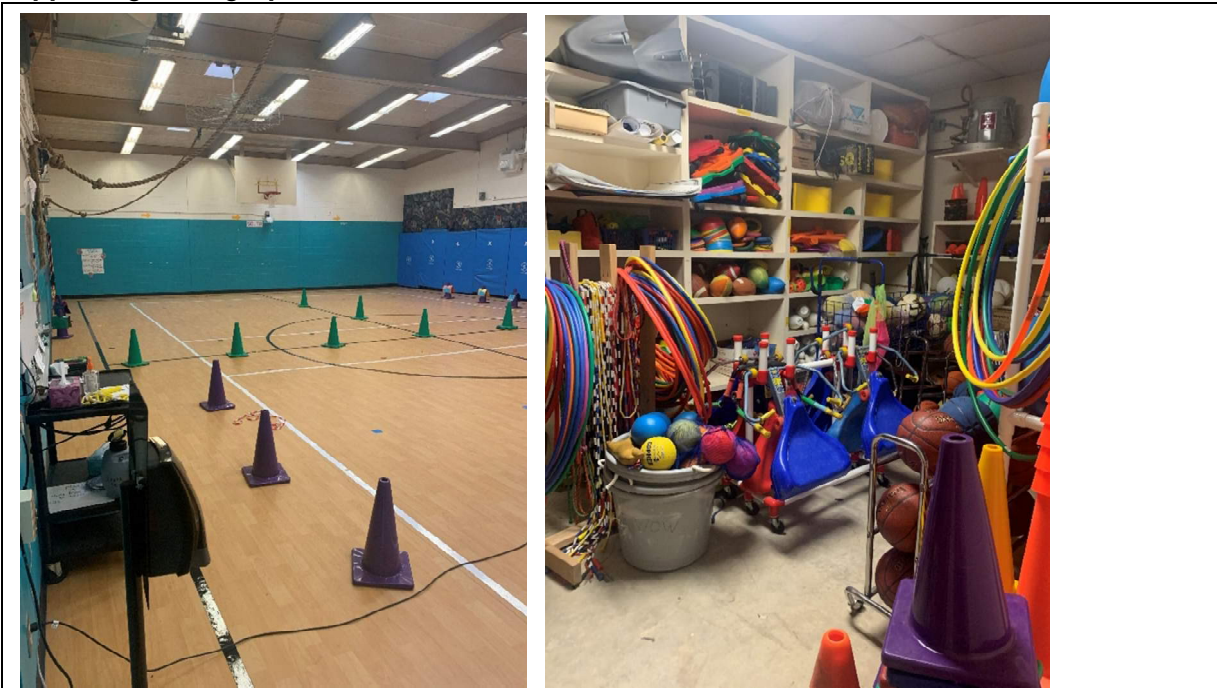
Gym is very undersized, with no natural daylight, and does not have adequate support space or restrooms.

Gym and Support Spaces: Undersized or not present.

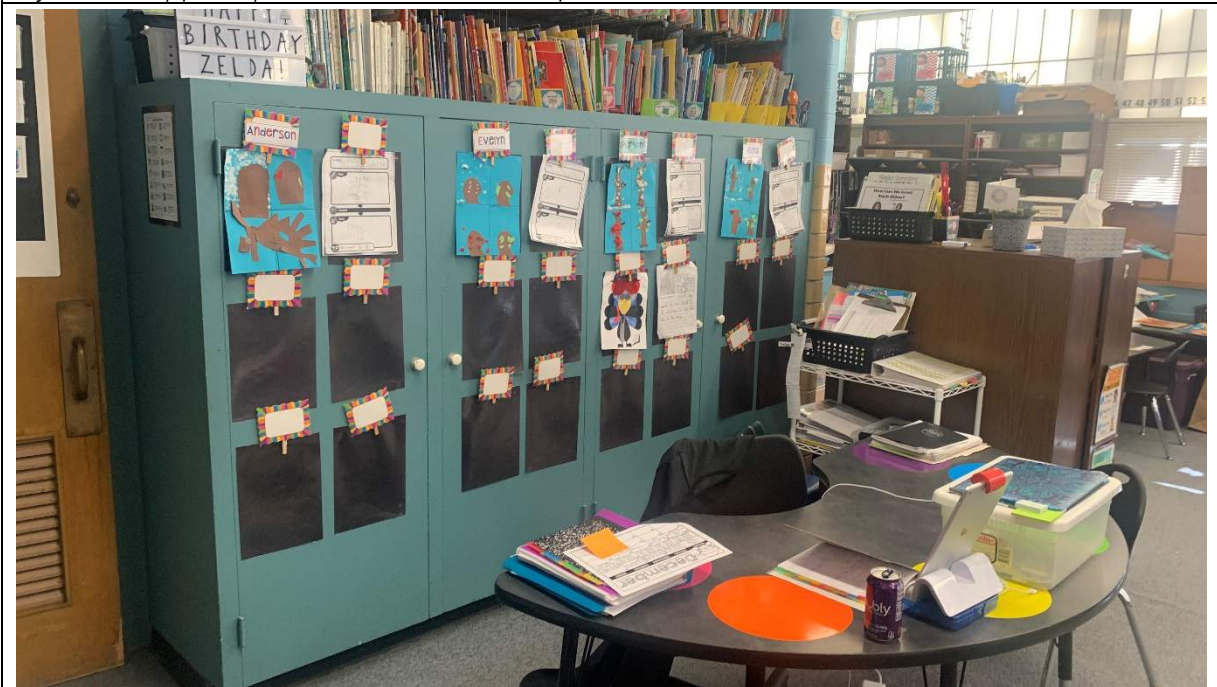
Storage is not consistent in all the studios. Entire school lacks storage spaces.

8 - Academics & Learning (cont.)		1	2	3	4	5	N/A			
8.3	Do studios have appropriate support spaces such as storage per the ed spec?		2					Comments	1.00 2.00	
1	Very unsatisfactory - None provided							Storage throughout school is almost nonexistent. Bathroom access is an issue throughout the school. Wing 400 and 500 students must go outside to use the restroom. Wing 200 has restrooms internal to rooms, but very small and not accessible.		
2	Unsatisfactory - Too small, disconnected, poor condition									
3	Neutral - Adequate size, average condition, needs updates or renovations to function well									
4	Satisfactory - Good size, connected, good condition									
5	Very Satisfactory - Generous size, connected, excellent condition									
N/A	Does not apply

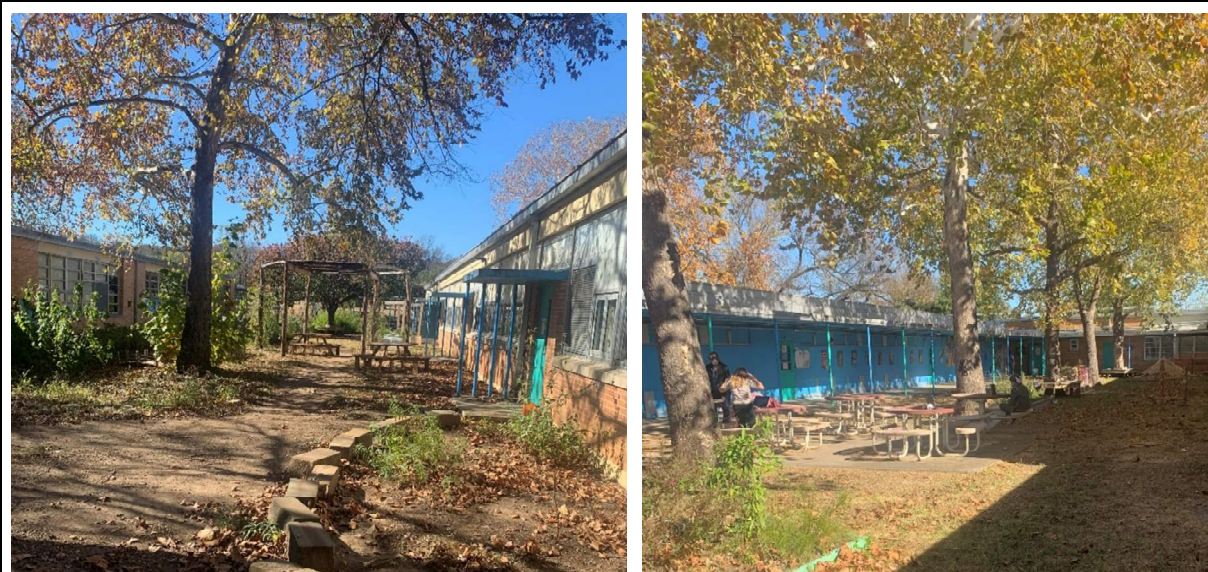
Breezeway circulation has some challenges. Requires student to go outside to use restroom. Outdoor space is utilized for spill-out/workspace. Ground improvements are needed to make it accessible and more fully utilized.

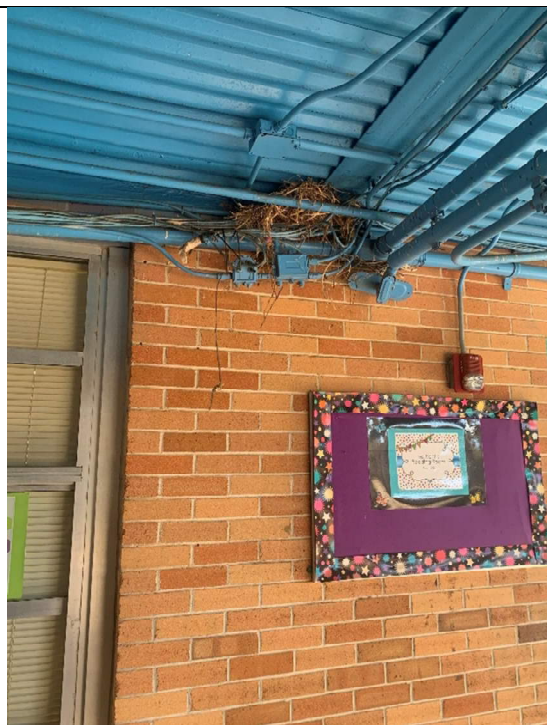
School noted many issues with pests/vermin.

5 - Environmental Quality (cont.)		1	2	3	4	5	N/A			
5.5	Does the building have odor or pest problems?	1						Comments	1.00	1.00
1	Very unsatisfactory - Evidence of both pests and odors							The school reports numerous issues with pests in all parts of the building.		
2	Unsatisfactory - Evidence of pests or odors									
3	Average - Limited evidence of pests, no odors									
4	Satisfactory - No evidence of pests / odors, school cleanliness in good condition									
5	Very Satisfactory - No evidence, school cleanliness in excellent condition									
N/A	Does not apply									
6 - Controllability of Systems		1	2	3	4	5	N/A		12.50	76%
