Educational Suitability Summary Report

Barrington Elementary School

Date: 01/14/2021

Score 57% Average

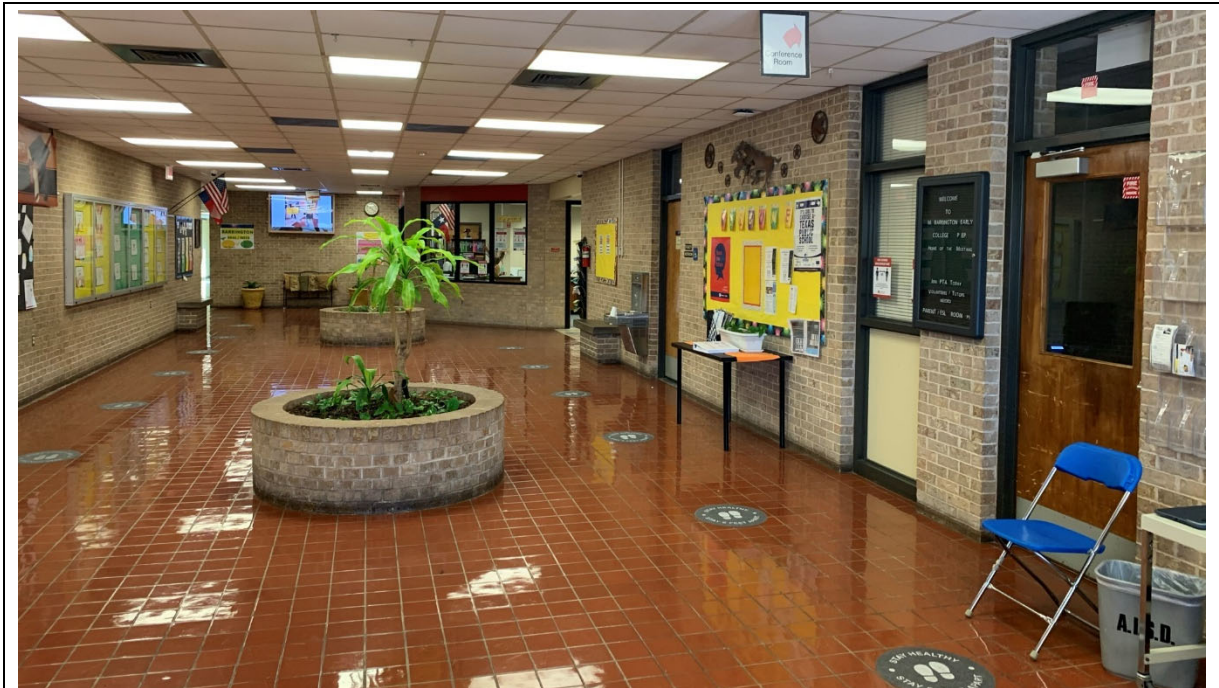
Main entry area is spacious and feels welcoming with displays and planters. The main entry does not have a secure vestibule and is far from reception at the end of the lobby.

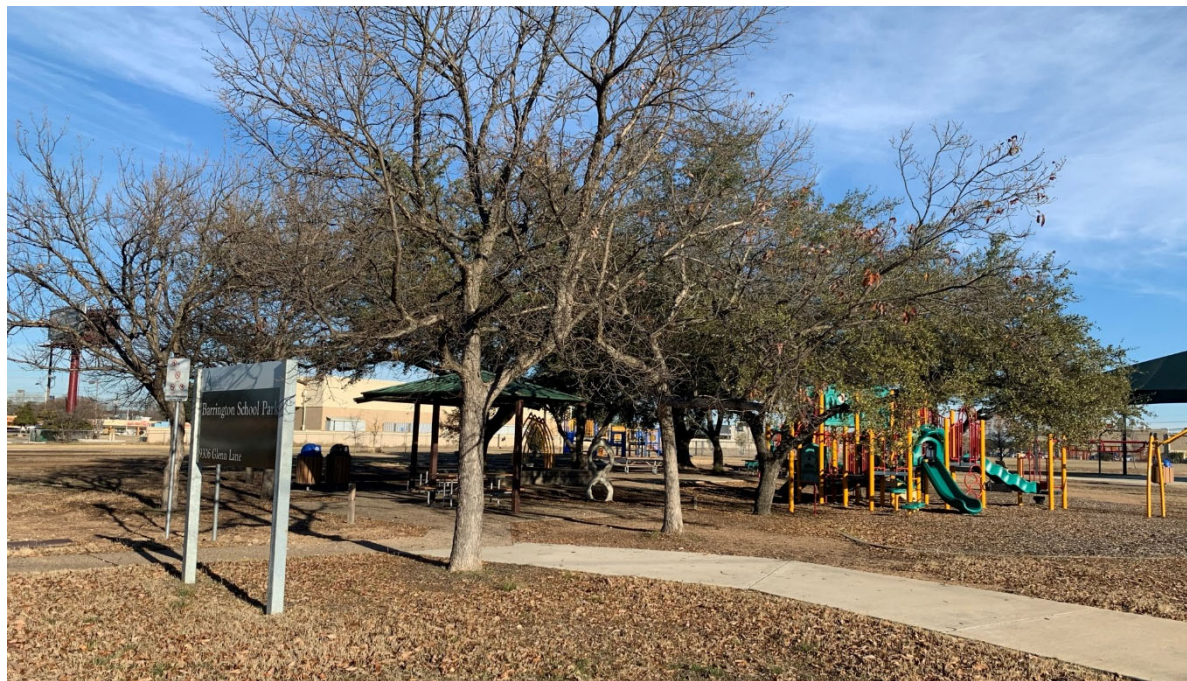
Playgrounds are in good shape and have some shade from trees. Playground are easily accessible to the public being adjacent to Barrington School Park.

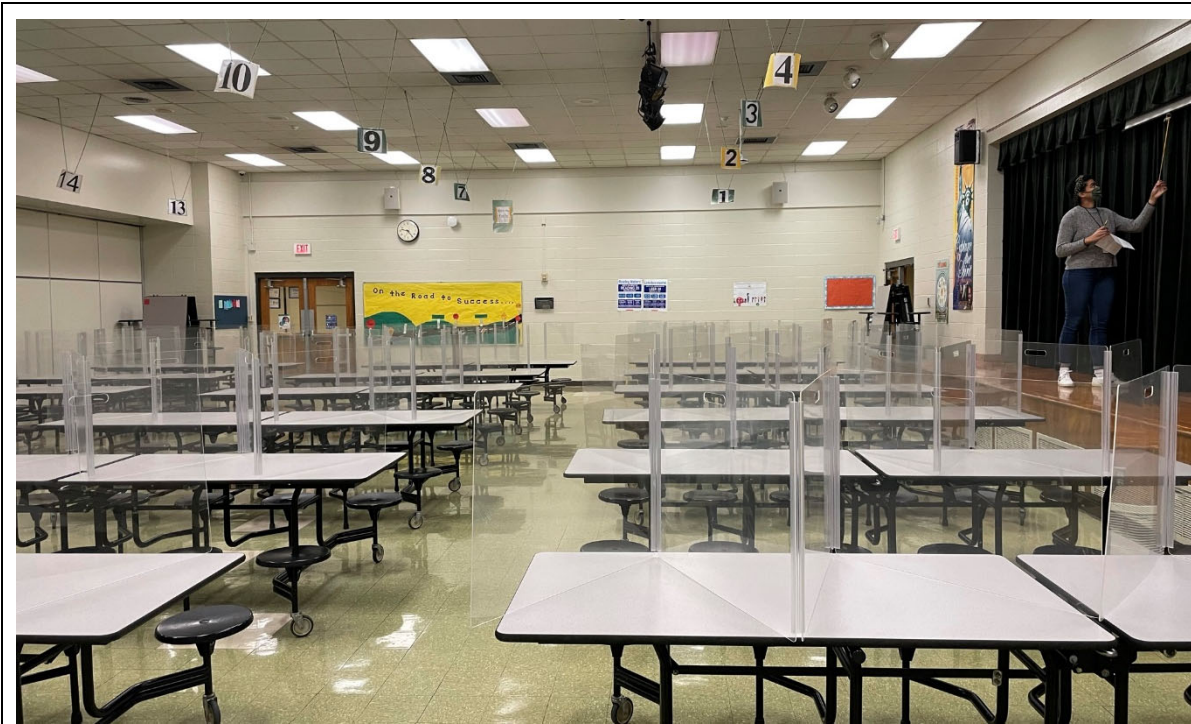
Cafeteria: The stage is undersized. The space feels outdated and has no access to natural light.

Cafeteria and kitchen are undersized and aged. There is an extremely small projection screen and only one option for seating. No available access to outdoors.

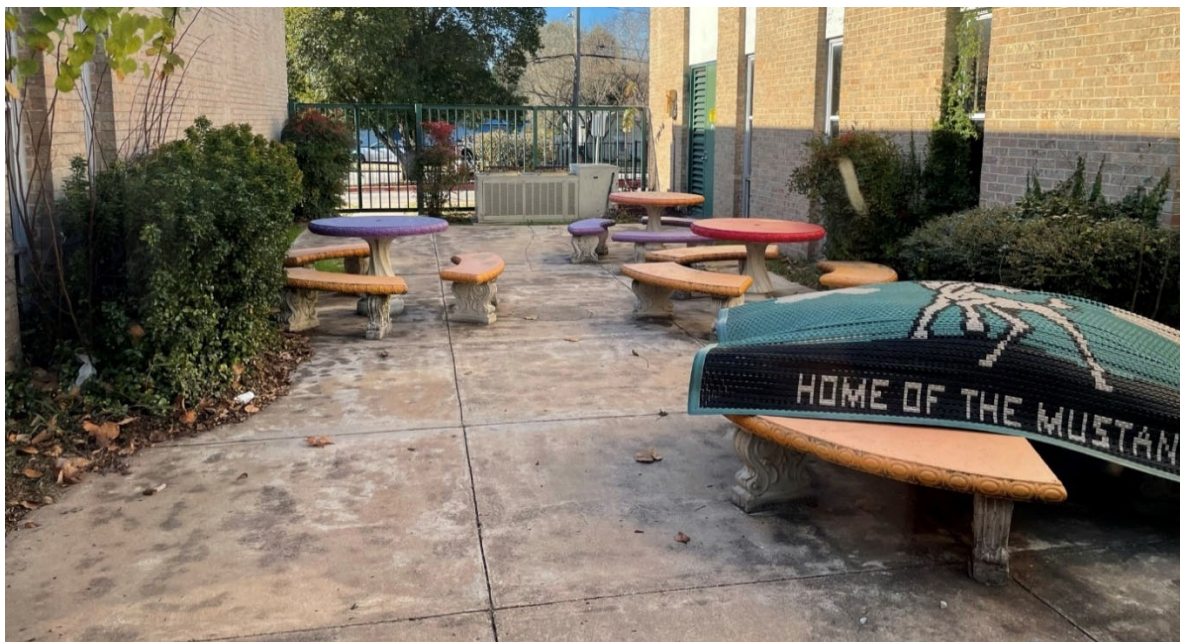
There are nice interior courtyards, but they do not seem to be utilized for outdoor learning. This could be an outcome of COVID-19 protocols and may not reflect a normal school year.

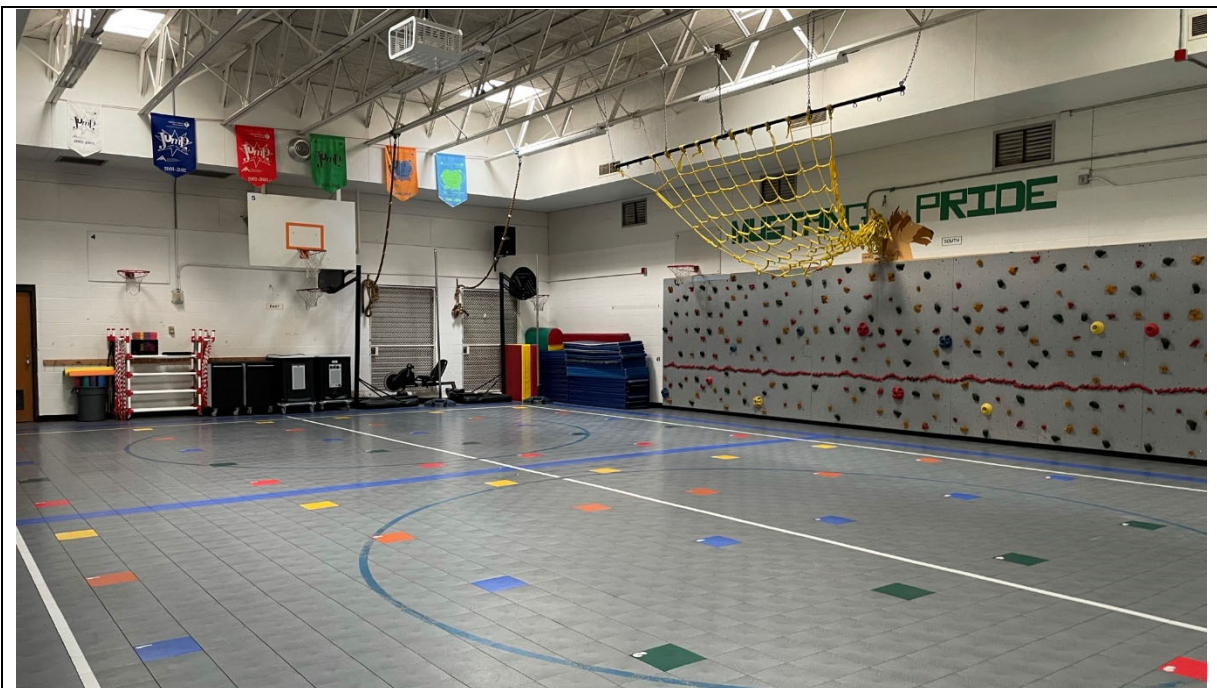
Gym is undersized and needs new flooring.

Gym is undersized and needs new flooring. It lacks storage and shares restrooms with the cafeteria. There is an operable wall between the gym and cafeteria spaces.

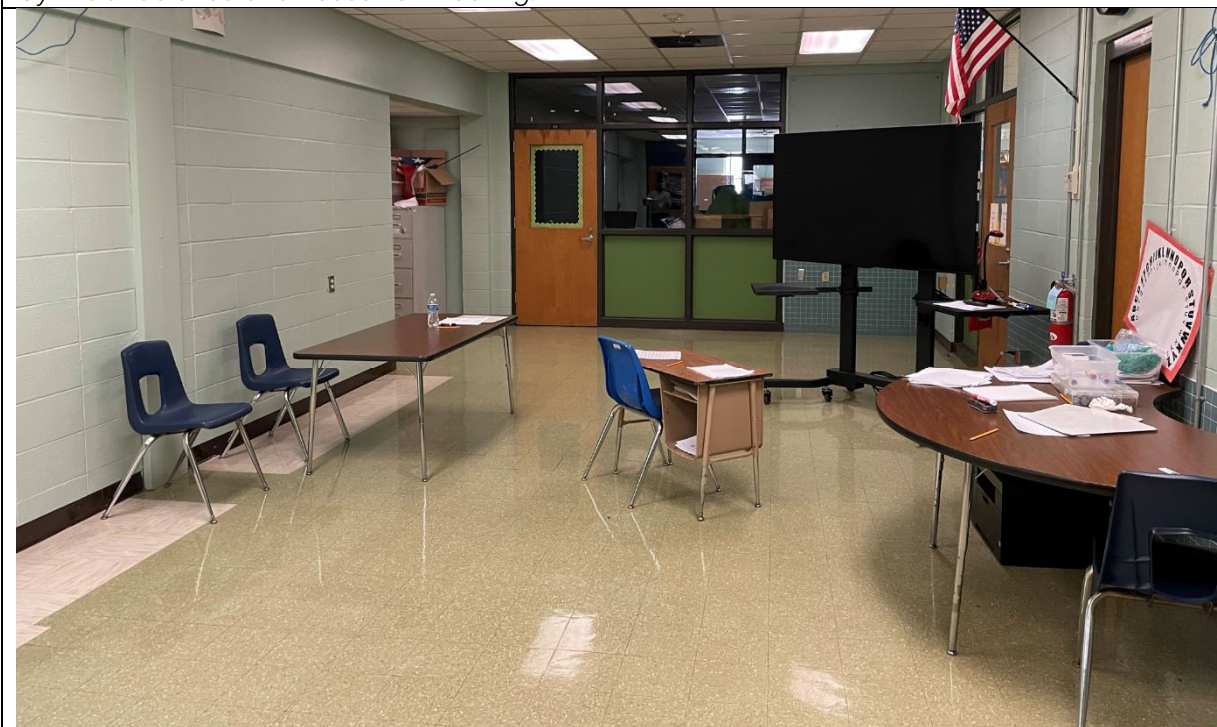
Neighborhood (Original Building): Neighborhood has visibility into each studio but lacks natural lighting or the ability to move through the spaces easily.

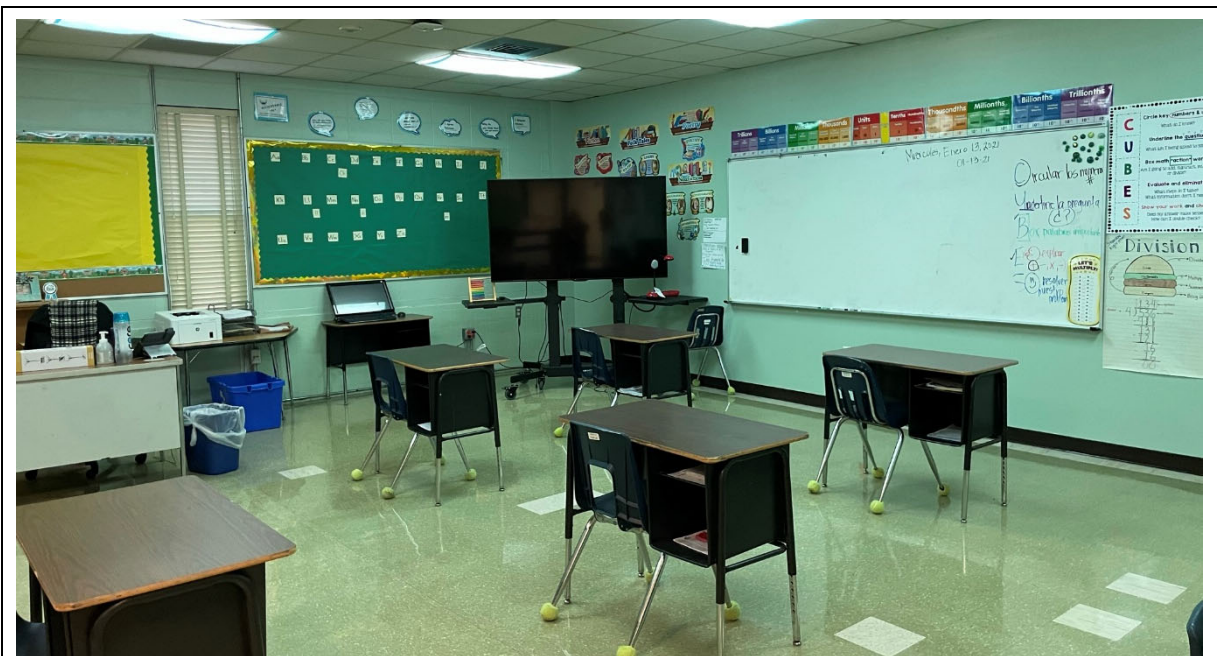
This is a typical studio and teachers put covers on lights to reduce glare and discomfort.

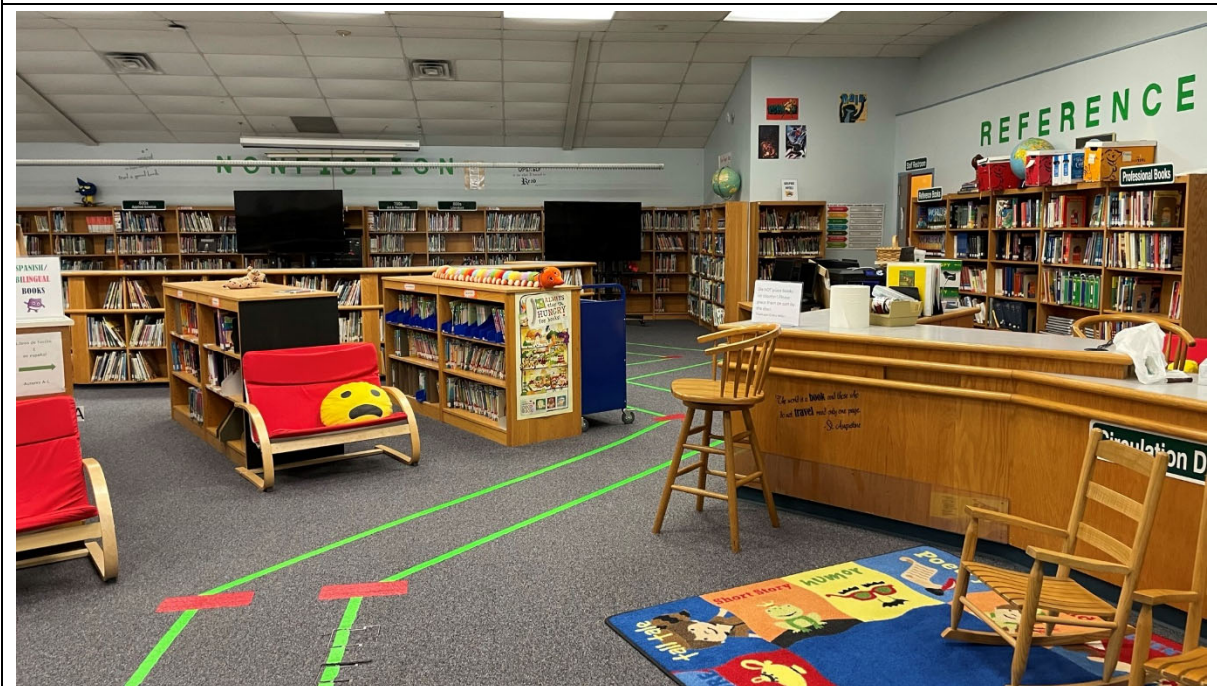
Media Resources: The space is open but not very flexible and is outdated.

The library is in an addition and not well-connected to the rest of the school. It consists of one large space with no dedicated areas or zones for quiet study. The furniture is mobile for easy reconfiguration and layout could be changed to support smaller groups.

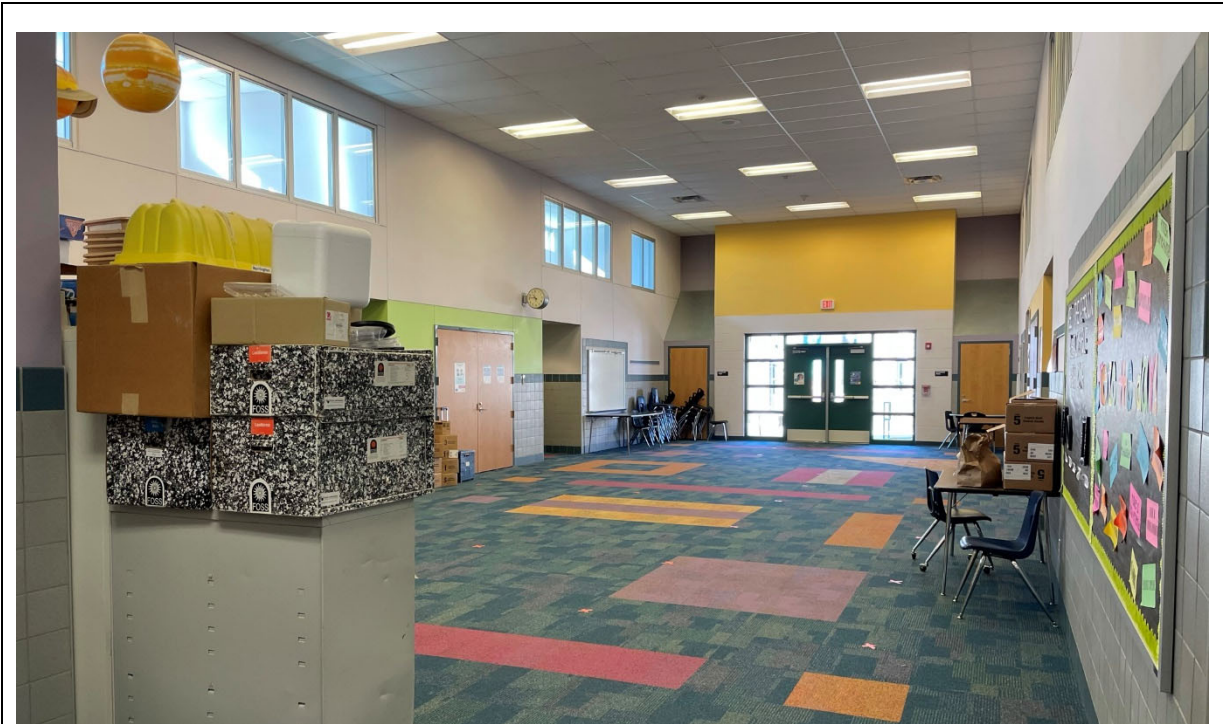
Annex D: The addition has a large collaboration space for students and access to natural light.

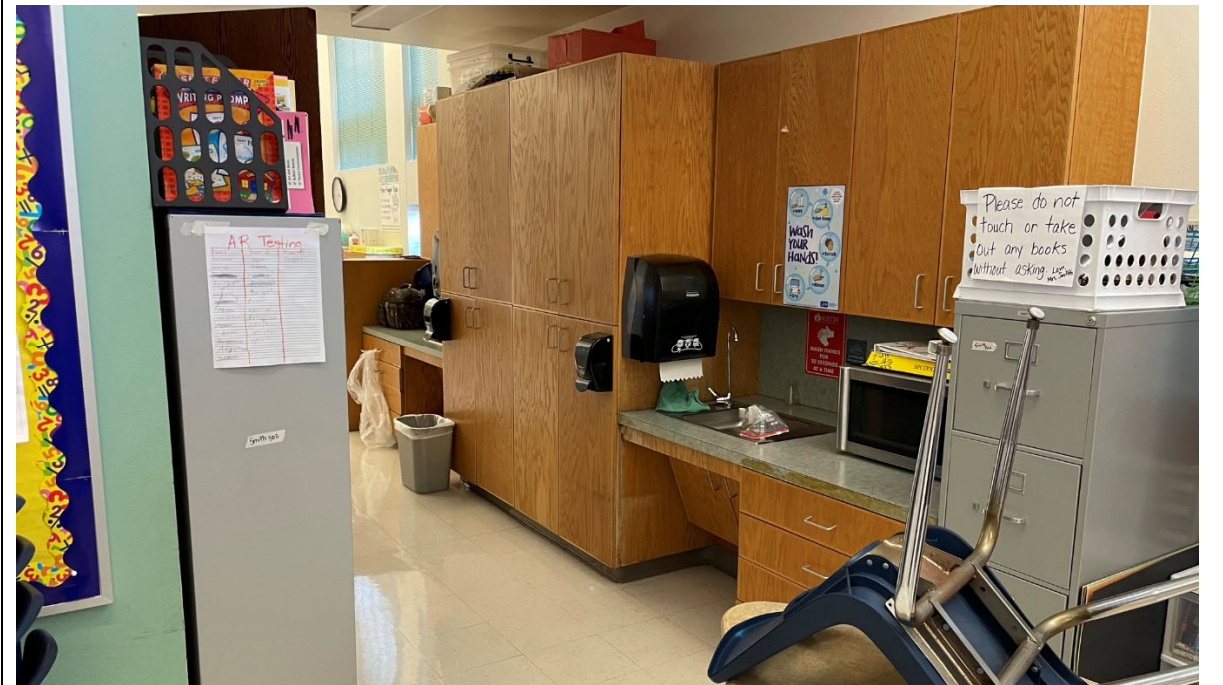
Annex B Studio: Studio storage is in the hallway between two connected studios.
