Educational Suitability Summary Report

Campbell Elementary School

Date: 01/14/2021

Score 62% Average

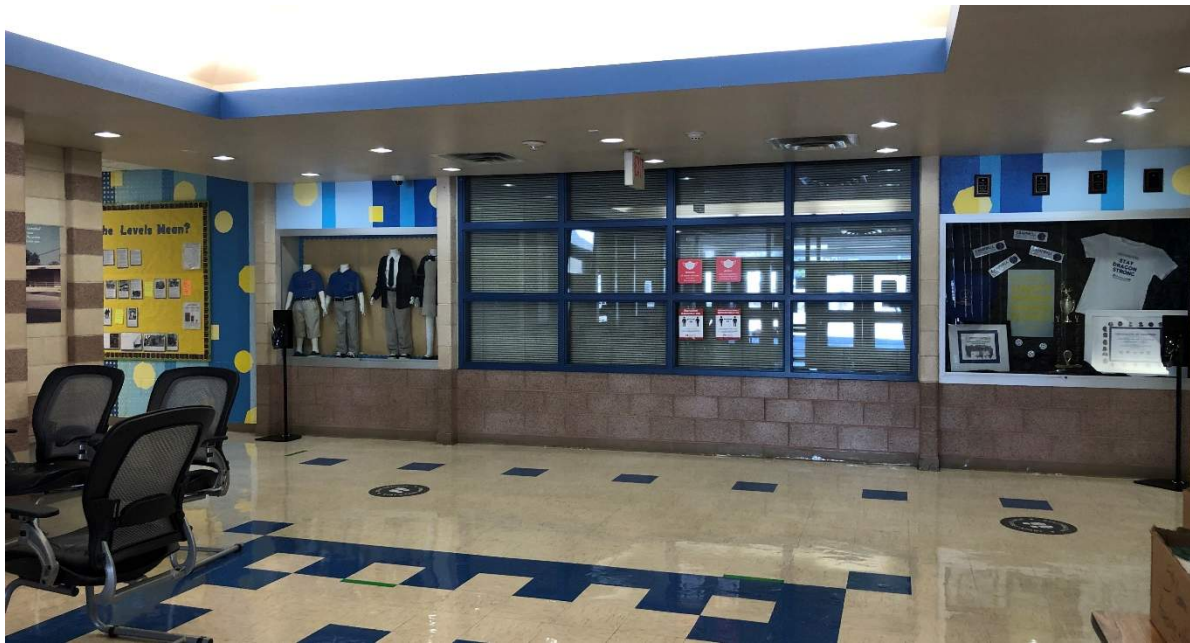
View of the main entry is welcoming with displays and use of color. The main entry does not have a secure vestibule, but there is an office window in the space to check in visitors.

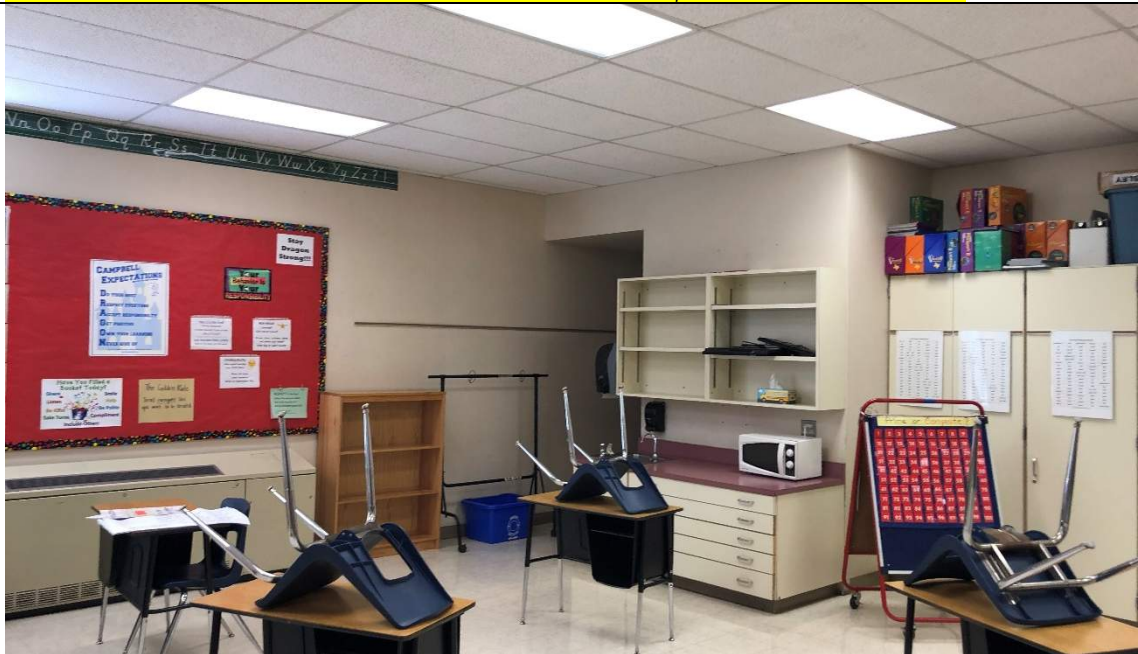
Typical studio has connection to adjacent studio through small bathroom corridor. It is requested that the studios be separated by a door that can close. Adjacent studio noise is distracting to learners. Typical studio furniture can be reconfigured, but not easily. Some furniture is in worn condition.

The principal would like to separate the studios from being connected at the bathrooms to create acoustic privacy and limit noise distractions. The retrofitted spaces for dance, black box theater, digital media lab and broadcast/green room need more specialized spaces that are specifically designed for these uses. An audio recording studio or recording booth would be highly desired and would complement the programs the campus is emphasizing. The campus also needs a middle school stage setup with more storage space and support spaces for the programs and productions the campus produces. One obstacle for performances is the operable partition between the cafeteria and the gym does not function well and is very difficult to open. It is typically kept closed, which limits the number of people who can attend.

Connected studios with configuration of connected bathrooms allow transmission of sound between studios. All studios have access to natural light and have views.

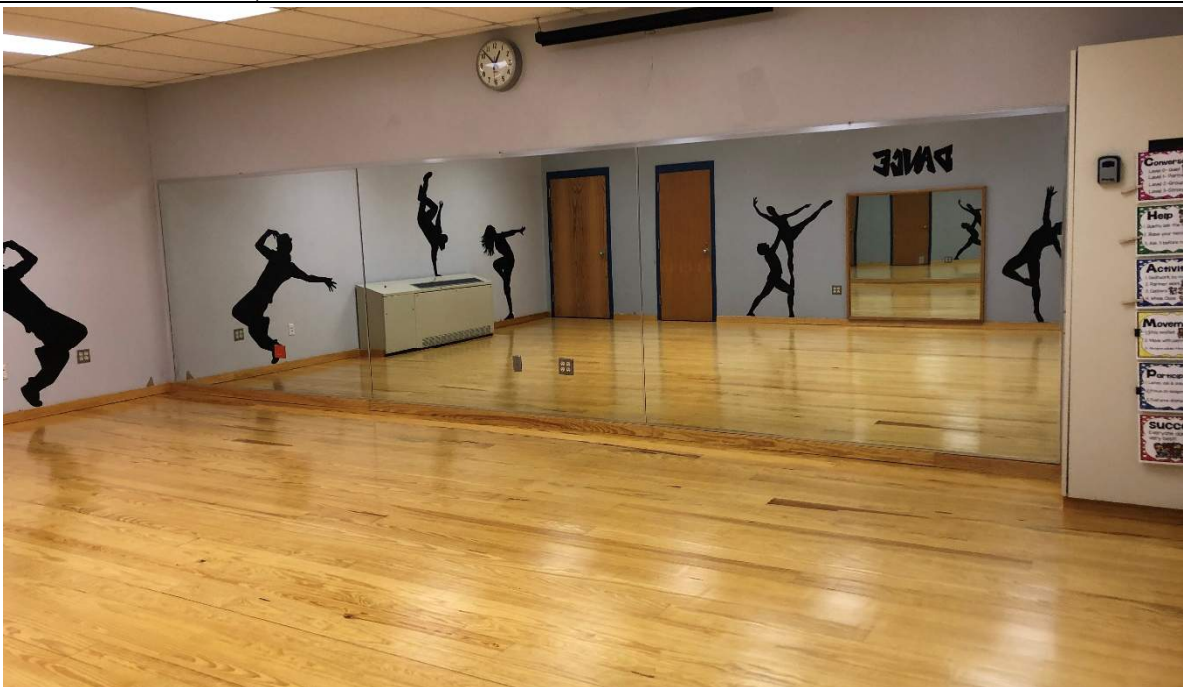
Opposite wall of dance room includes built-in storage cabinet.

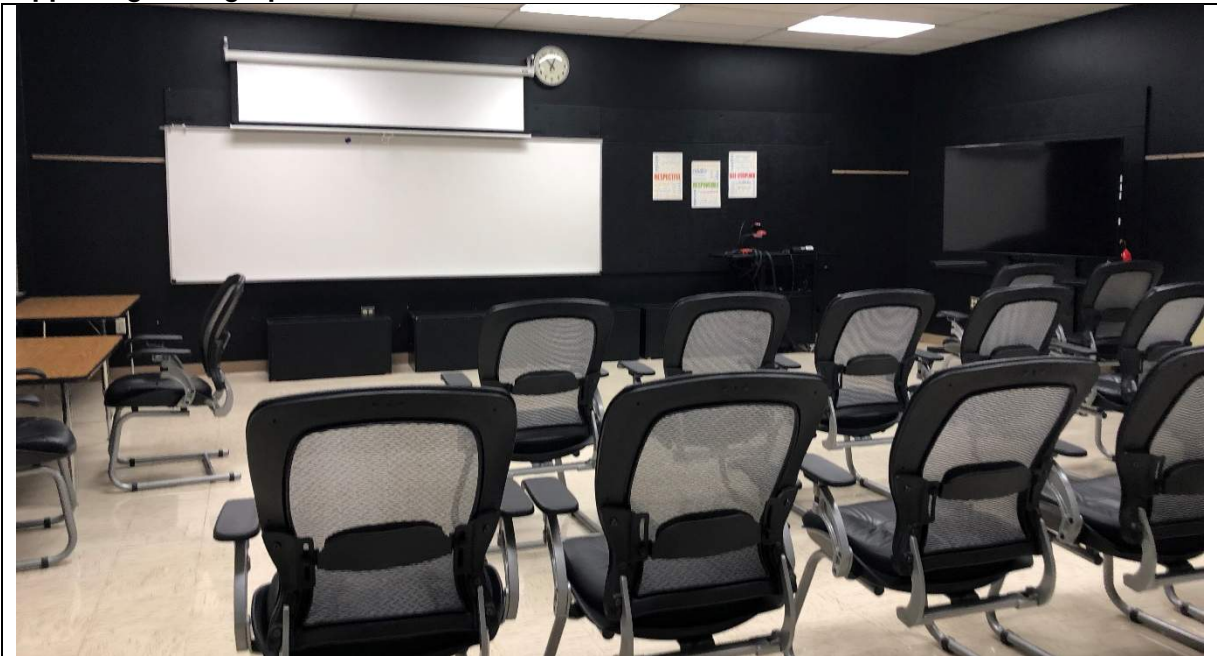
Converted studio serves as a black box theater. Space has connected storage closet and ADA-compliant restroom.

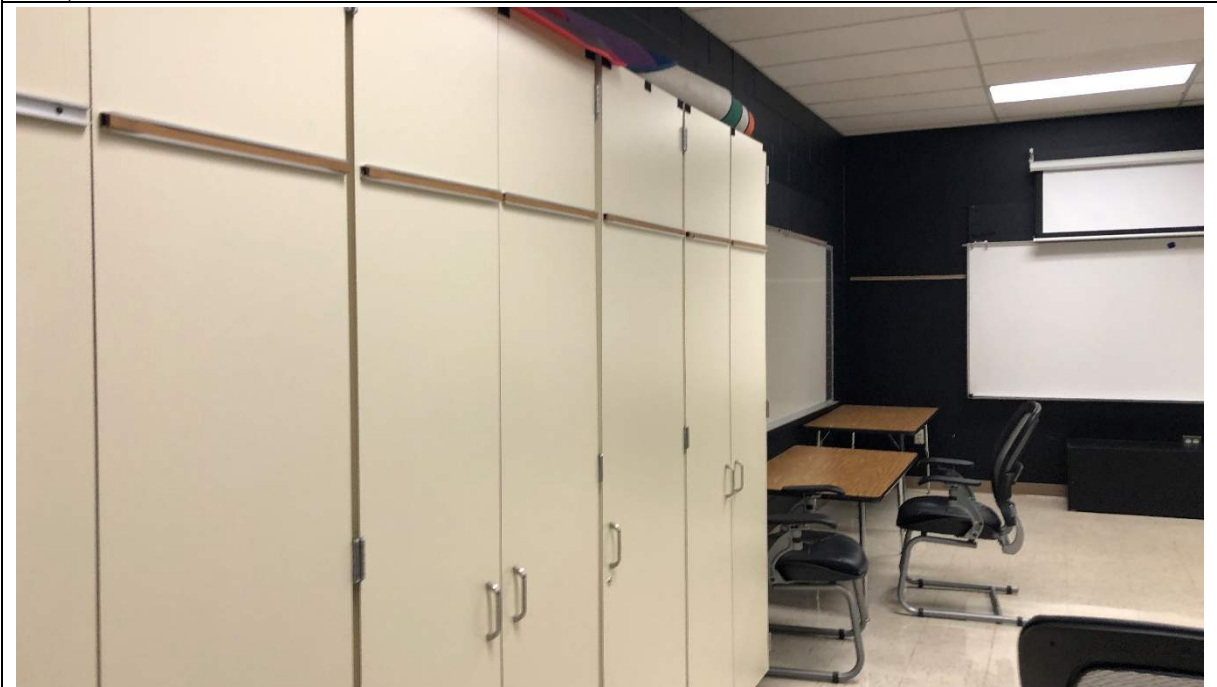
Black box theater room includes built-in cabinet storage.

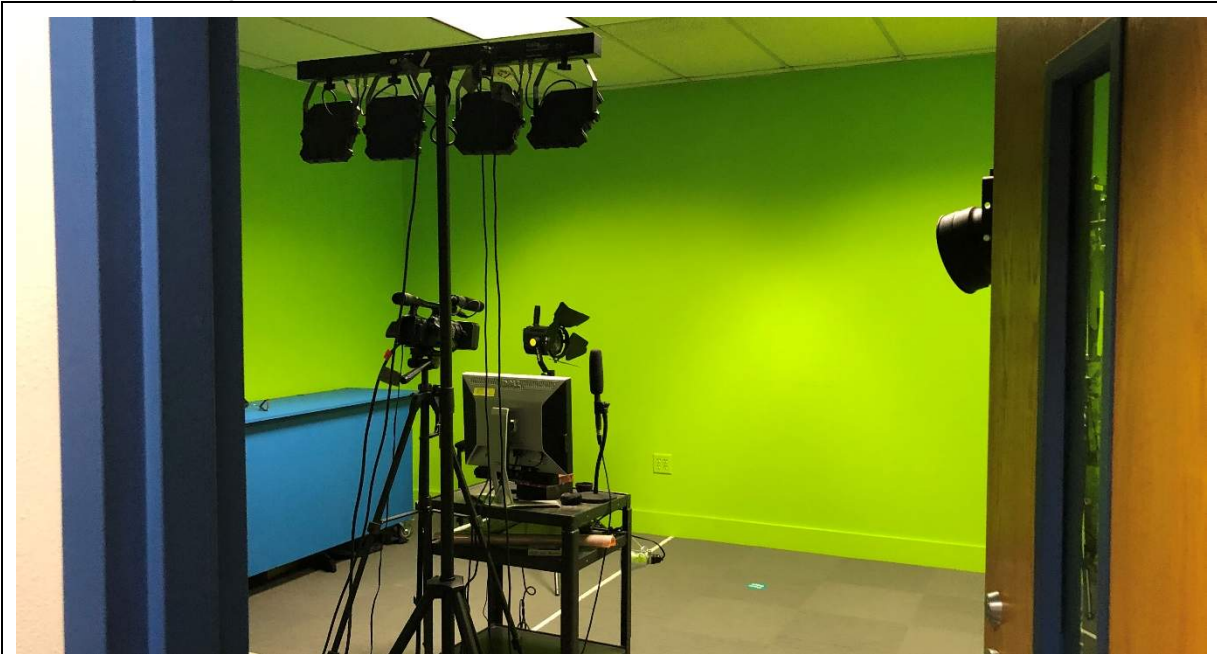
Dedicated green room for video media production.

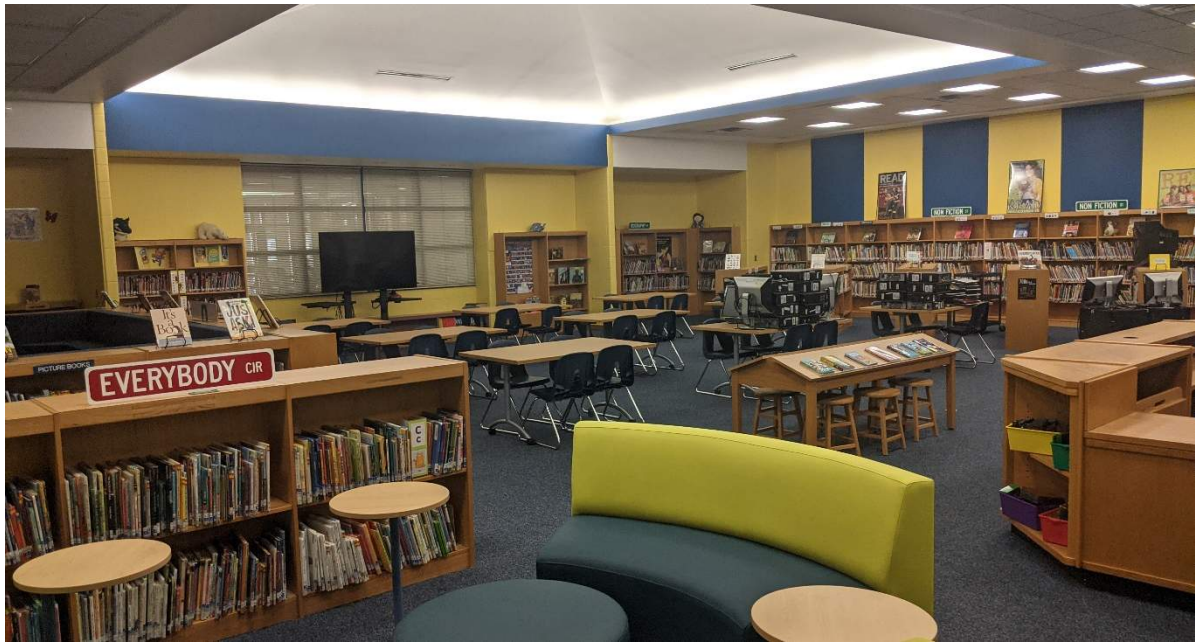
Library has a mix of furniture for social interaction. Tables have wheels for ease of reconfiguration and chairs are stackable for storing.

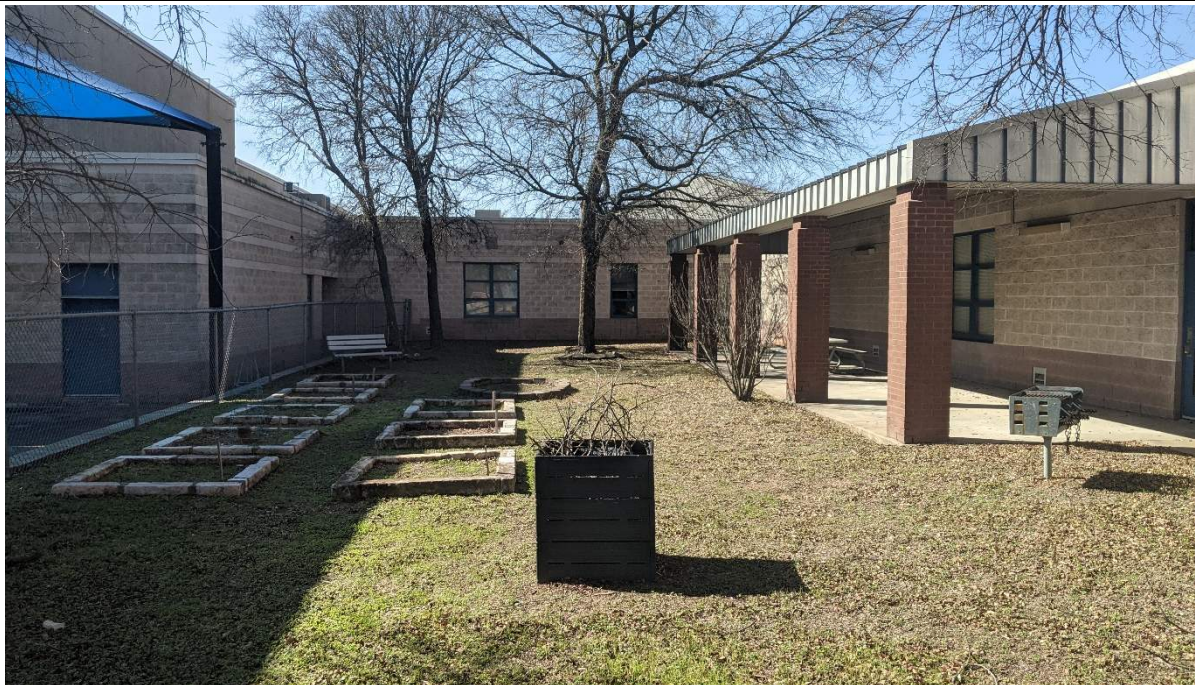
Studio wing with direct connection to small, fenced-in exterior space. There is a picnic table and a bench. Area needs further development to function well as an outdoor learning space. It was noted by the District Project Manager that the cover (left side of image) for the play area is torn and needs to be replaced.

There are two partially developed outdoor spaces for learning with a large wooden deck and a small, fenced-in area that is directly connected to a studio wing. Both need furniture to function well. The wooden deck area lacks shade and needs further development to operate as an outdoor studio.

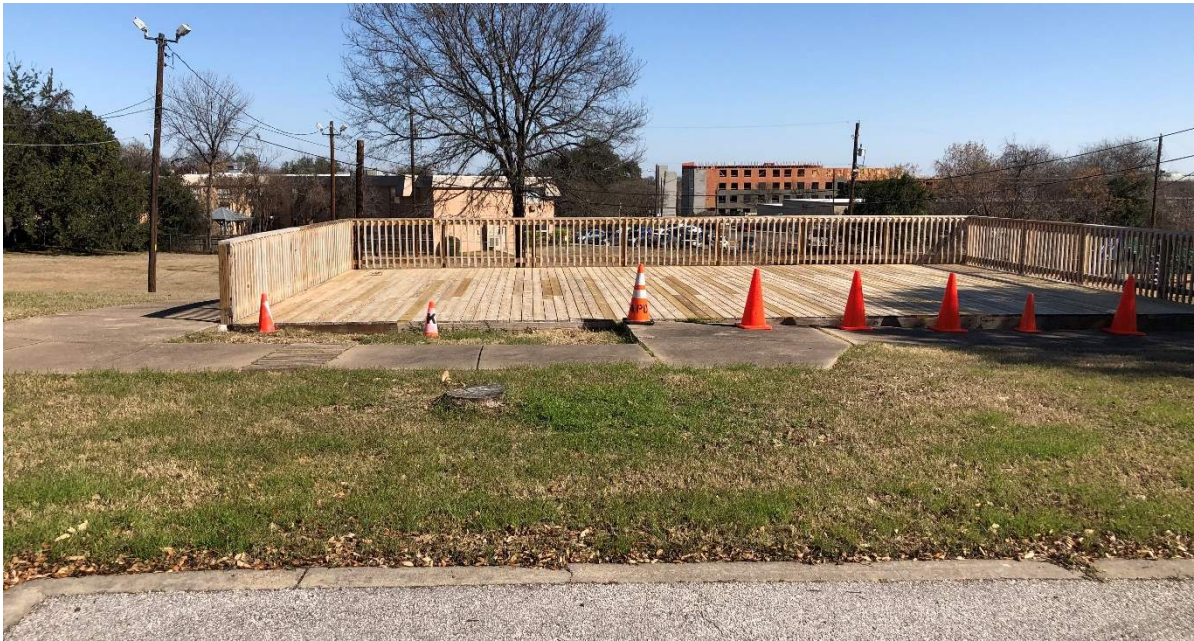
Wooden deck was built as an Eagle Scout project. It needs further development with shade and furniture to function as an outdoor studio space.

The campus has exterior spaces that the principal would like to develop. The wooden deck constructed as an Eagle Scout project needs shade, electrical, data and furnishings to make it a functional outdoor learning space. Connection to Wi-Fi would be ideal to have lessons outside. The other spaces are outfitted only with picnic tables under large trees and a smaller outdoor space with direct access to the studio wing needs access to power and data along with shade. A proper covered walkway is desired to connect to the building in the event of inclement weather. [REDACTED]

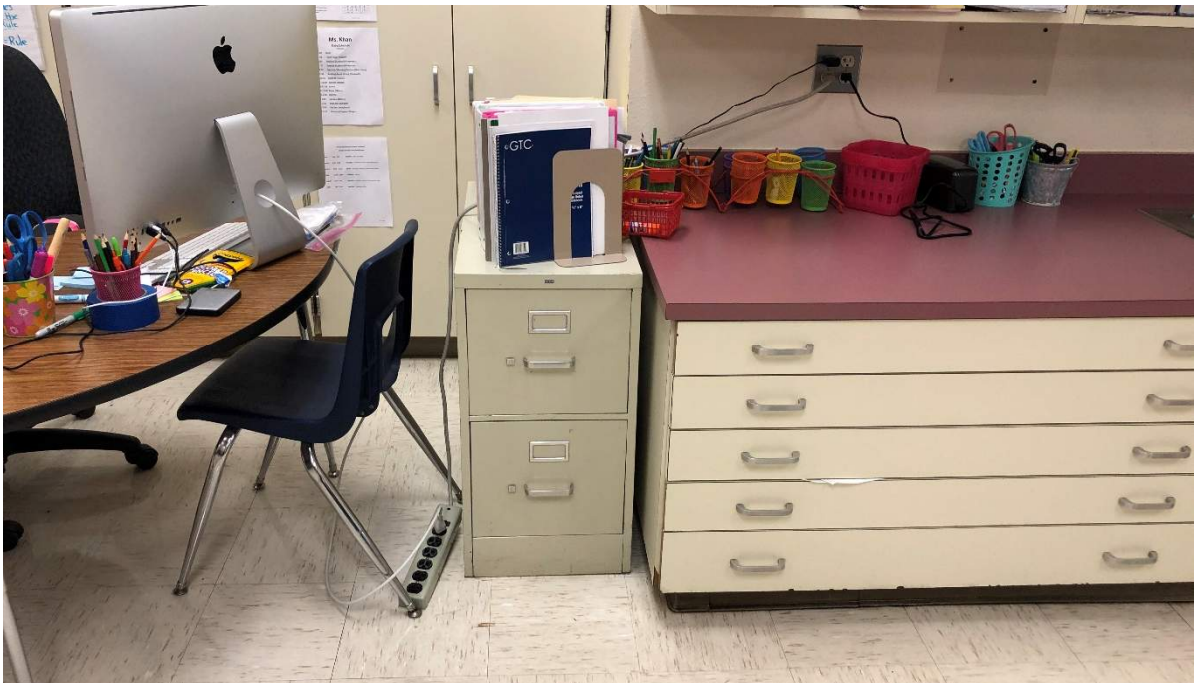
Electrical connections are lacking in studios for charging devices. Extension cords and power strips are used in studios and there are no centralized charging locations.

Extension cords are frequently used in studios throughout the campus. There are not adequate charging locations for devices and no centralized charging location. The reception area lacks digital media signage.

13 - Technology (cont.)		1	2	3	4	5	N/A				
13.3	Are there adequate charging locations for devices?	1						Comments	1.00	1.00	
1	Very unsatisfactory - No centralized charging location										
2	Unsatisfactory - Centralized charging location, but inadequate in size for number of devices										
3	Average - Charging cart or tower but not adequately sized for number of devices										
4	Satisfactory - Charging cart or tower not centralized										
5	Very Satisfactory - Charging cart or tower located centralized location. Excellent condition										
N/A	Does not apply
