## Educational Suitability Summary Report

Casey Elementary School

Date: 12/22/2020

**Score 64% Average**

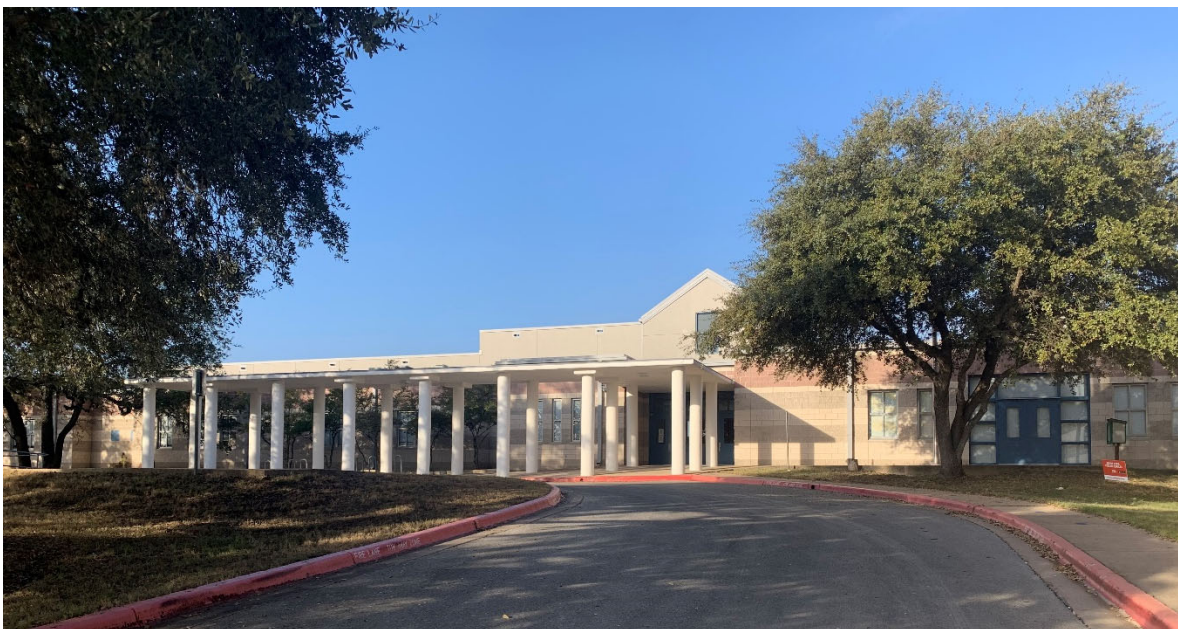
*A large, covered walkway provides a welcoming front entrance.*

The building has a large, covered walkway that defines the main entry well. Separate drop-off loops exist for vehicle and bus traffic, but exterior signage is lacking, and wayfinding is difficult.

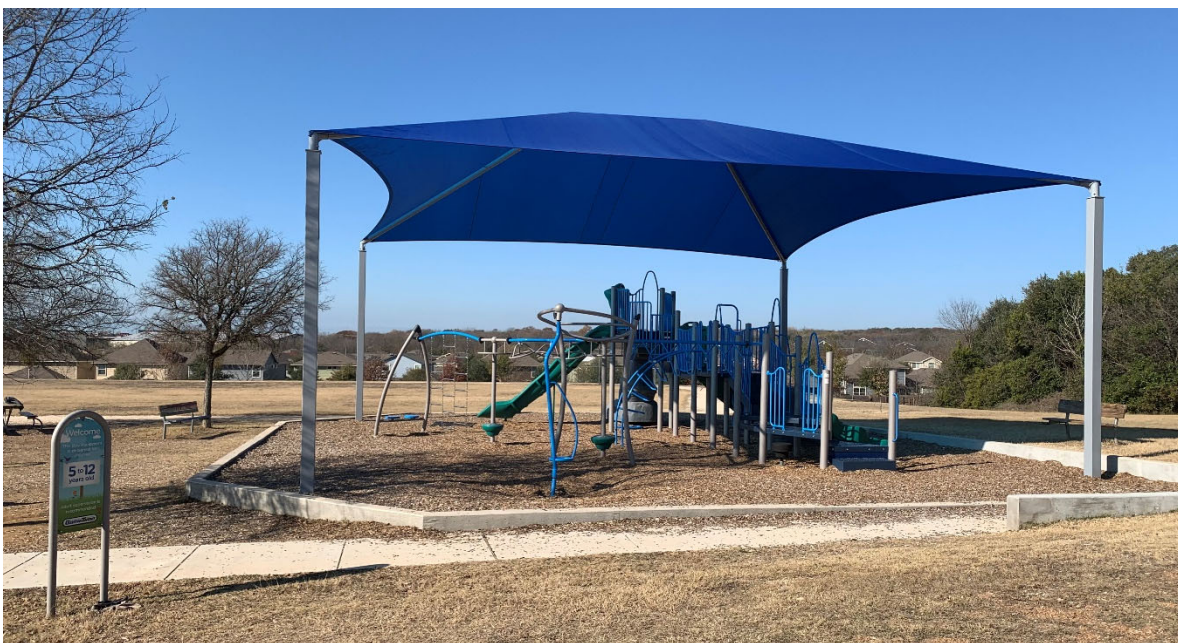
*The play area is fully covered and in excellent condition.*

2.2	Are active playgrounds (elementary only) and support spaces configured per the ed spec?					5		Comments	1.00 <b>5.00</b>
1	Very unsatisfactory - No dedicated active playground							The playgrounds are fully shaded and seem in good condition. (Monitoring answer, does not affect score for Outdoor Learning and Activity.)	
2	Unsatisfactory - Too small, poor condition, no shade provided								
3	Average - Adequate size, adequate condition, needs some renovations or updates to function well, 50% or less shade coverage over play structure								
4	Satisfactory - Good size, good condition, more than 50% shade coverage over play structure								
5	Very satisfactory - Generous size, excellent condition, full shade coverage over play structure								
N/A	Does not apply

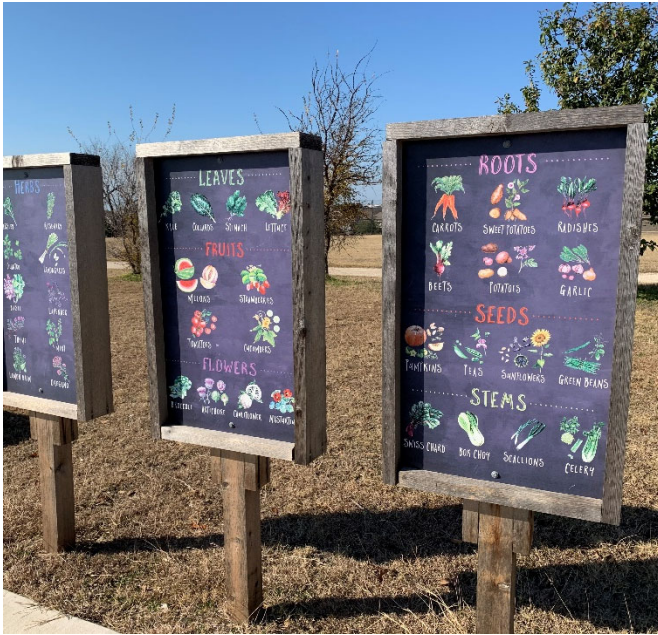
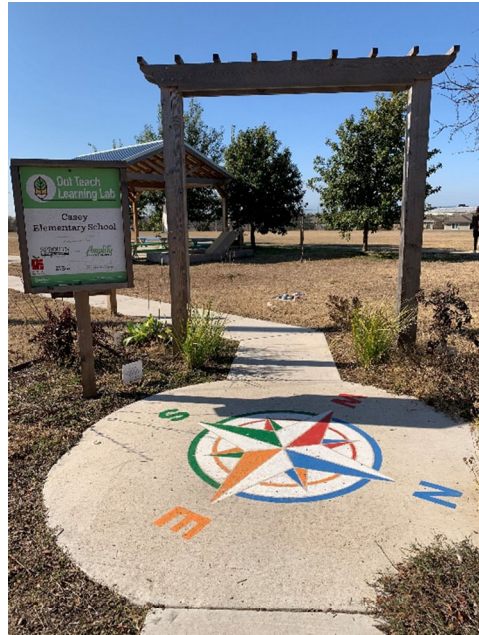
*Educational material is provided for the community garden (left) and a sizable outdoor learning lab is adjacent to the community garden (right).*

An outdoor learning lab, including a covered outdoor studio, community garden, mindfulness path and music lab, is large and well-maintained, but lacks direct connection to the indoor learning spaces. The playgrounds are fully shaded and appear to be new.

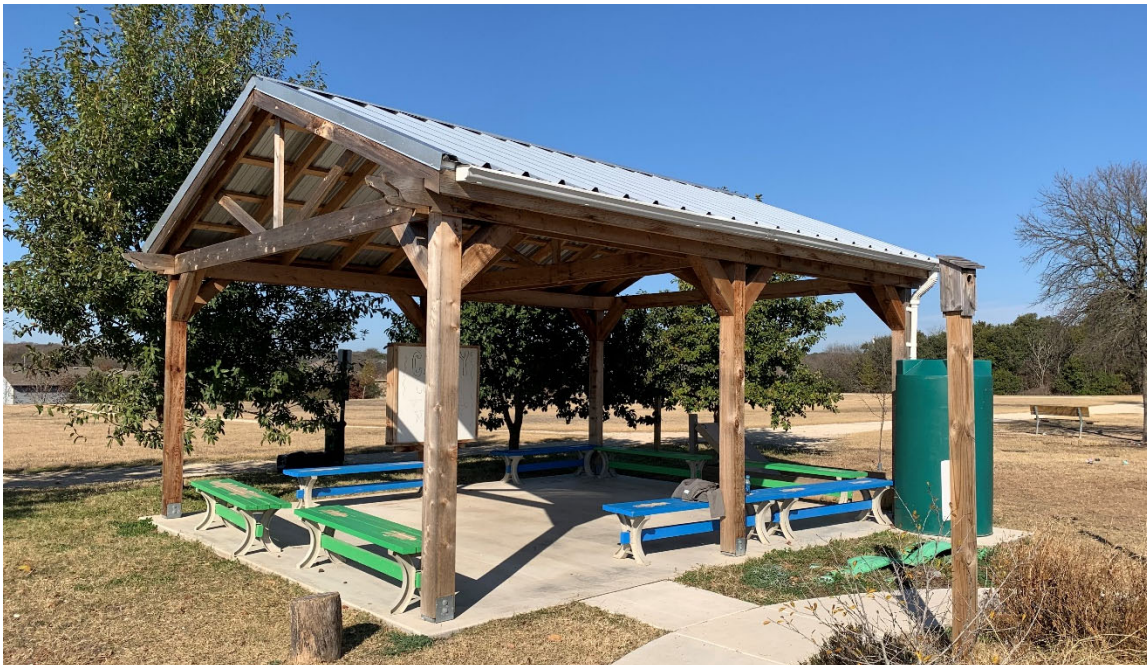
*The outdoor studio is fully covered and contains a writable surface.*

2.1	Are outdoor studios and support spaces appropriately configured per the ed spec?			3				Comments	1.00 <b>3.00</b>
1	Very unsatisfactory - No dedicated outdoor studios							The outdoor studio is smaller than a typical studio and not directly adjacent to the learning neighborhoods, but is fully shaded and functions well.	
2	Unsatisfactory - Too small, poor condition, disconnected from learning spaces, no flexibility, no shade provided								
3	Average - Adequate size, adequate condition, needs some renovations or updates to function well, 50% or less shade coverage over studio area								
4	Satisfactory - Good size, good condition, connected to learning spaces, good flexibility, more than 50% shade coverage over studio area								
5	Very satisfactory - Generous size, excellent condition, connected to learning spaces, excellent flexibility, full shade coverage over studio area								
N/A	Does not apply

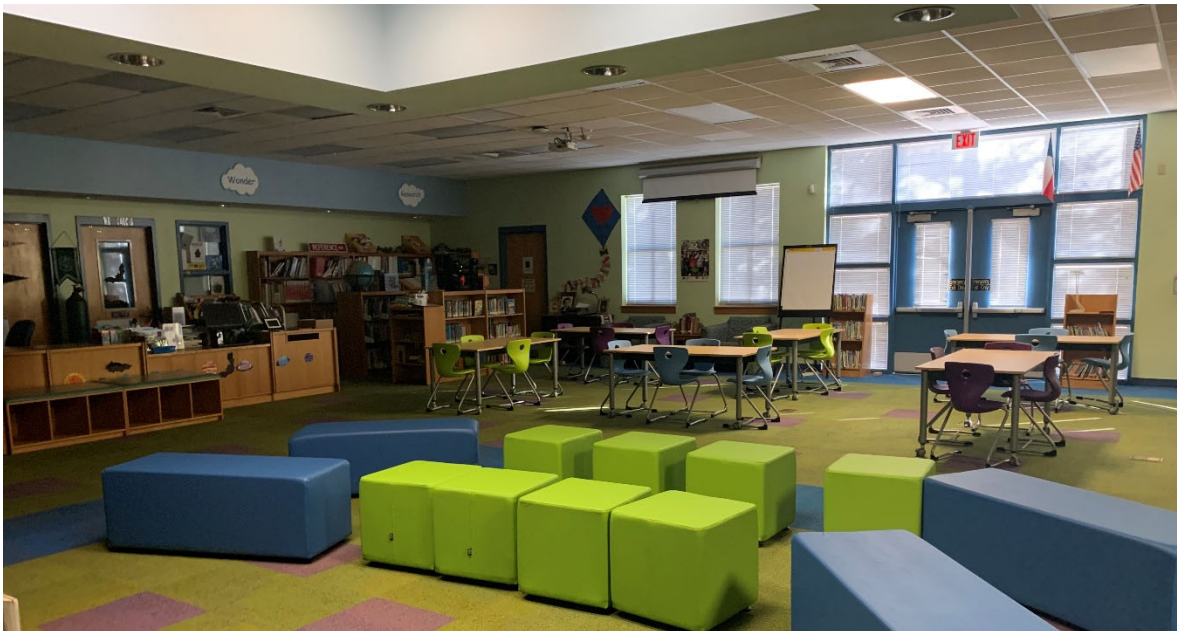
*Media Center: The library is in good condition and most furniture is easy to reconfigure.*

The media resources space contains a variety of flexible furniture that supports social interaction and group work well. No breakout rooms are present, but students can easily reconfigure the furniture in the library to support quiet study. Direct exterior access allows visitors to utilize the library for after-hours functions.

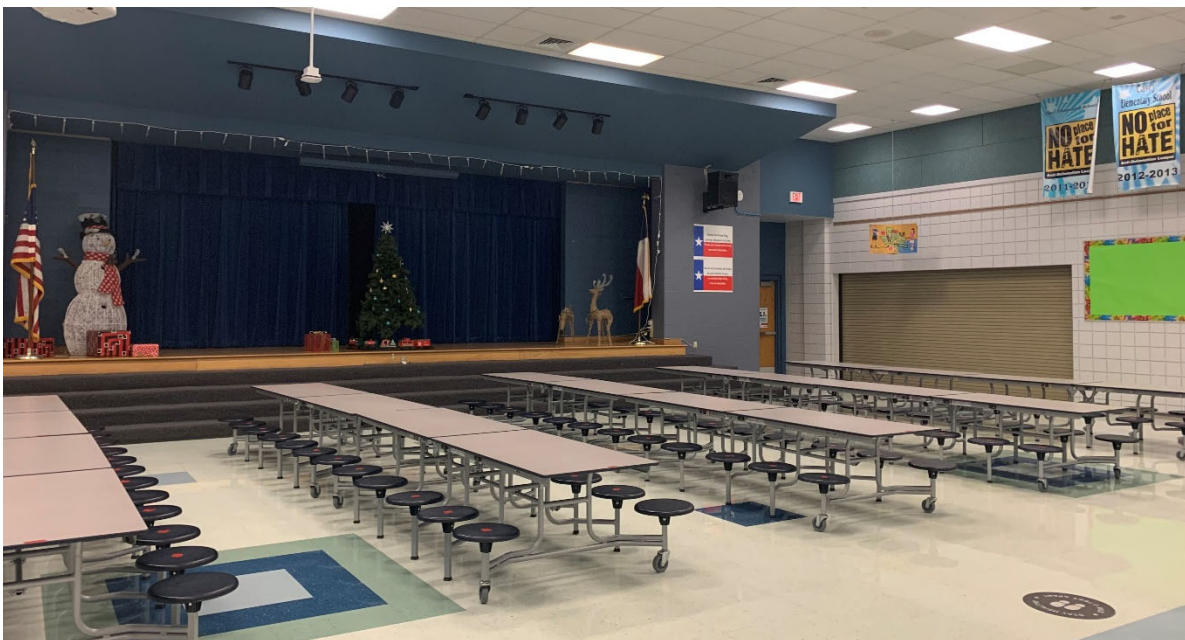
*The furniture in the cafeteria is not easily movable and no outdoor dining is available.*

11.1	Is the Dining Commons appropriately configured per the ed spec?			3				Comments	1.00 3.00
	1 Very unsatisfactory - Too small, missing program spaces 2 Unsatisfactory - Too small, poor condition, only one option for eating space provided, inadequate circulation 3 Average - Adequate size and condition, needs updates or renovations to function well 4 Satisfactory - Good size and condition, good circulation, multiple options for eating space (ex: connection to outdoor eating space) 5 Very Satisfactory - Generous size, excellent condition and circulation, multiple options for eating space (ex: connection to outdoor eating space) N/A Does not apply	The cafeteria is a good size at 4000 SF. Only 1 option for eating space and 1 type of furniture is provided. No outdoor dining option is present.

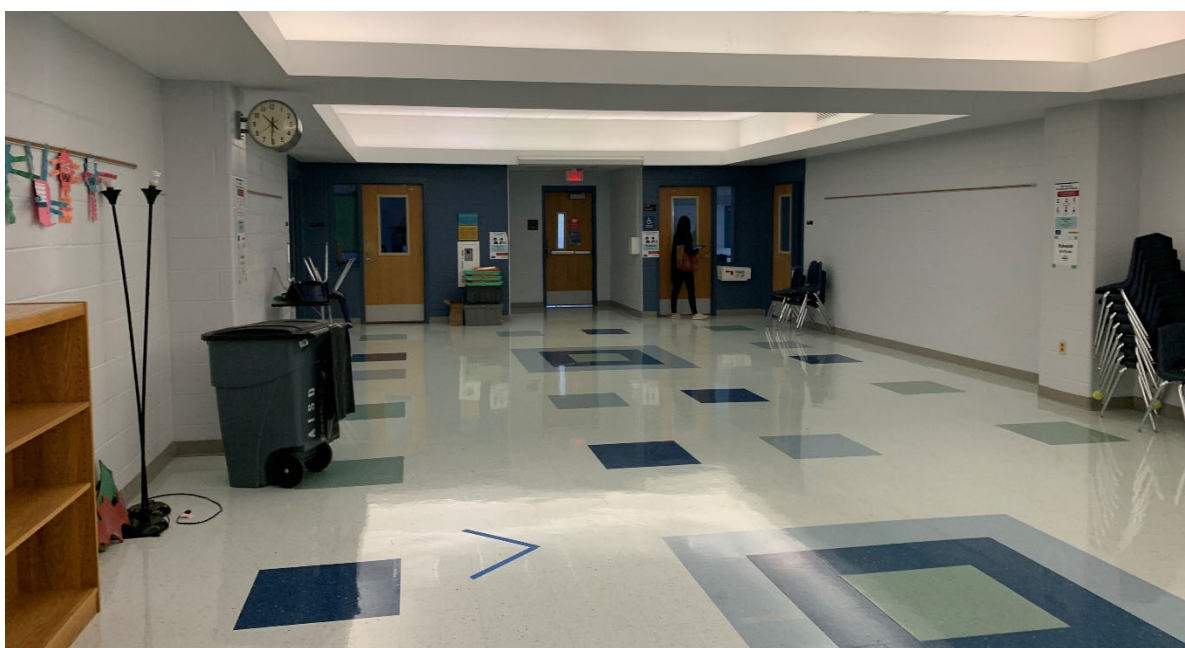
*Learning Neighborhood: Learning studios have poor visibility into the collaboration space.*

8.4	Do typical learning neighborhoods have small group rooms and open collaboration space?		2					Comments	1.00 <b>2.00</b>
	1 Very unsatisfactory - No breakout rooms or open collaboration spaces are provided							No breakout rooms are provided. Open collaboration spaces are only provided in some wings and have limited visual connection to adjacent learning spaces.	
	2 Unsatisfactory - Too small or too few, poor condition, no flexibility, lacks visual connection to learning neighborhood, poor acoustic privacy								
	3 Average - Adequate size, adequate condition, needs some renovations or updates to function well								
	4 Satisfactory - Good size, good condition and flexibility, transparency and connection to learning neighborhood, acoustic privacy								
	5 Very Satisfactory - Generous size, excellent condition and flexibility, transparency and connection to learning neighborhood, acoustic privacy

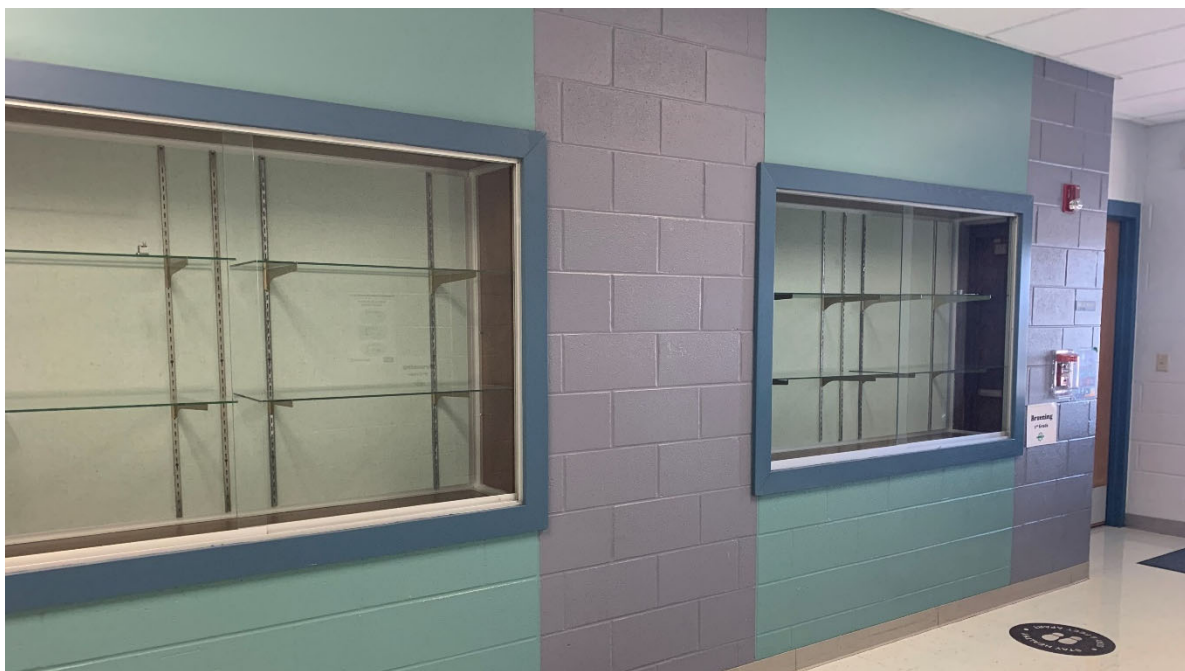
*Large display cases exist in the entry corridor, but more are needed throughout the academic wings.*

8.9	Are there adequate places to display the evidence and artifacts of learning (both 2D and 3D)?			3				Comments	1.00 <b>3.00</b>	
1	Very unsatisfactory - No dedicated space							Corridors have tack strips and a few display cases.		
2	Unsatisfactory - Too small, non-dedicated, poor condition									
3	Average - Adequate size, adequate condition, needs updates or renovations to function well									
4	Satisfactory - Good size, good condition									
5	Very Satisfactory - Generous size, excellent condition									
N/A	Does not apply

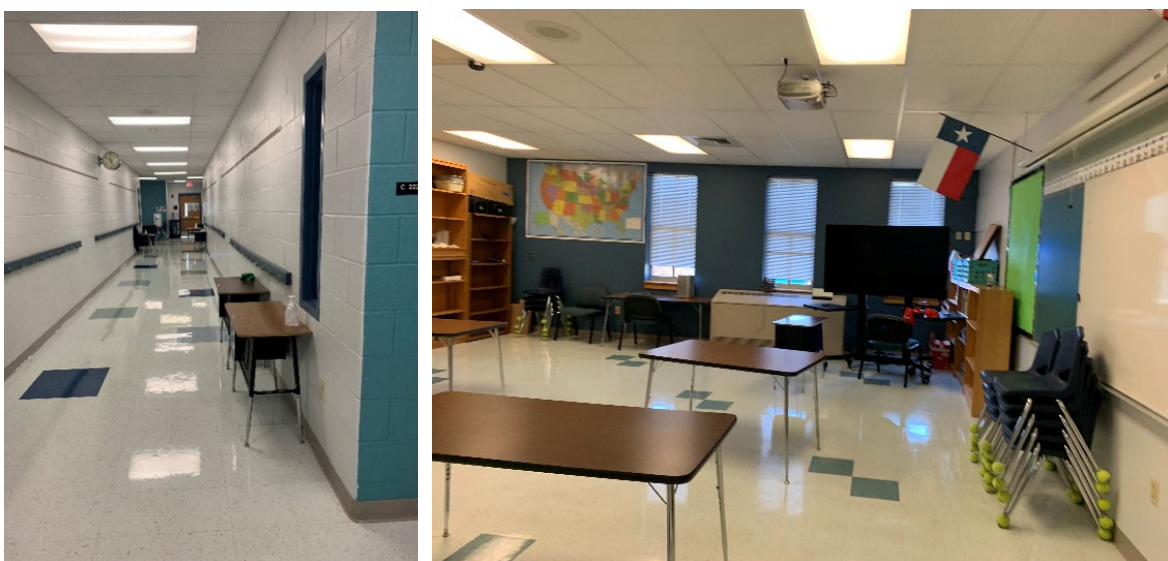
*Academic Wing: Limited visibility between studios and corridors exists (left); furniture in the studios is outdated and difficult to reconfigure (right).*

The media center is the only space that has a variety of flexible furniture. Studios have single desks and loose chairs that are cumbersome to rearrange for project-based learning. Collaboration areas lack furniture that could promote social interaction and group work. The cafeteria provides only one seating option: long tables with attached stools.

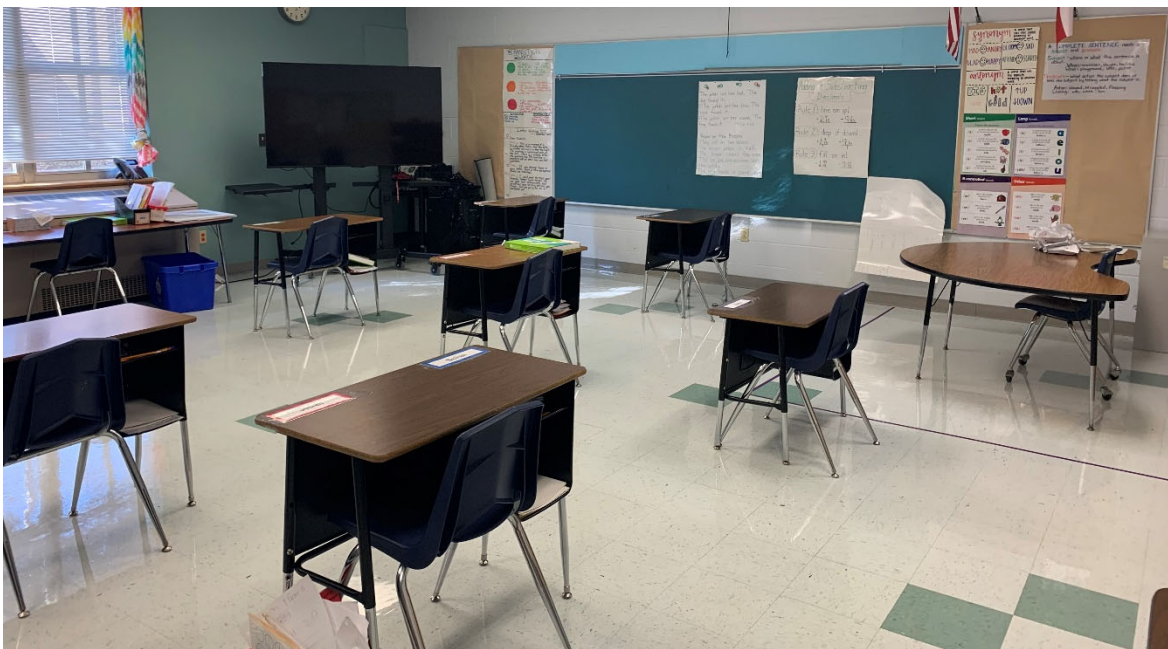
*Digital display screens in the studios work well, but the furniture is outdated, and studios lack whiteboards.*

Studio spaces support instructional technology well with ample wall outlets, projectors and digital display screens. However, charging carts are needed throughout campus to support technology. The cafeteria has a large projector and screen that can be shared with the adjacent gymnasium. Digital media signage is missing in the reception area.
