Educational Suitability Summary Report

Gullett Elementary School

Date: 01/11/2021

Score 51% Average

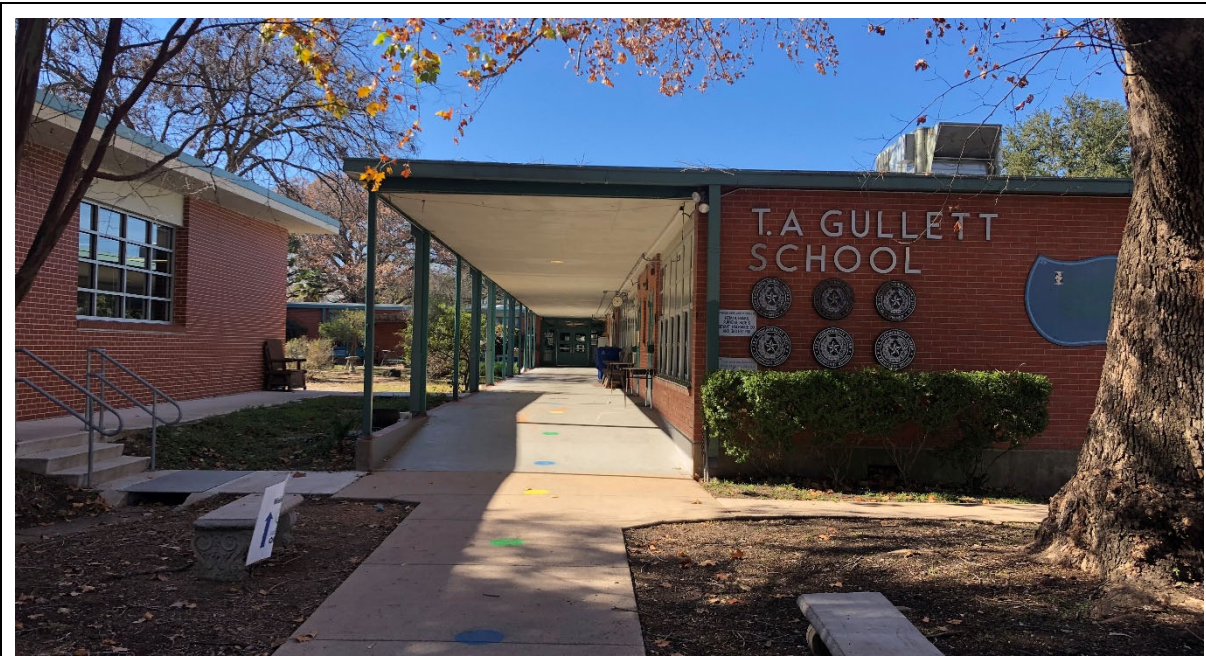
The school was built in the late-1950s and is nicely integrated with the surrounding old growth trees and the neighborhood.

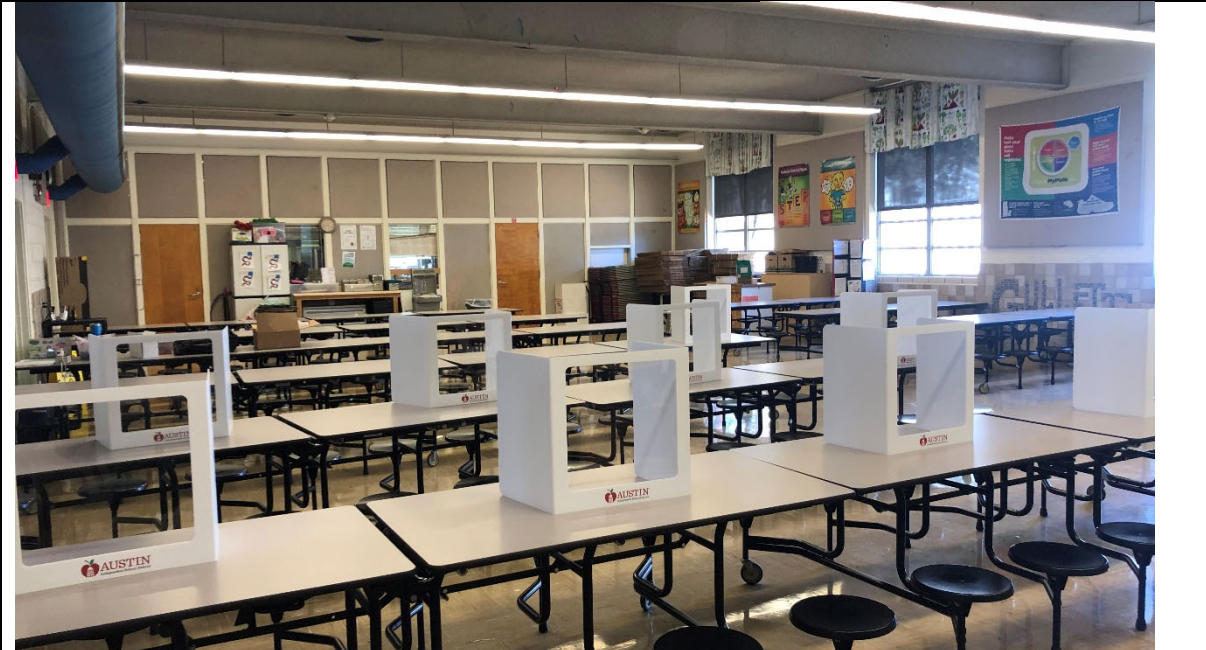
Cafeteria and kitchen are very undersized. Kitchen is 850 square feet and requires exterior freezer/coolers. Stage within cafeteria is not accessible.

Cafeteria and kitchen are undersized, and finishes are very unsatisfactory.

11.1	Is the Dining Commons appropriately configured per the ed spec?		2					Comments	1.00 2.00
	1 Very unsatisfactory - Too small, missing program spaces 2 Unsatisfactory - Too small, poor condition, only one option for eating space provided, inadequate circulation 3 Average - Adequate size and condition, needs updates or renovations to function well 4 Satisfactory - Good size and condition, good circulation, multiple options for eating space (ex: connection to outdoor eating space) 5 Very Satisfactory - Generous size, excellent condition and circulation, multiple options for eating space (ex: connection to outdoor eating space) N/A Does not apply	For school's current enrollment (525), cafeteria should be approx. 3,000 SF (1/3 population * 17 NSF). Current cafeteria is 2,150 SF.

11.2	Are the Food Services support spaces appropriately configured per the ed spec?		2					Comments	1.00 2.00
	1 Very unsatisfactory - None provided 2 Unsatisfactory - Too small, disconnected, poor condition 3 Neutral - Adequate size, average condition, needs updates or renovations to function well 4 Satisfactory - Good size, connected, good condition 5 Very Satisfactory - Generous size, connected, excellent condition N/A Does not apply	Very undersized kitchen, one small serving line. Freezer / cooler are accessed from outside off of the main corridor.

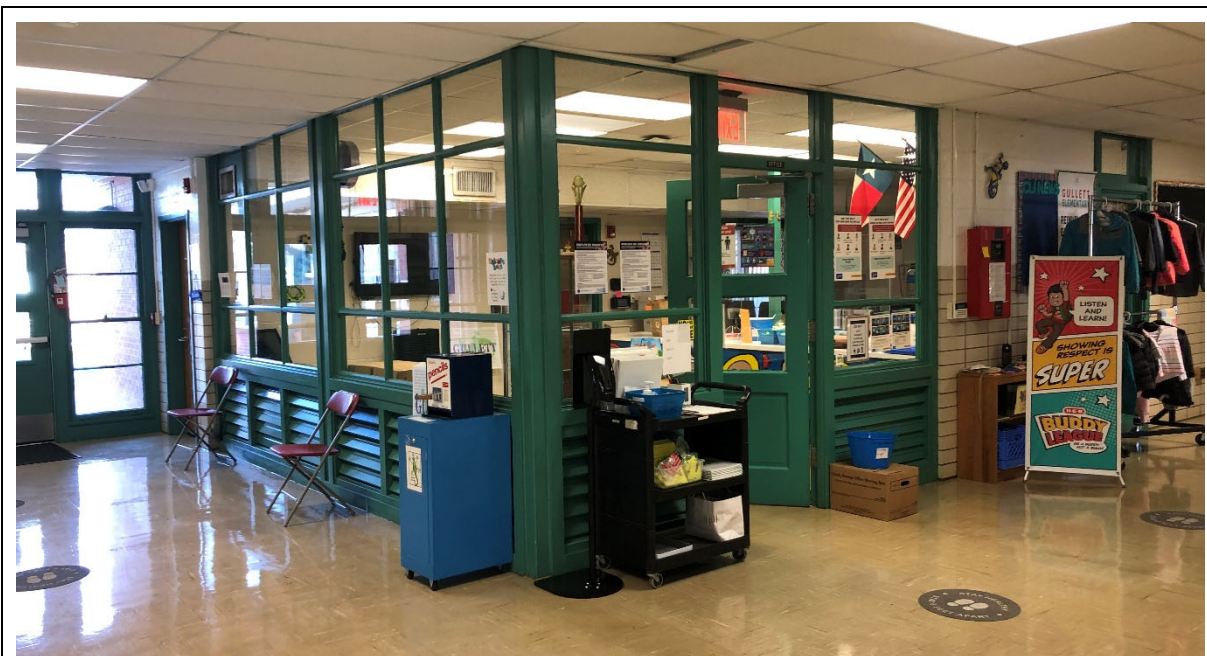
Administration: Main office is located near the primary entry. It is missing many programmatic elements, such as a conference room, staff lounge, separate offices for principal / Asst. Principal, and nurse's office.

The administration area does not feel welcoming and is too small. [REDACTED]

[REDACTED] There is no conference room available for teacher/parent use. The nurse's office does not accommodate a cot.

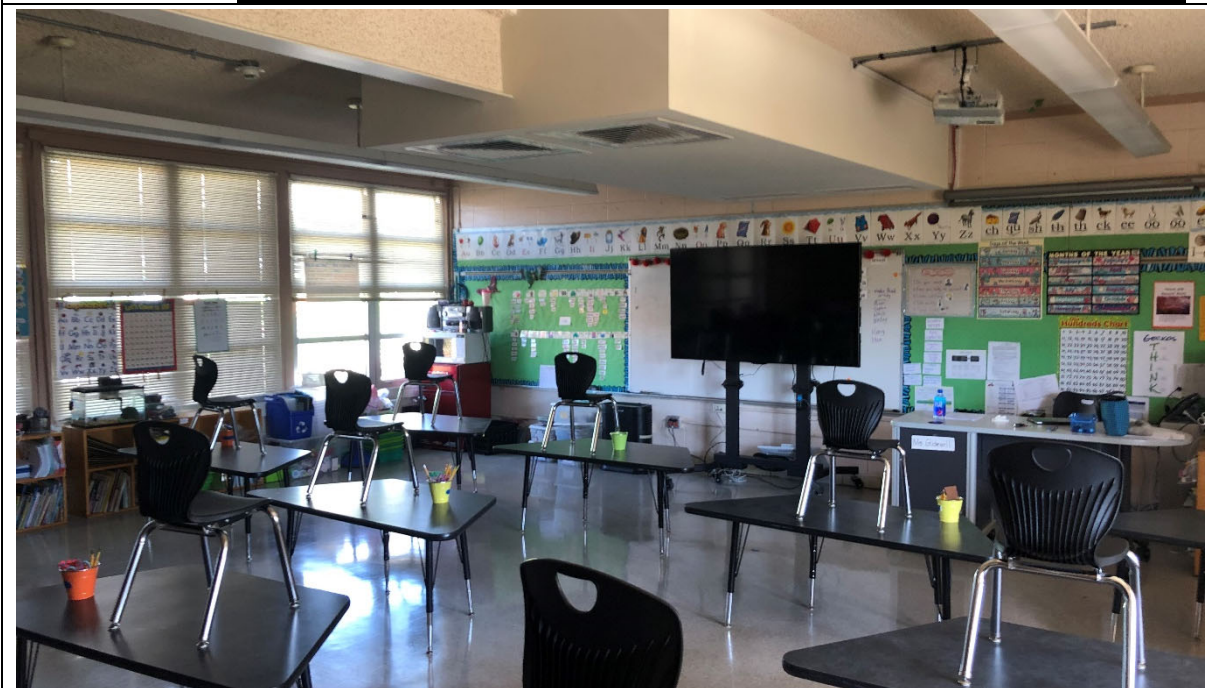
All studios are undersized. There is some casework storage, but storage is severely lacking throughout the school. Studios all have ample access to daylight with windows on both sides of the room.

All studios are undersized per Ed Spec. Collaboration takes place outdoors. Special education studios are in portables and do not have changing tables.

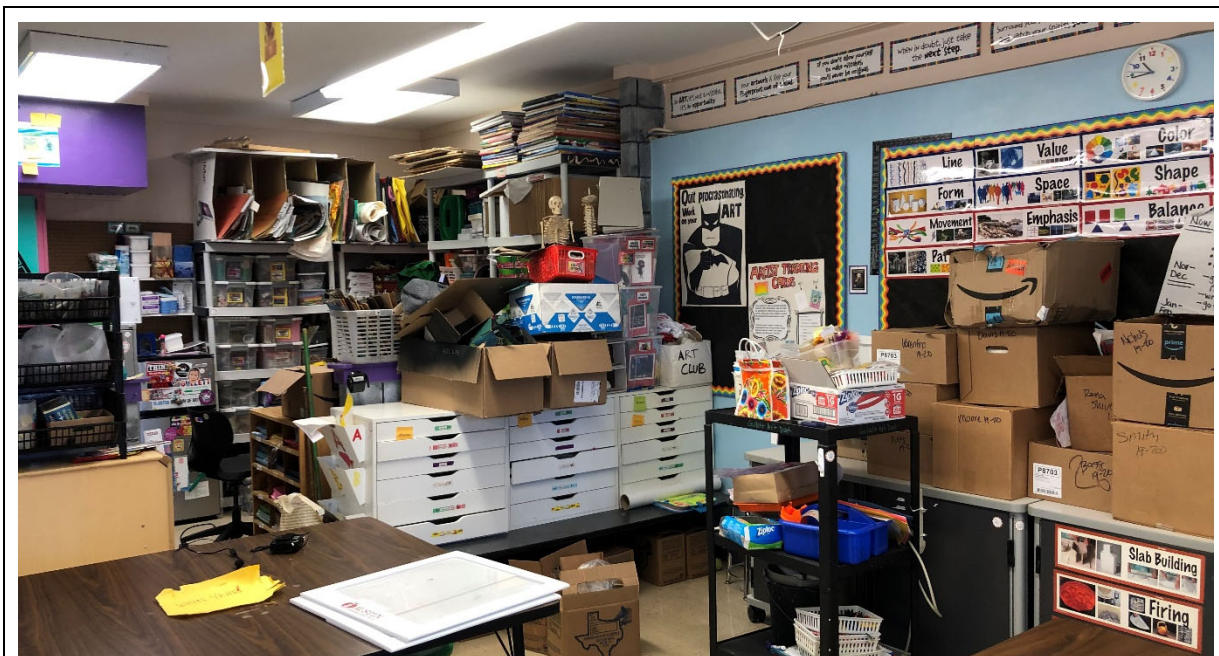
Art studio does not have any storage and is a regular studio turned into an art room. Kiln is in janitors' closet/electrical room, creating a safety concern.

9.3	Are Visual Arts spaces and storage appropriately configured per the ed spec?	1						Comments	1.00 1.00	
	1 Very unsatisfactory - Too small, missing program spaces							No storage room; kiln is in janitors' closet/electrical room.		
	2 Unsatisfactory - Too small, poor condition									
	3 Average - Adequate size, adequate condition, needs some renovations or updates to function well									
	4 Satisfactory - Good size, good condition									
	5 Very Satisfactory - Generous size, excellent condition									
	N/A Does not apply

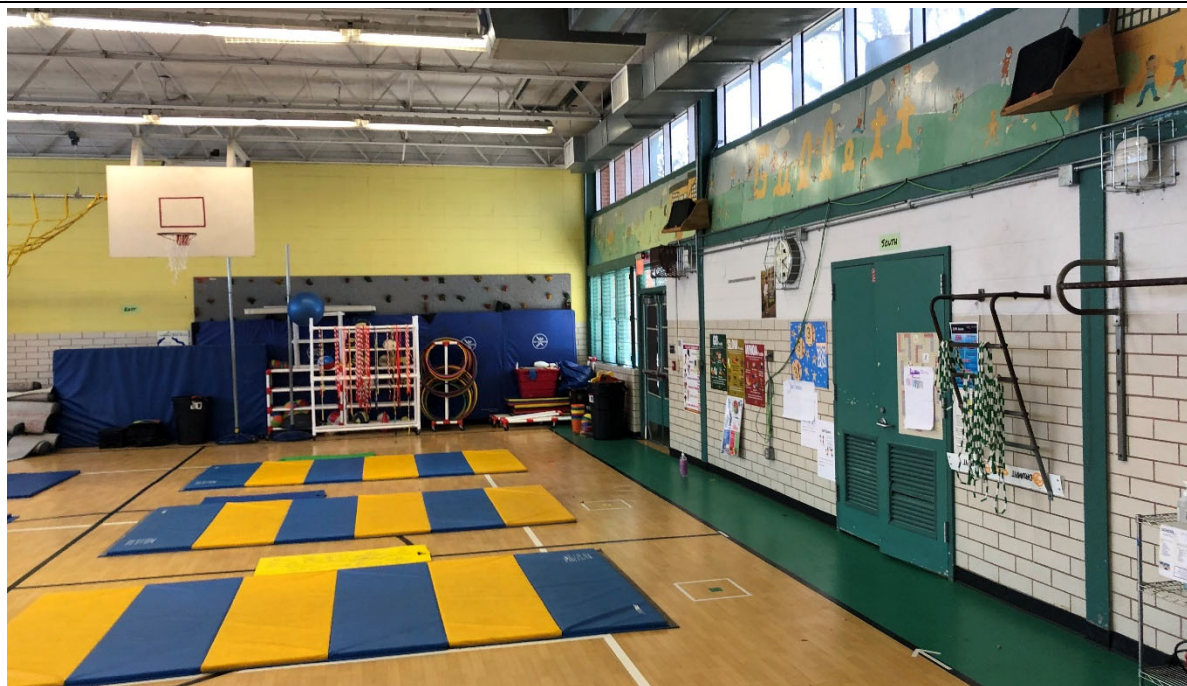
Gym is undersized and there is no office or storage available. .

Gym is undersized and missing support spaces. There is no storage or PE instructor office.

10 - PE and Wellness		1	2	3	4	5	N/A	10.00	40%
10.1	Does the campus meet the ed spec standard for physical education program spaces?		2					Comments	1.00 2.00
	1 Very unsatisfactory - Too small, missing program spaces 2 Unsatisfactory - Too small, poor condition 3 Average - Adequate size, adequate condition, needs some renovations or updates to function well 4 Satisfactory - Good size, good condition 5 Very Satisfactory - Generous size, excellent condition N/A Does not apply	Undersized by about 600 sq. ft.; small storage disconnected from interior.

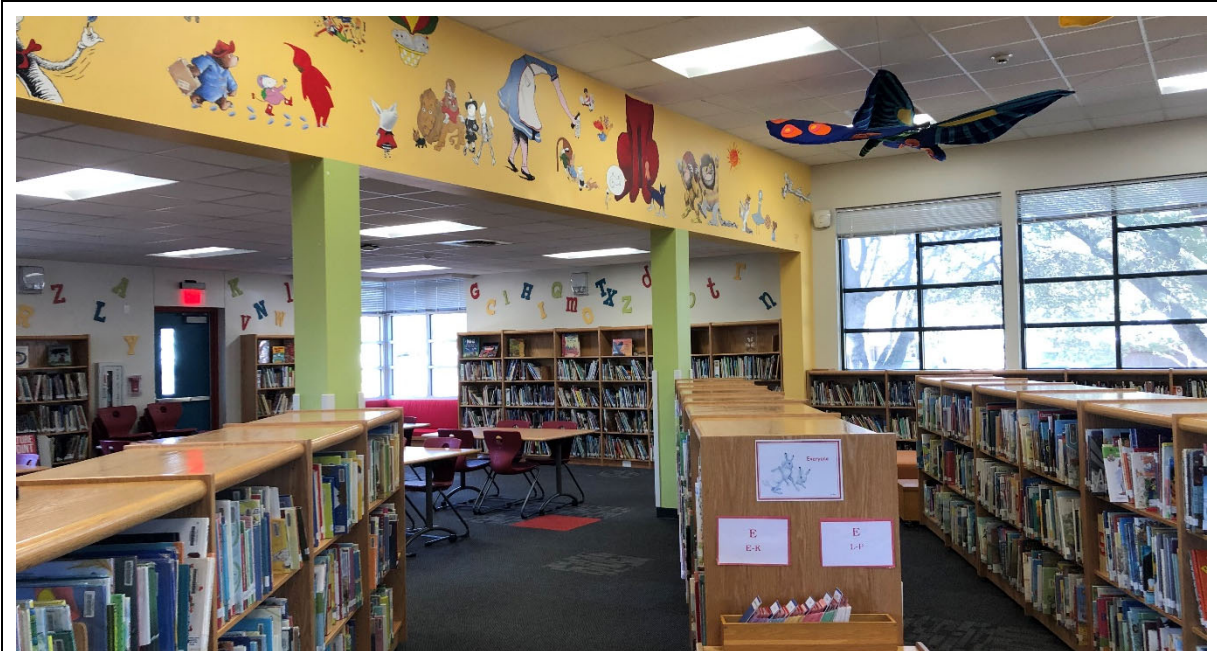
Media Center is about five years old and is satisfactory. There are multiple types of seating. Media Center is accessed from exterior, and there is no key card access.

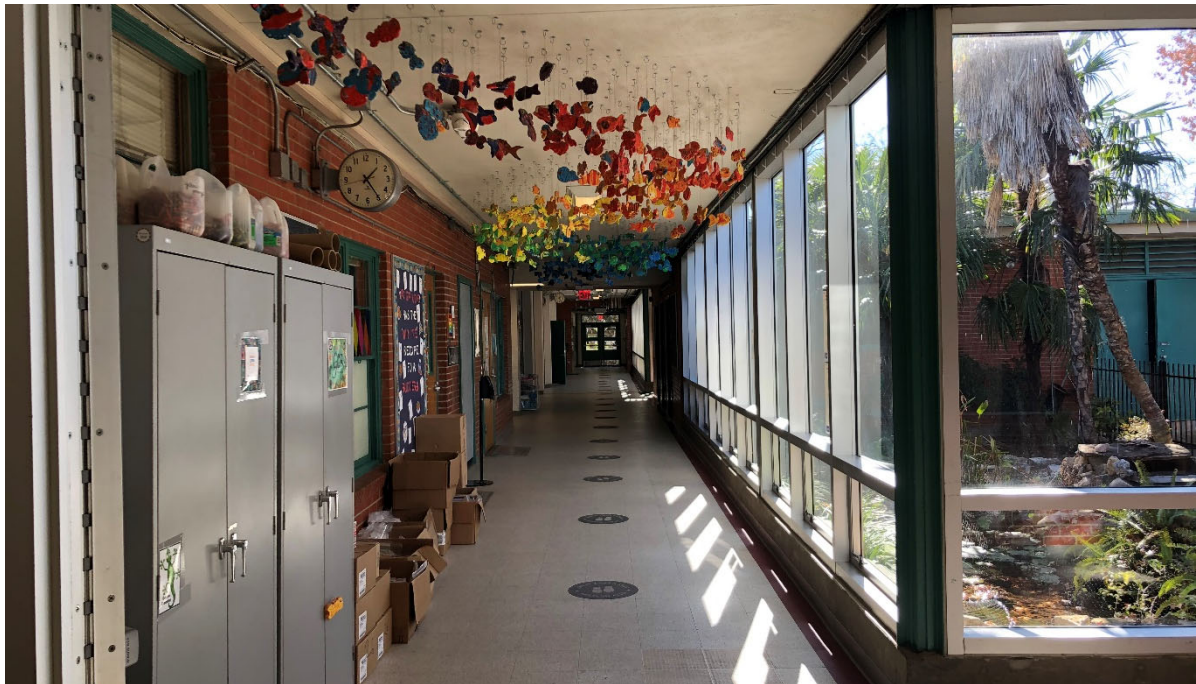
Main Hallway: There is a lot of natural light and great connection to the outdoors and the gardens. Storage is nonexistent throughout the school and many corridors have storage cabinets. Main corridor also does not have any climate control, no heating or cooling.

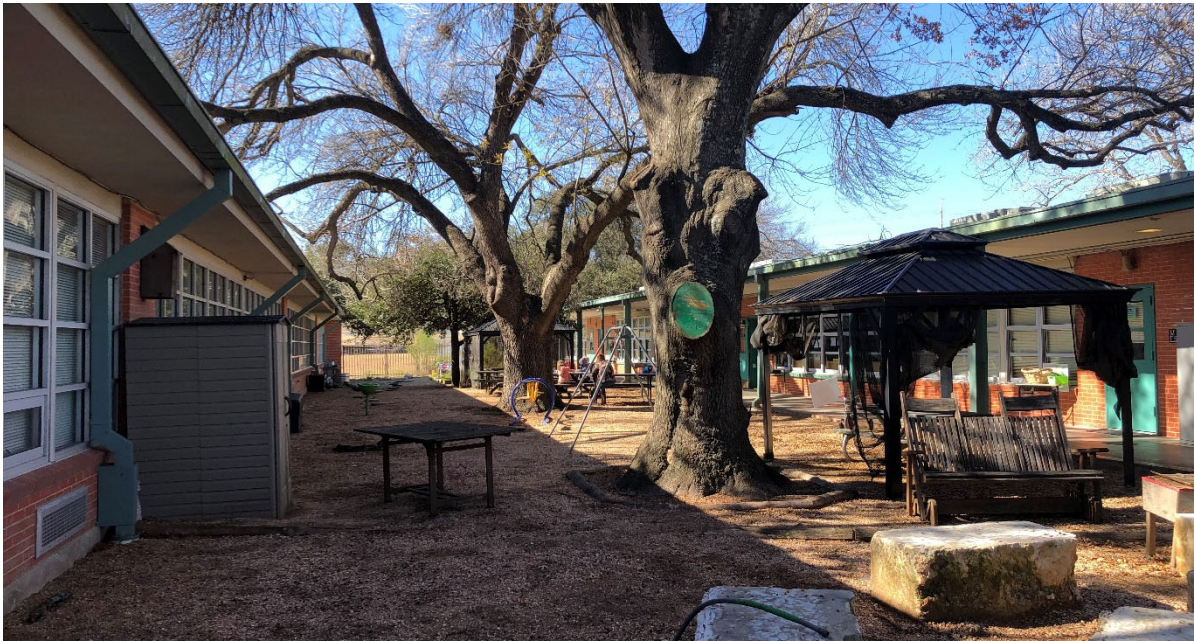
Space between the wings provides garden space and informal seating. [REDACTED] Large trees are found throughout the site.

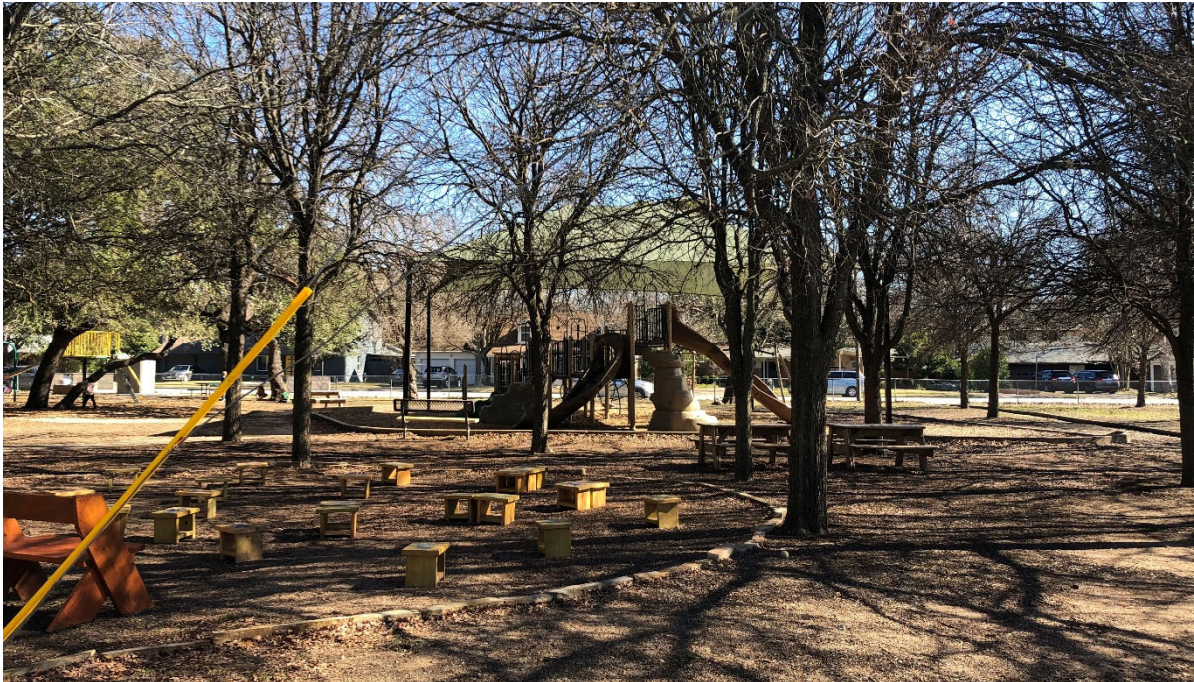
Throughout the campus, the school has created these informal studio areas with little benches. Active playgrounds are in good shape and have shade.

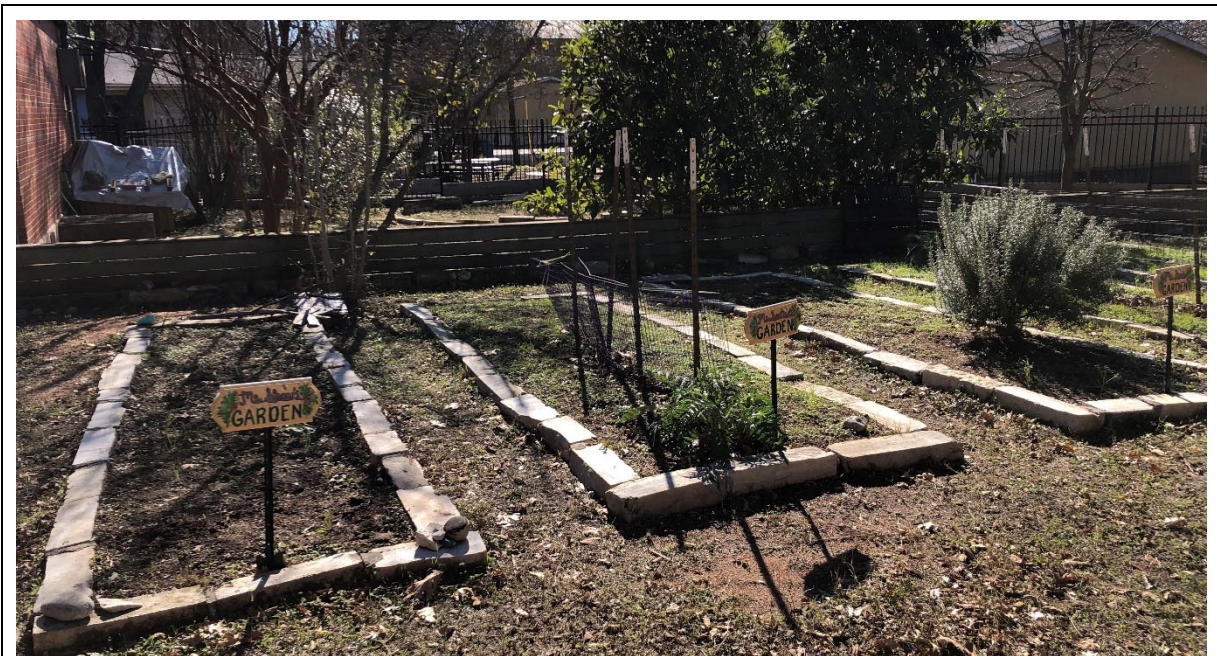
Gardens are a beloved feature of Gullett. Each teacher has their own garden bed.

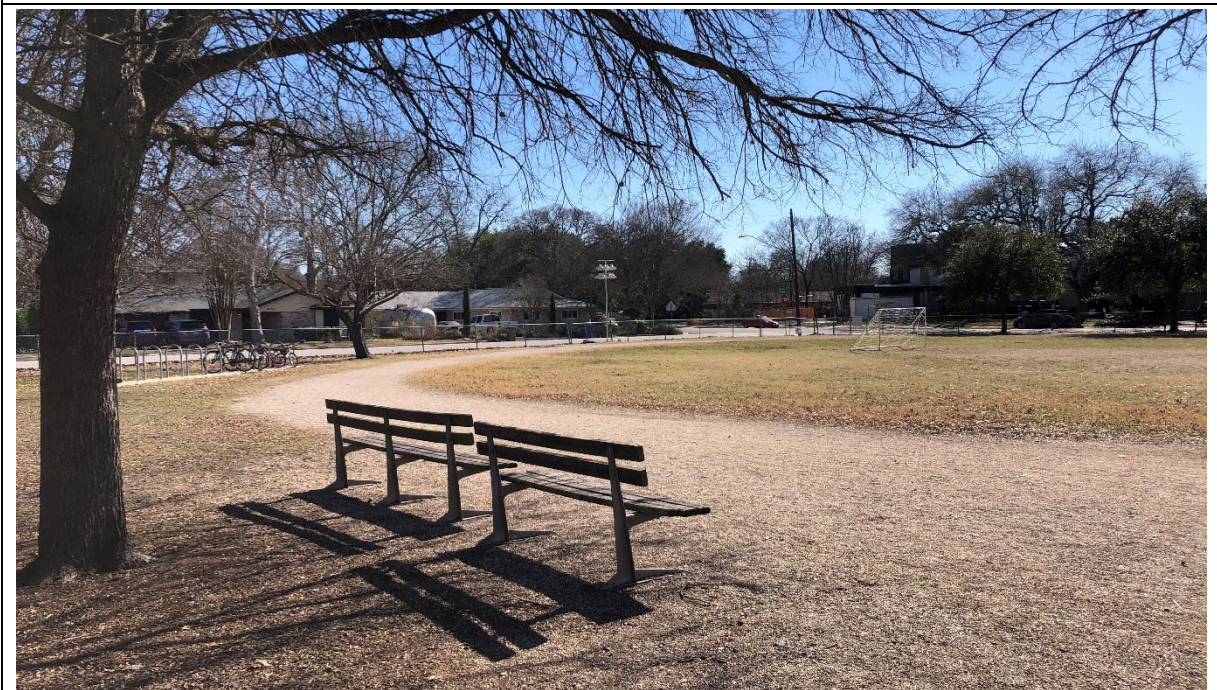
Running track is uneven and creates trip-and-fall hazards.
