Educational Suitability Summary Report

Hill Elementary School

Date: 01/04/2021

Austin ISD Educational Suitability Assessment Criteria

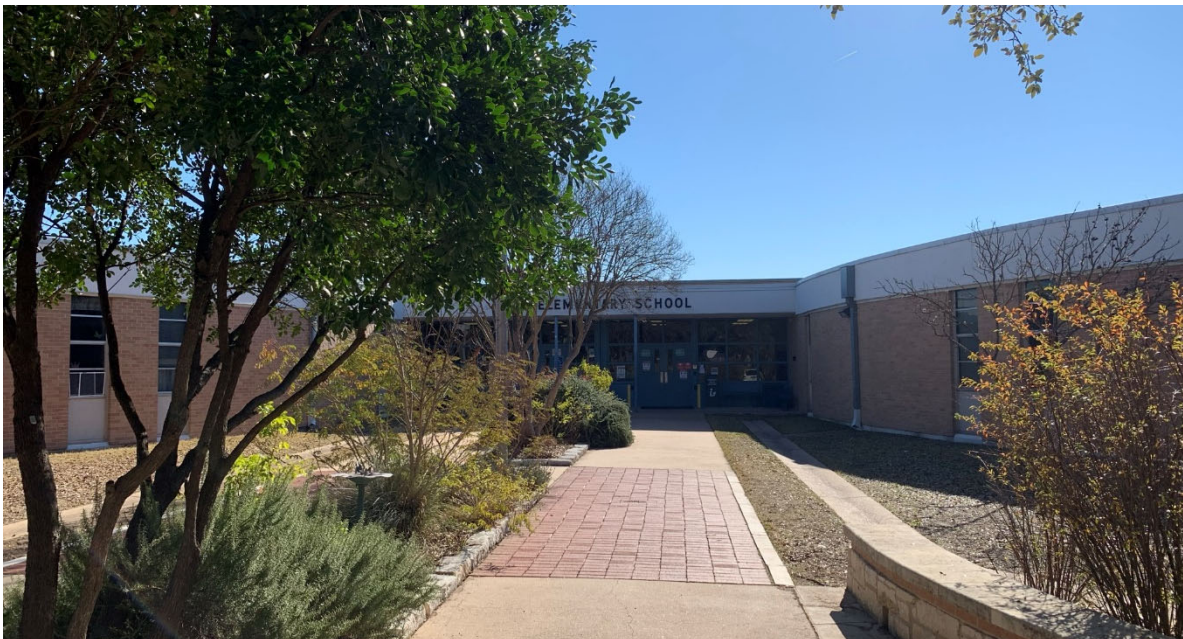
School Entry: Nicely landscaped front area of school. No canopy or overhang is provided at the entry.

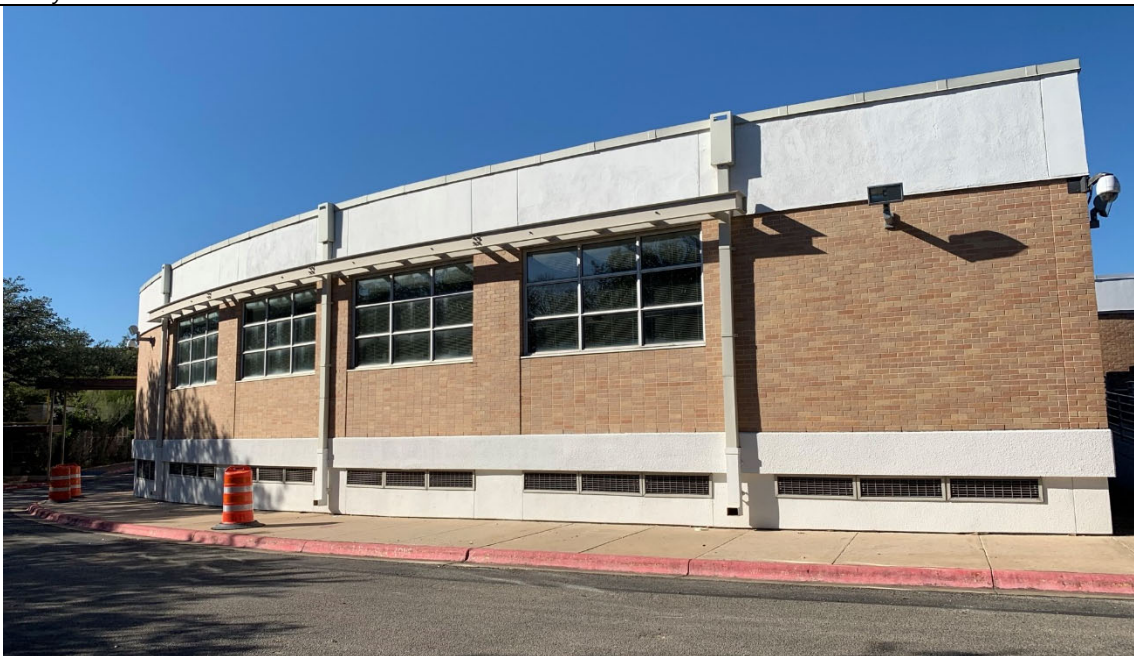
Brick and stucco are in good condition. Stucco was recently painted.

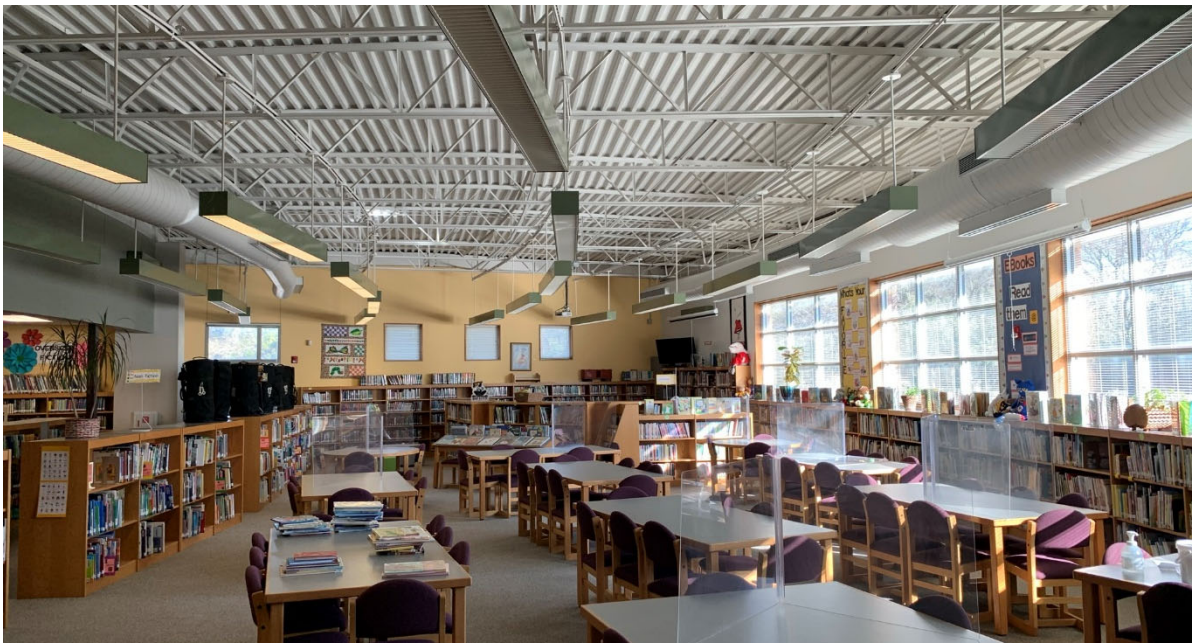
Media Center: Adequate size and nicely daylit space. Furniture is heavy and not easily reconfigurable.

Library is adequate size and has nice daylight space. The furniture is heavy and cumbersome to move. There are no small group rooms available. The technology is adequate – projector, display and computer area.

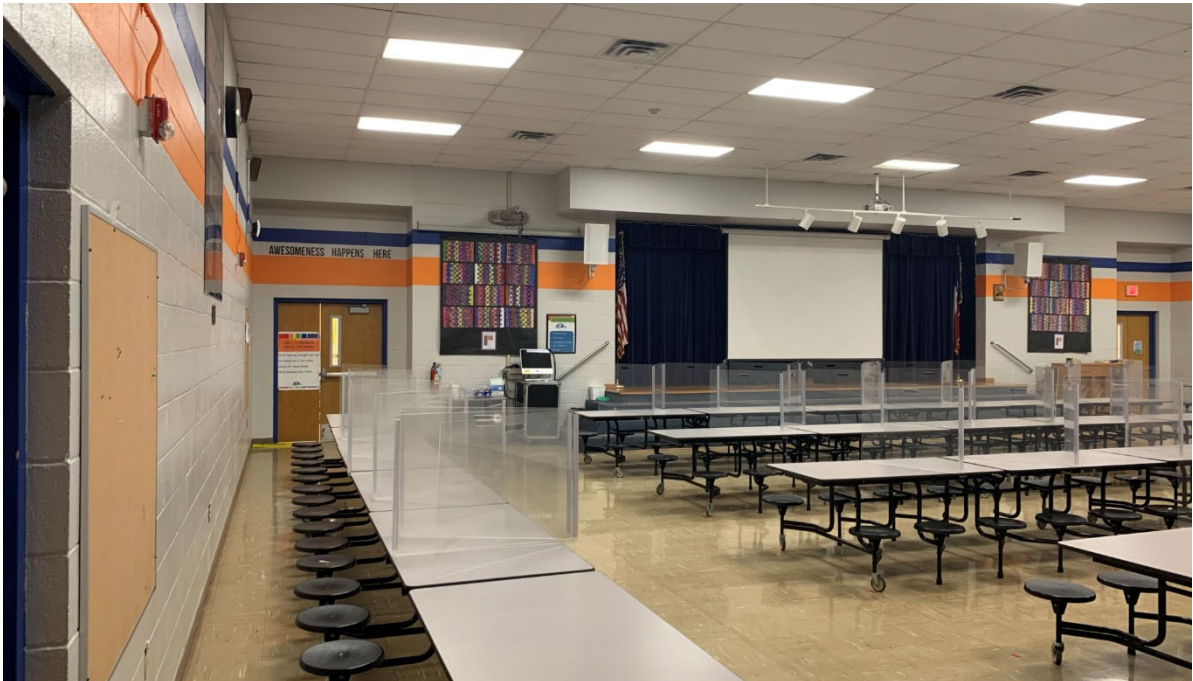
Cafeteria and support spaces are undersized per Ed Spec. Stage is small and ramp is outside of the cafeteria for stage access.

Cafeteria is undersized for enrollment. Once the existing gym moves to the new addition, the cafeteria could expand to take the additional square footage. The combined square footage would meet Ed Spec requirements.

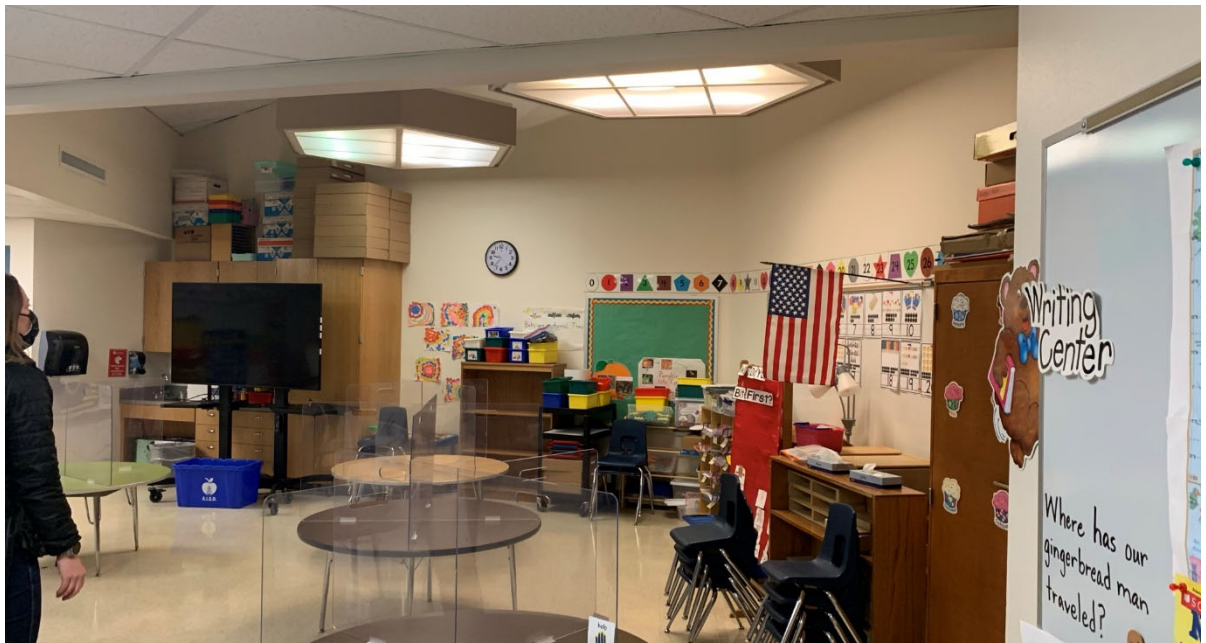
Studio in the interior of the ring. Studio is undersized per Ed Spec and does not have any access to natural daylight and no transparency between the studio and corridor.

Existing studios are undersized and do not have any collaboration space available. Studios in new addition will meet Ed Spec.

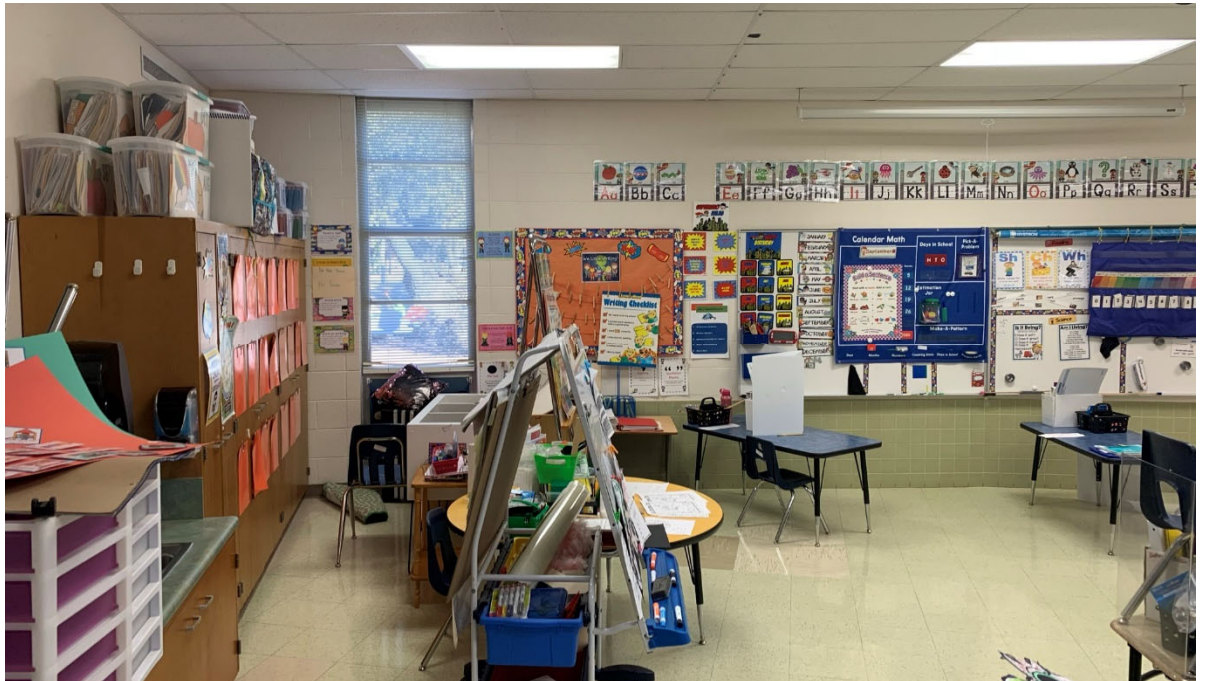
Typical studio on the exterior of the ring. Studio is undersized per Ed Spec. There are limited windows but natural daylight/views to the exterior are provided.

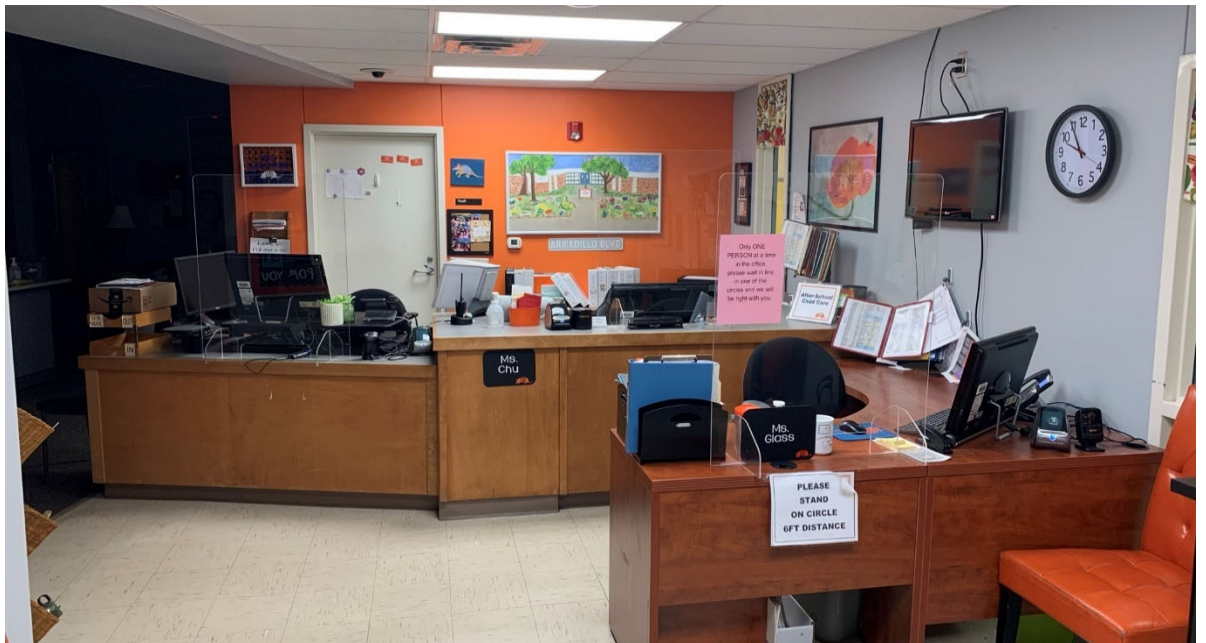
Reception at Main Office: Reception is unwelcoming and cramped with dated furnishings and limited seating.

[REDACTED]. The space is small and not welcoming and there isn't a conference room available for teacher/parent use.

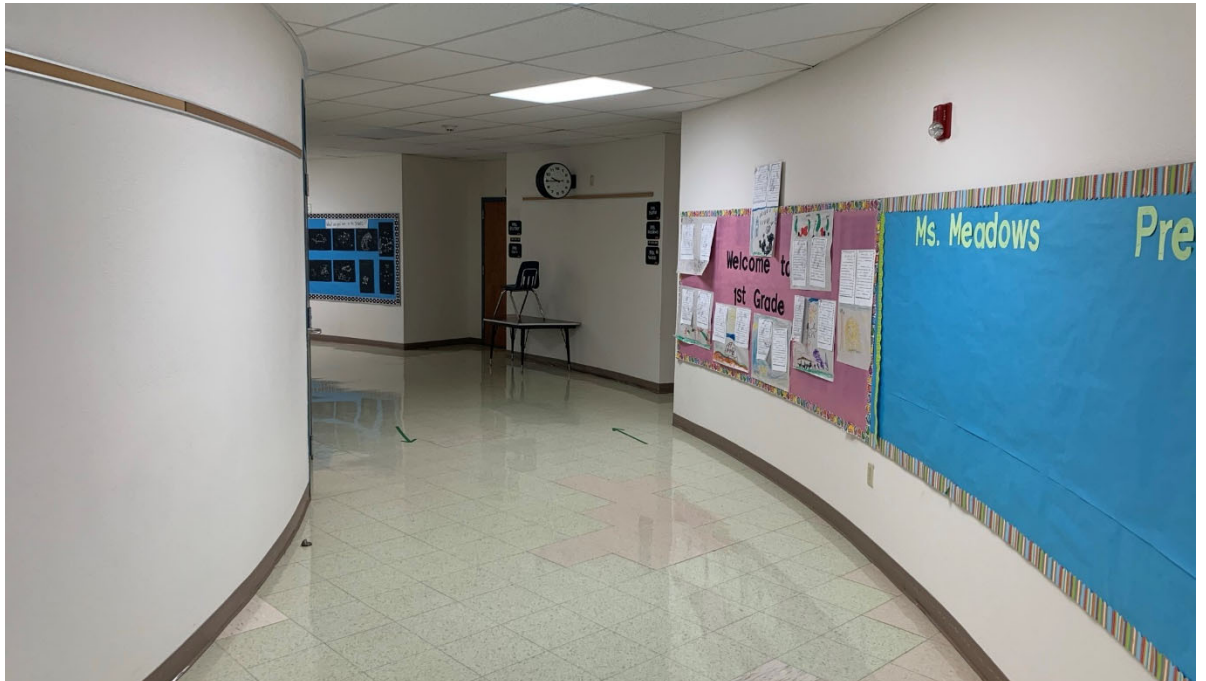
Corridor is a circle.

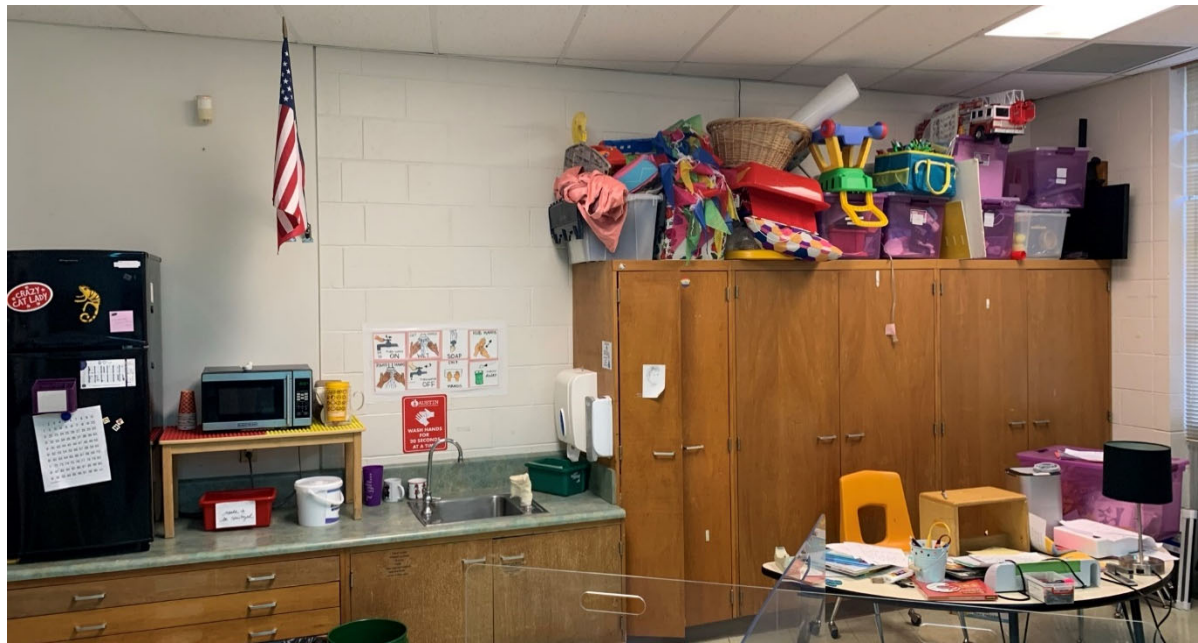
Casework storage is dated and insufficient throughout the school.

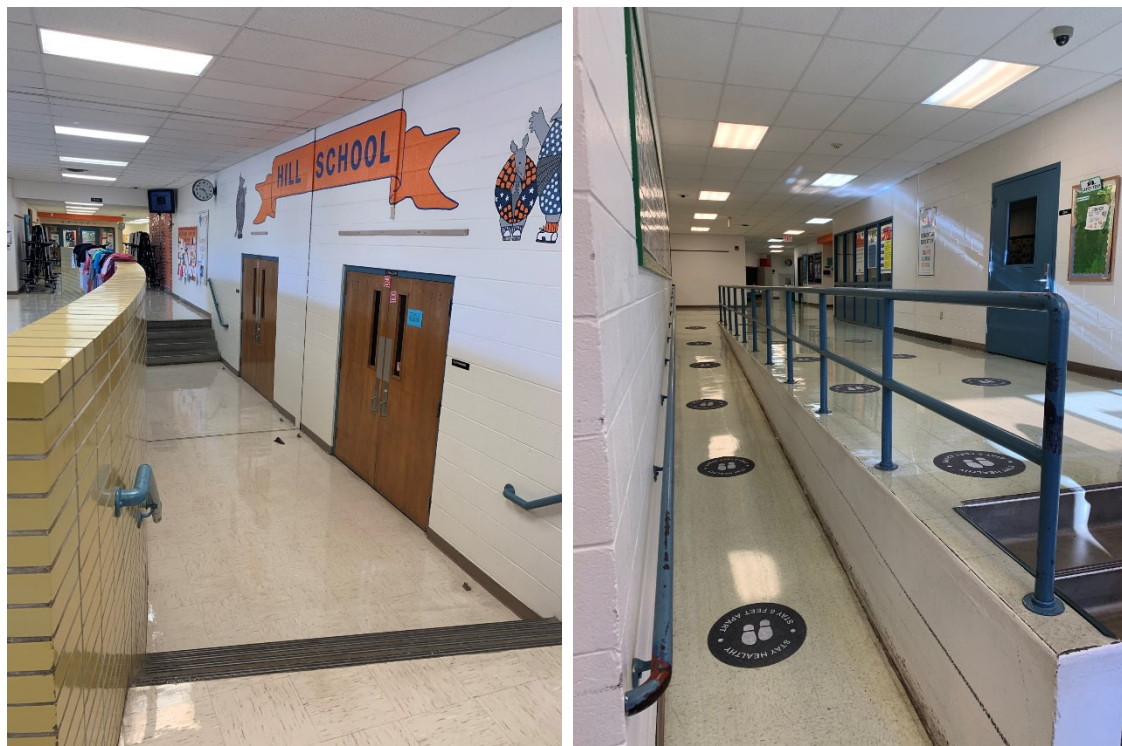
Steps to cafeteria and gym along main corridor. Accessible ramp is on side hallway.

The school has a few level changes. The ramp to get down to the gym and cafeteria is in the hallway, and if a student needs to go to the gym, they have to travel through the cafeteria. This does not promote equity among students that have mobility concerns.

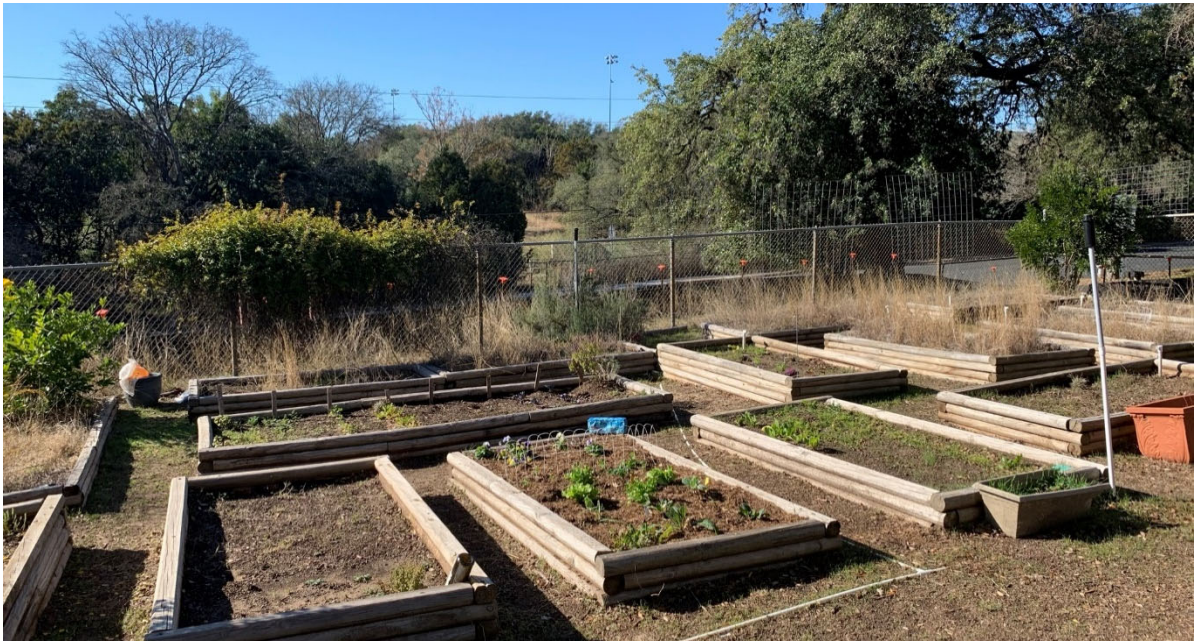
Gardens are in excellent condition. Somewhat removed from the school, but a path will be provided to the gardens with opening of new addition. New teaching spaces will also be close to the gardens. A renovation of the garden beds is being planned for school year 2021-2022.

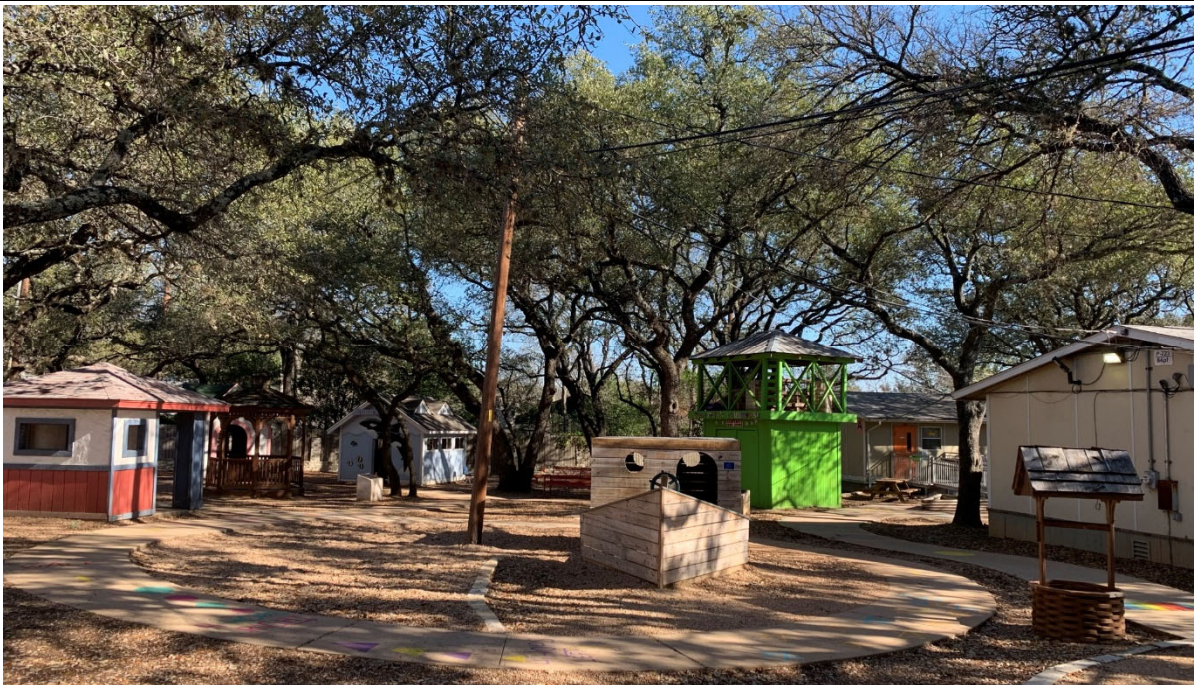
Exterior play area: Hill Harbor - small pavilion play structures are provided and nicely integrated with trees and landscape.
