Educational Suitability Summary Report

Maplewood Elementary School

Date: 01/12/2021

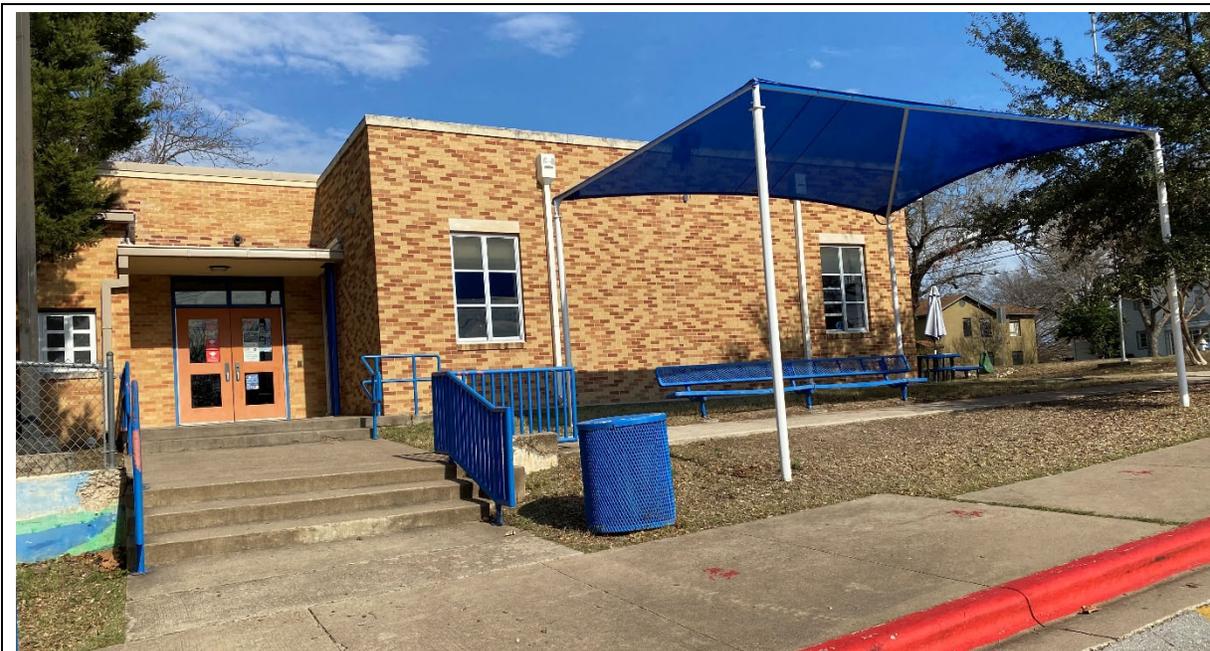
Student drop-off has a covered waiting area but is not located near the main entrance. Queuing space is limited.

Student drop-off happens in the visitor parking lot and has a small queue area. The school provides an overhang for waiting at this location. Bus drop-off happens on the residential street and does not have cover. School signage is on the busier street but is not on the adjacent corner to the main entrance.

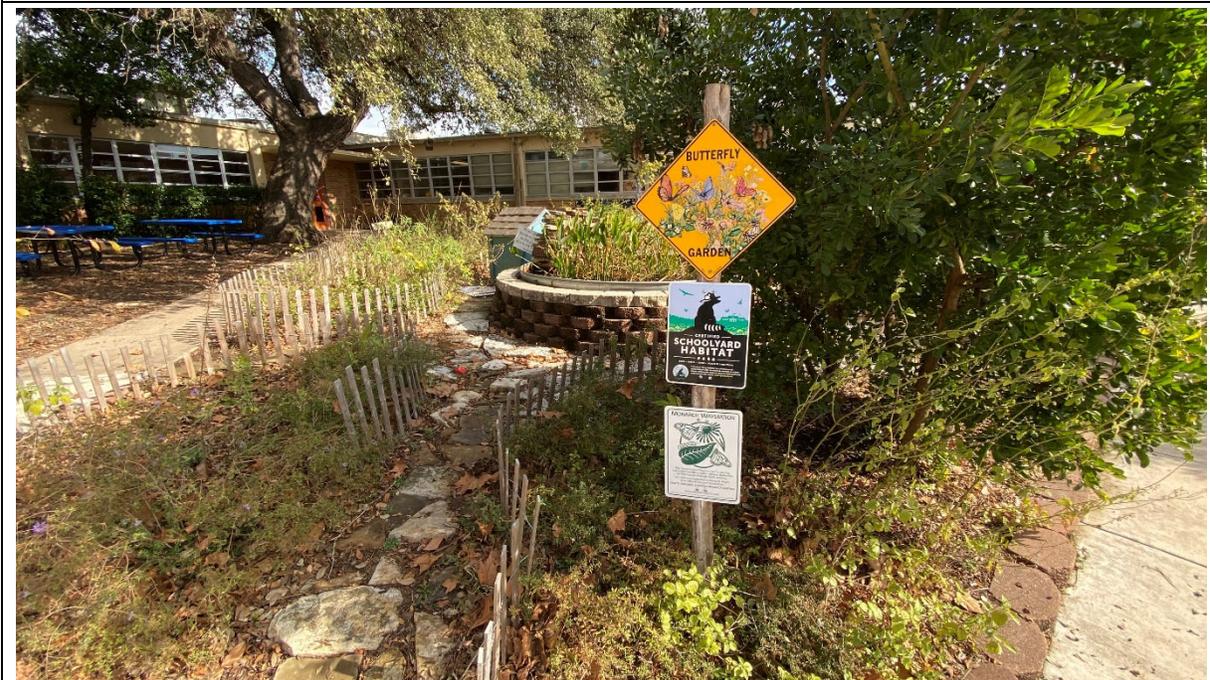
Central outdoor area features a learning pond, butterfly garden and a seating area.

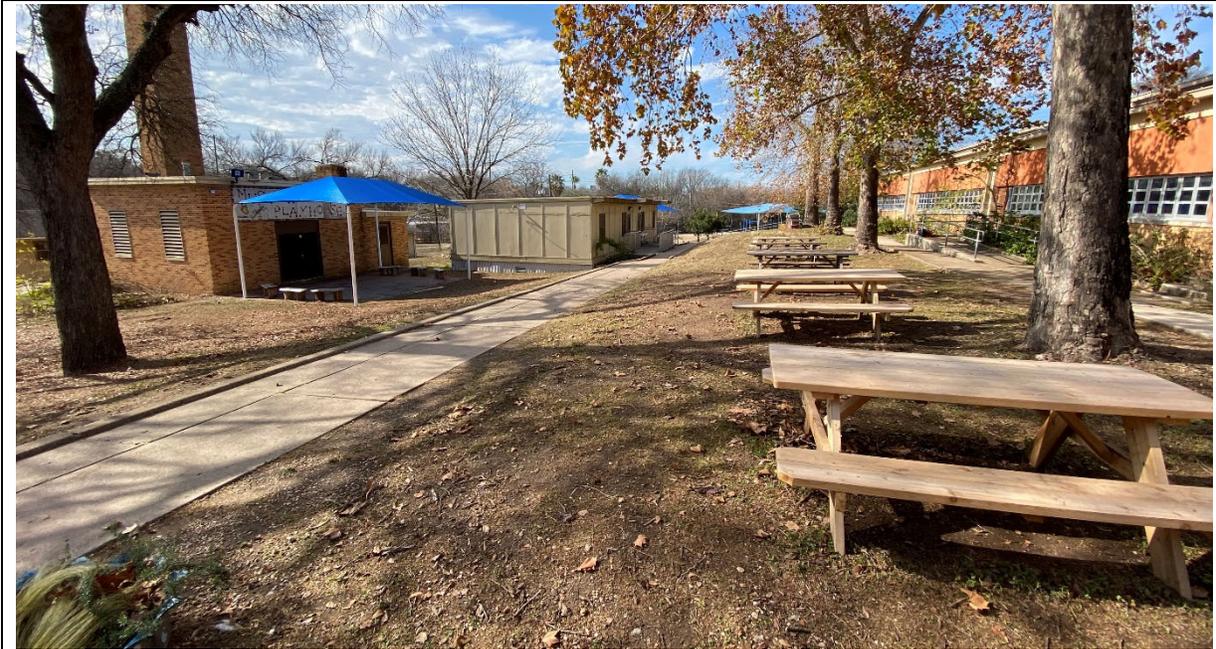
They have converted the old boiler building into the backdrop of the outdoor stage. Outdoor tables and the topography create a lot of seating space.

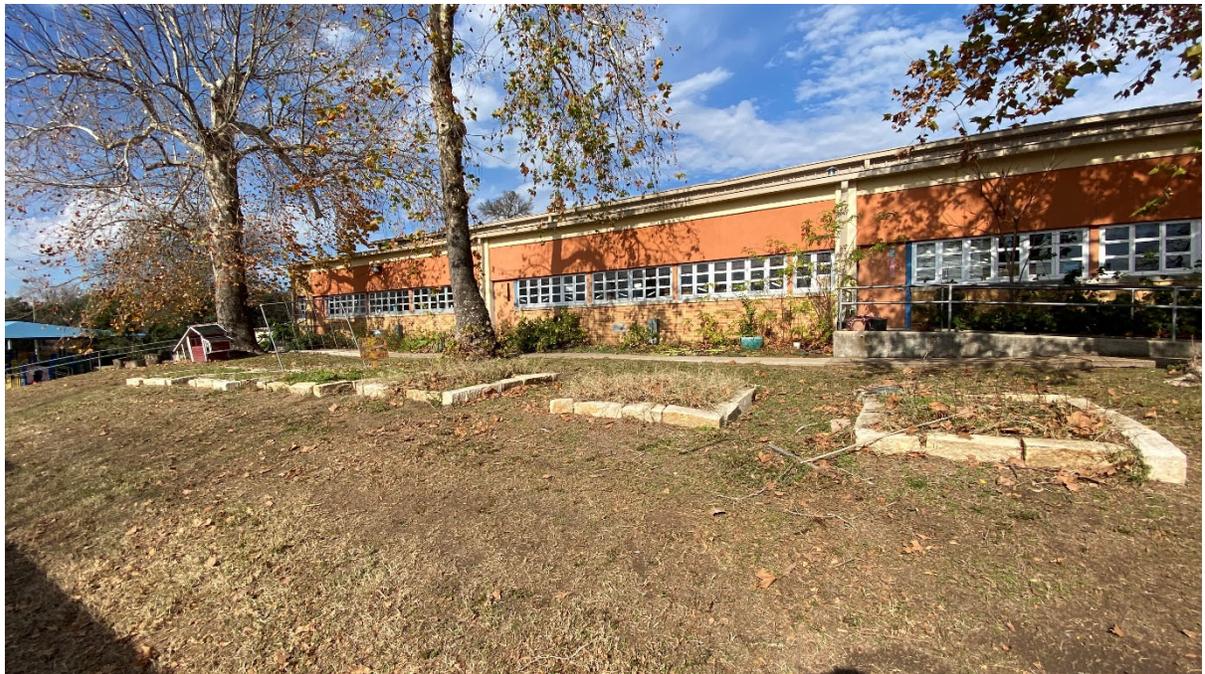
There are many planter beds in similar condition around this central outdoor space. They appear well-used and tended to and are near a water source.

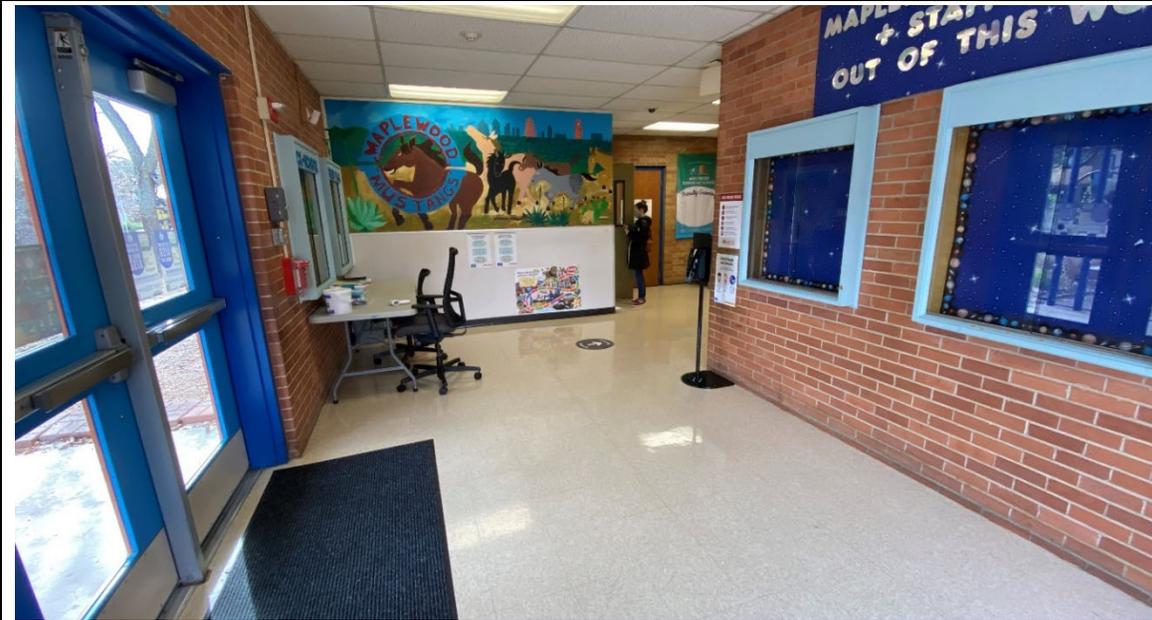
Murals and displays show school pride.

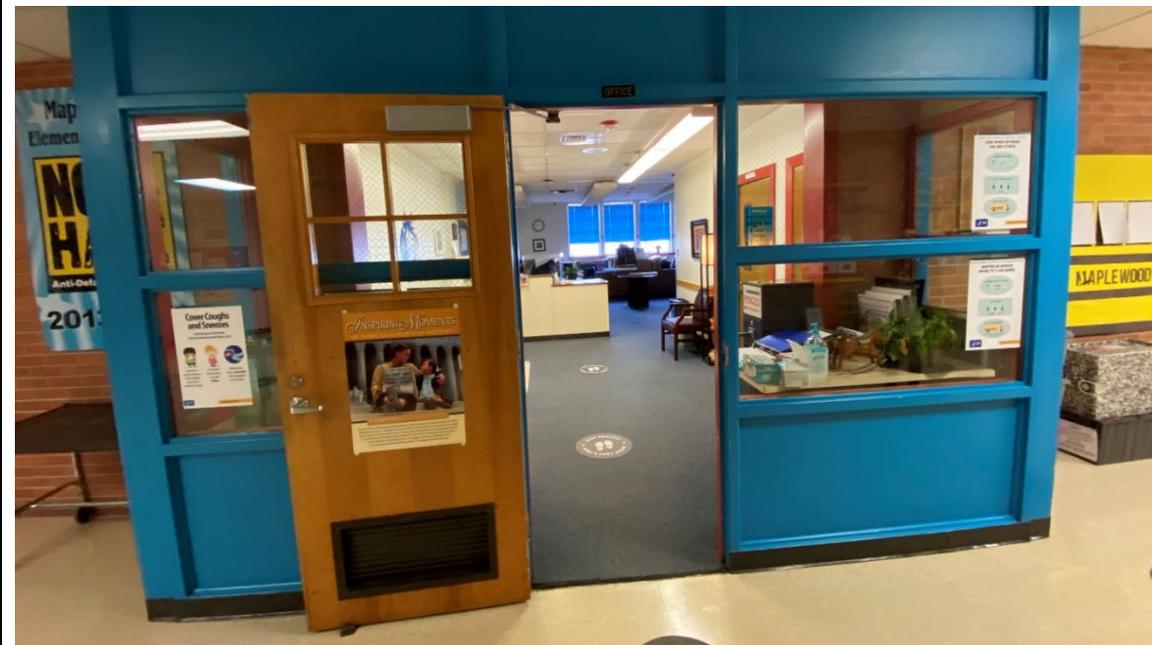
Administration Spaces feel welcoming and are adequately sized.

The large size of the room feels welcoming and has informal seating. Acoustics in admin spaces could use improvement. There is no conference room for public/parent use; this space was converted to an office.

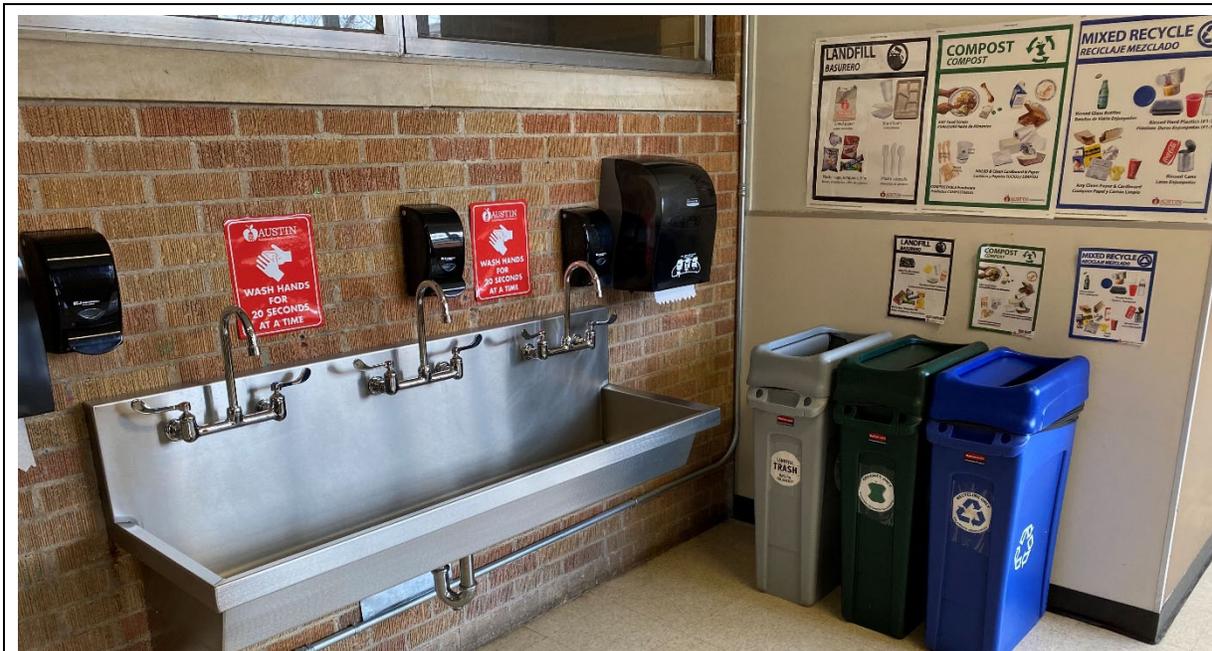
Waste collection is clearly presented and labeled in various areas similar to the one shown.

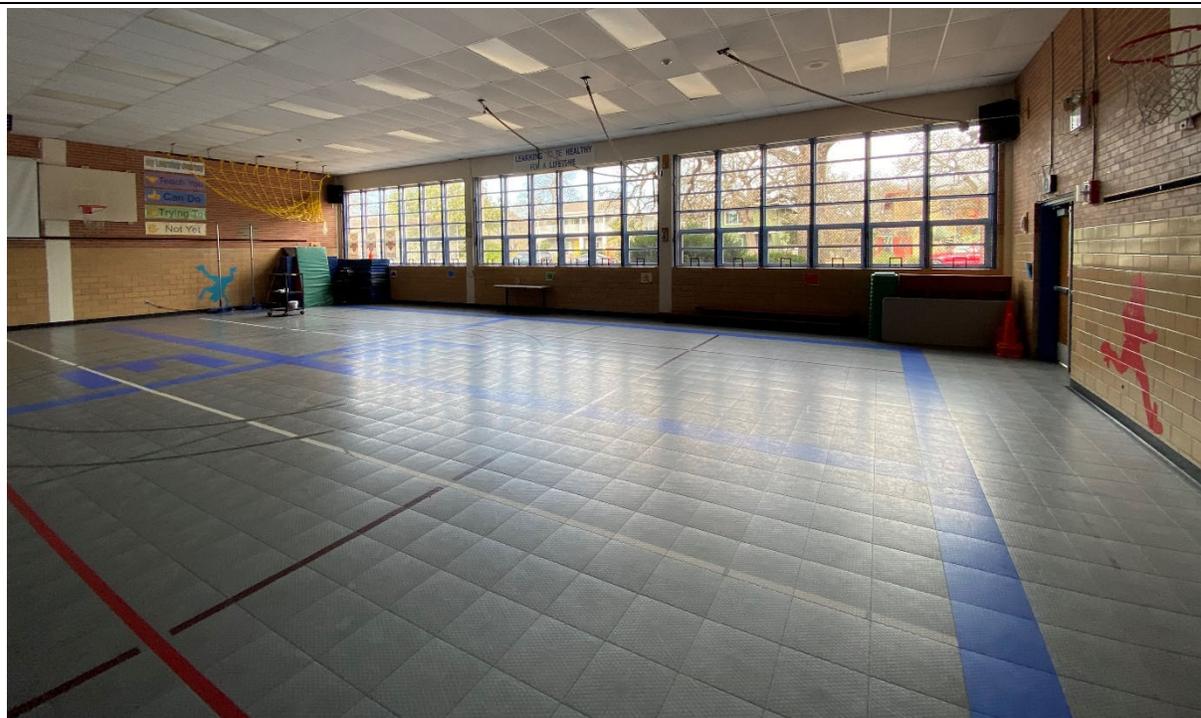
Gym is undersized and the flooring needs renovated. Receives great natural light.

The gym is undersized and needs new flooring. Physical education support spaces are disconnected and across the corridor.

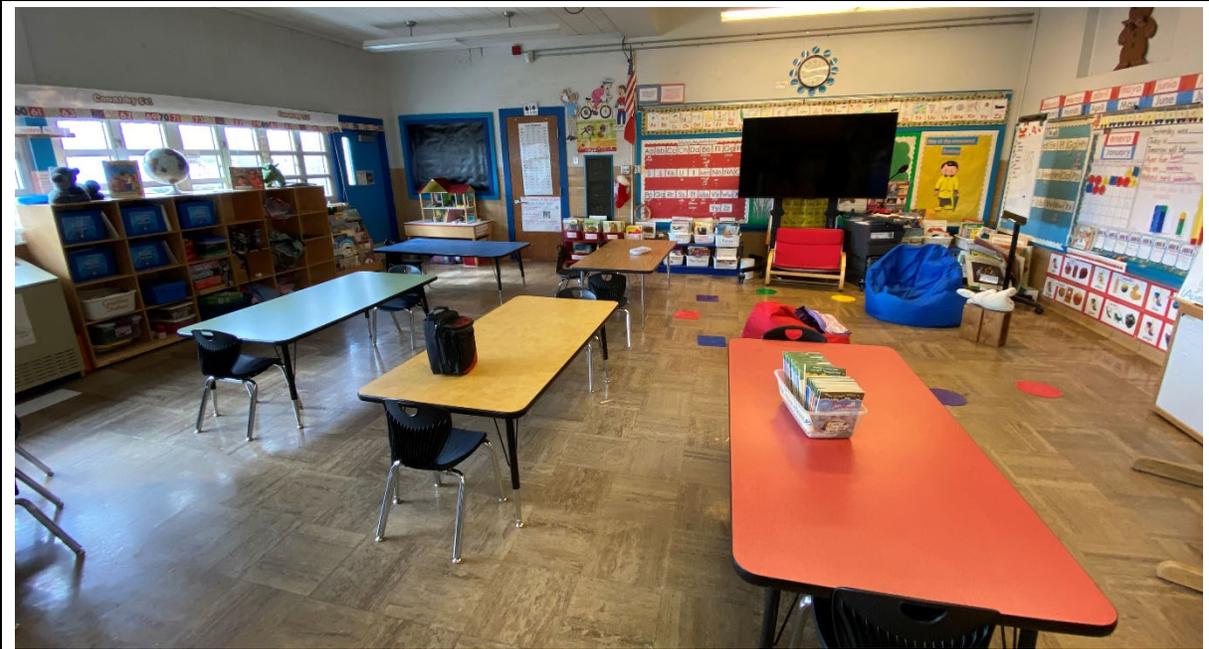
Typical Studio: Space is adequately sized but lacks storage space. Studios receive great natural light.

Studios are an appropriate size but lack adequate storage and have no transparency to the corridor. The building is not set up for learning neighborhoods and does not have small group or collaboration areas or areas to work independently.

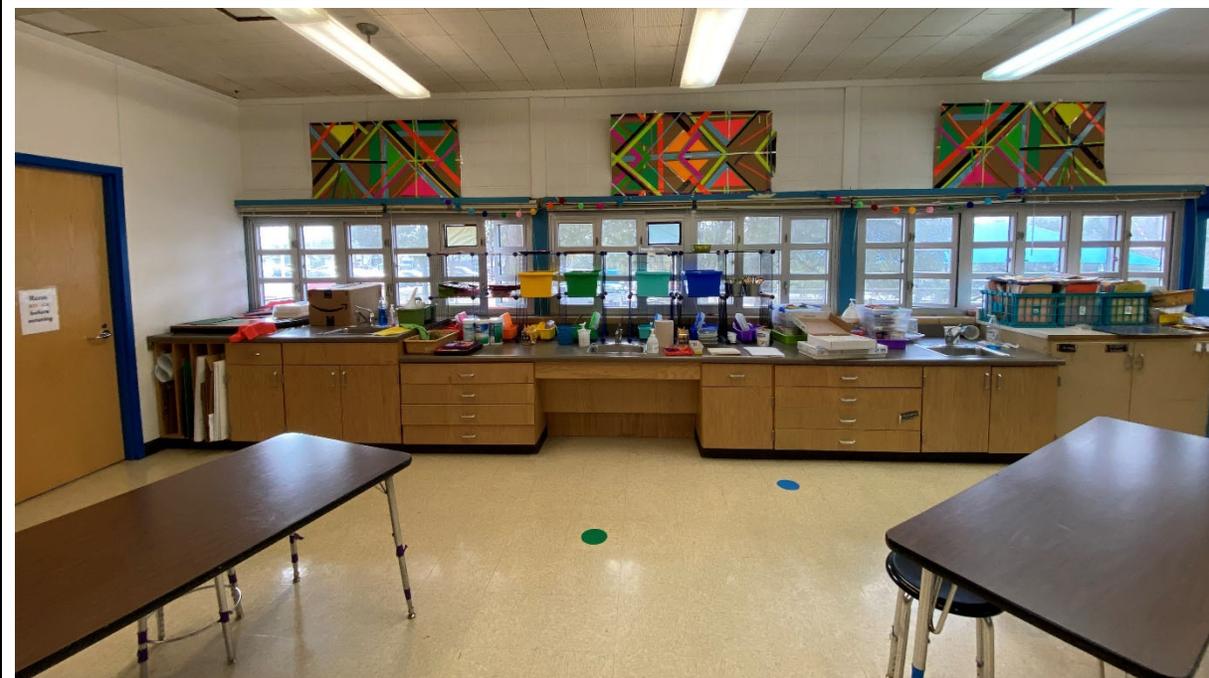
Art studio has plenty of great storage and good natural light. The room appears in newer condition.

9.3	Are Visual Arts spaces and storage appropriately configured per the ed spec?				4			1.00	4.00
	1 Very unsatisfactory - Too small, missing program spaces 2 Unsatisfactory - Too small, poor condition 3 Average - Adequate size, adequate condition, needs some renovations or updates to function well 4 Satisfactory - Good size, good condition 5 Very Satisfactory - Generous size, excellent condition N/A Does not apply	Comments New storage spaces. Art room was renovated 3 years ago.
