Educational Suitability Summary Report

Oak Hill Elementary School

Date: 12/10/2020

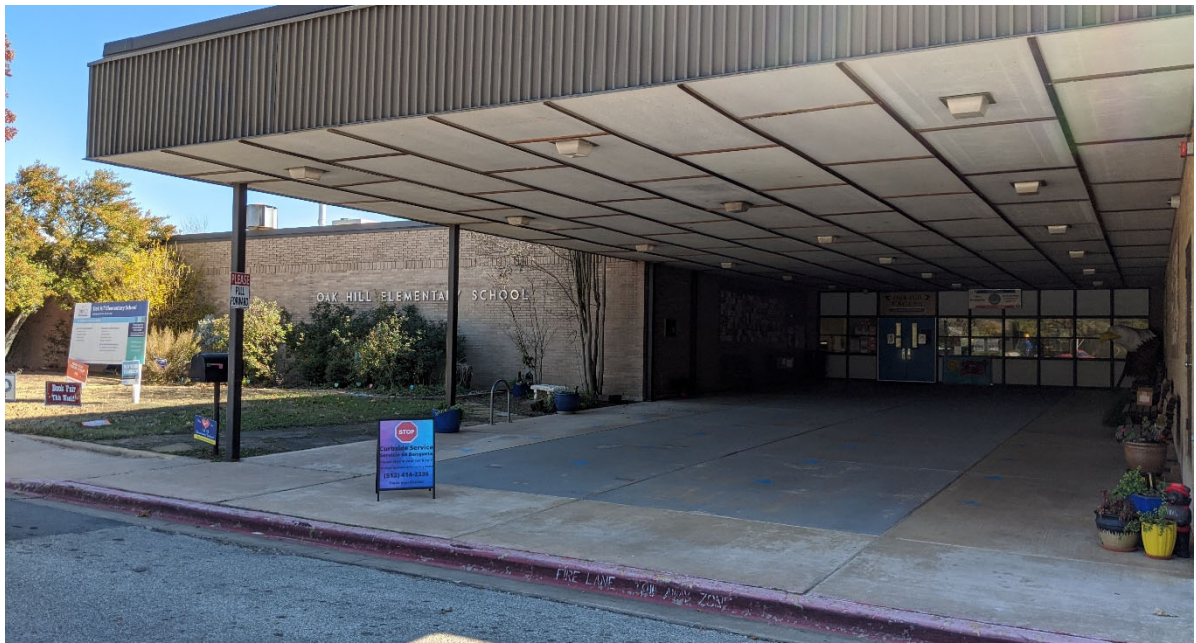
Main entry to the school with large canopy.

Building entry is well-defined with a monument sign near the road, and a large, covered entry canopy. Signage on building could be improved to be more visible.

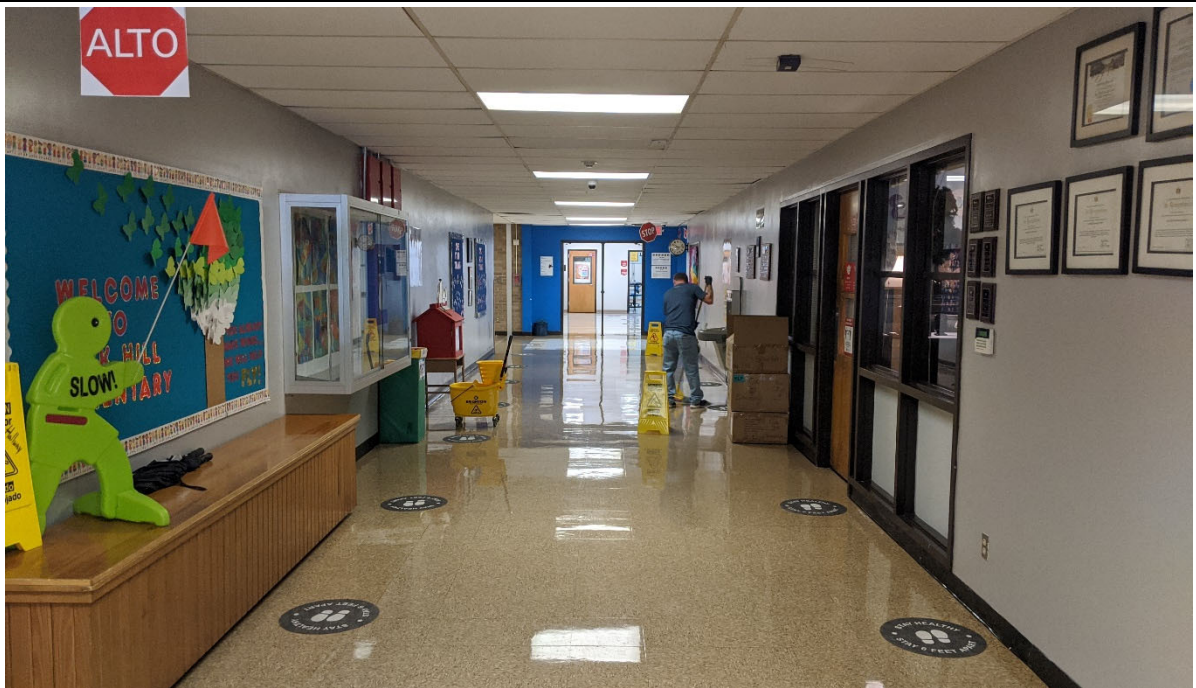
Display case for student work is small and is the only one on campus.

8.9	Are there adequate places to display the evidence and artifacts of learning (both 2D and 3D)?		2					Comments		1.00	2.00	
1	Very unsatisfactory - No dedicated space							One display case for 3D work in entry hallway. Some areas for display of 2D work throughout school, but no bulletin boards in hallways.				
2	Unsatisfactory - Too small, non-dedicated, poor condition											
3	Average - Adequate size, adequate condition, needs updates or renovations to function well											
4	Satisfactory - Good size, good condition											
5	Very Satisfactory - Generous size, excellent condition											
N/A	Does not apply

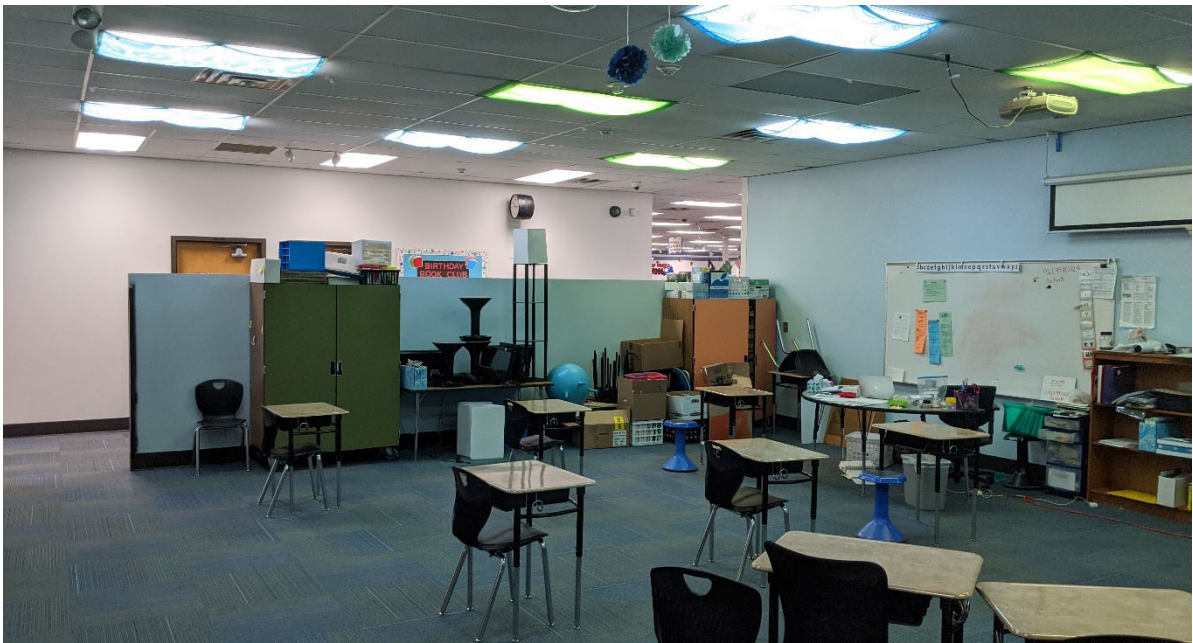
Environmental Quality: No natural light and no acoustic or visual privacy in studios.

There is no acoustic separation between studios and hallways, creating distractions for students and teachers. Most studios have no access to natural light, and when windows are present, they are undersized.

5 - Environmental Quality		1	2	3	4	5	N/A	25.00	44%	
5.1	How are acoustics in studios in general?	1						Comments	1.00	1.00
1	Very unsatisfactory - Recognized word/sound from adjacent studio/corridor							No acoustic separation between hallways and studios.		
2	Unsatisfactory - Audible sound from adjacent studio/corridor									
3	Average - Slight sound from outside room									
4	Satisfactory - Walls to deck insulated only white noise from mechanical system									
5	Very satisfactory - Able to hear quiet speaking from across the room									
N/A	Does not apply

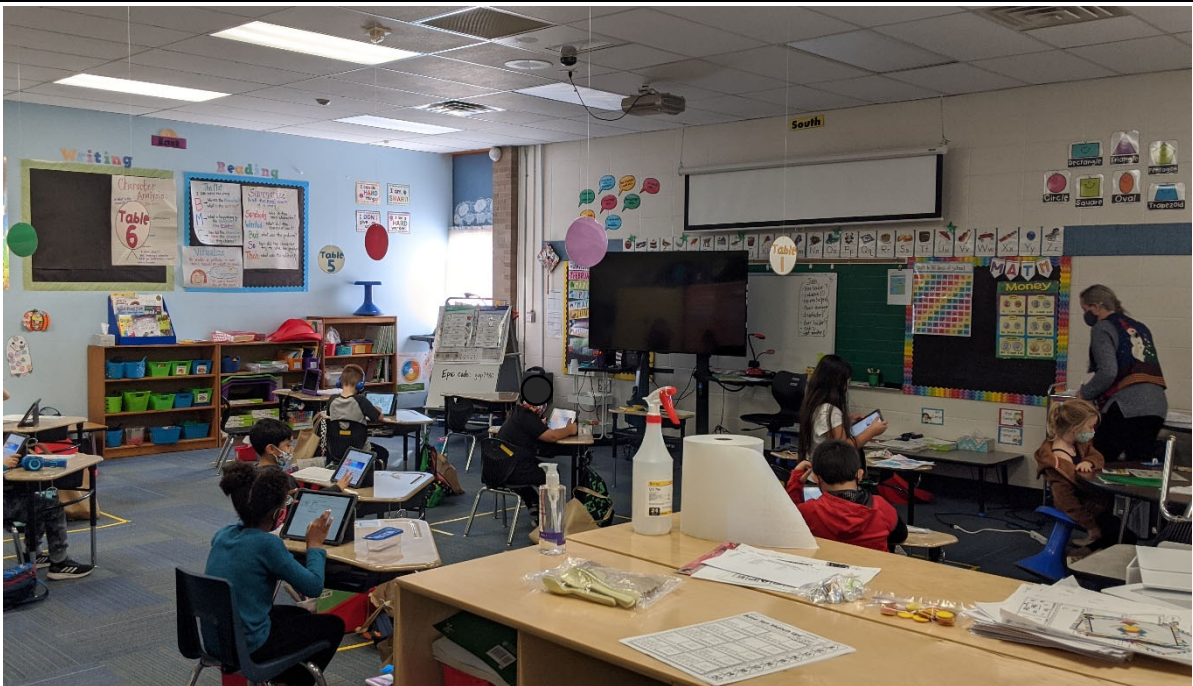
Environmental Quality: When studios have windows, they still do not have enough daylight.

5.3	Is there access to natural light in studios?		2					Comments	1.00	2.00
1	Very unsatisfactory - No learning spaces have natural light							Few studios have access to natural light.		
2	Unsatisfactory - 1-25% of learning spaces have natural light or windows are too small to let in light									
3	Average - 26-50% of learning spaces have natural light									
4	Satisfactory - 51-75% of learning spaces have natural light									
5	Very satisfactory - 76-100% of learning spaces have natural light									
N/A	Does not apply

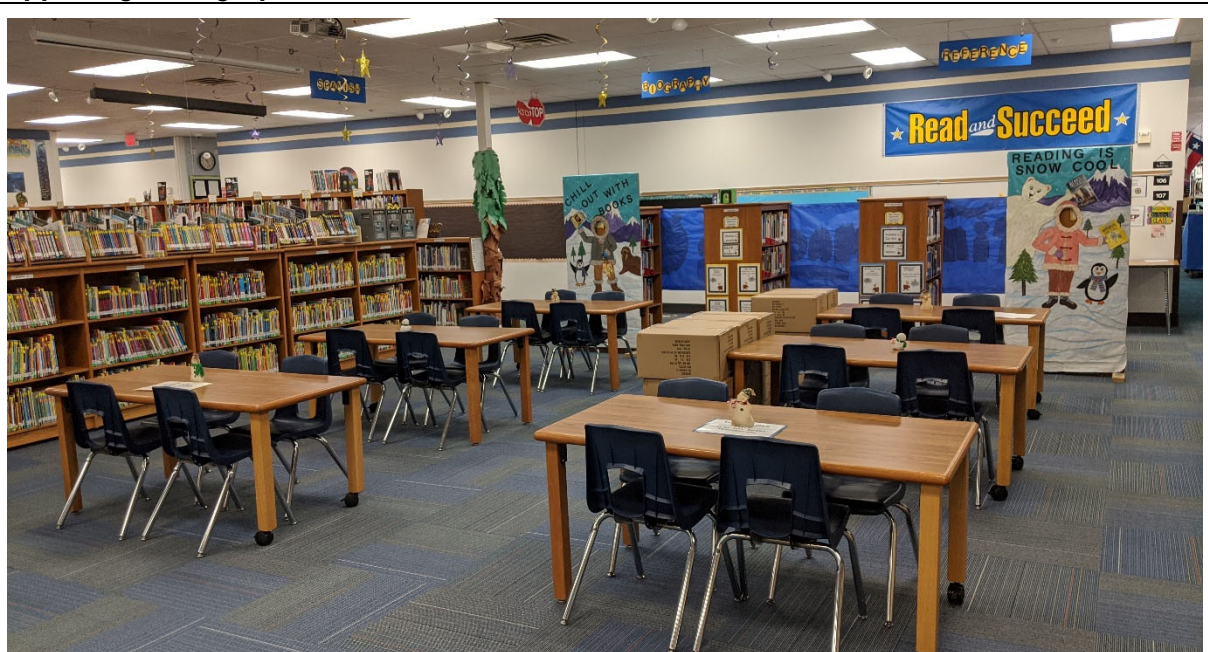
Media Center: Library has movable furniture and some stacks that can move to reconfigure the space.

The library is centrally located in the main building, but because it is open to the rest of the school, it has limited acoustic privacy. Some of the furniture and stacks are movable, allowing spaces to be rearranged for different sized groups.

12.4	How well does the Library/Media Center support collaborative work in small groups (4-8 students)?			3				Comments	1.00 3.00
	1 Very unsatisfactory - No breakout rooms, no flexible furniture, no support 2 Unsatisfactory - Too small, one area, poor condition 3 Average - Adequate size, multiple areas provided, needing updates or renovations to function well 4 Satisfactory - Clusters or small rooms adjacent to media center, flexible furniture, good condition 5 Very Satisfactory - Multiple clusters or small rooms adjacent to media center, flexible furniture, excellent condition N/A Does not apply							Some movable furniture allows areas to be rearranged.

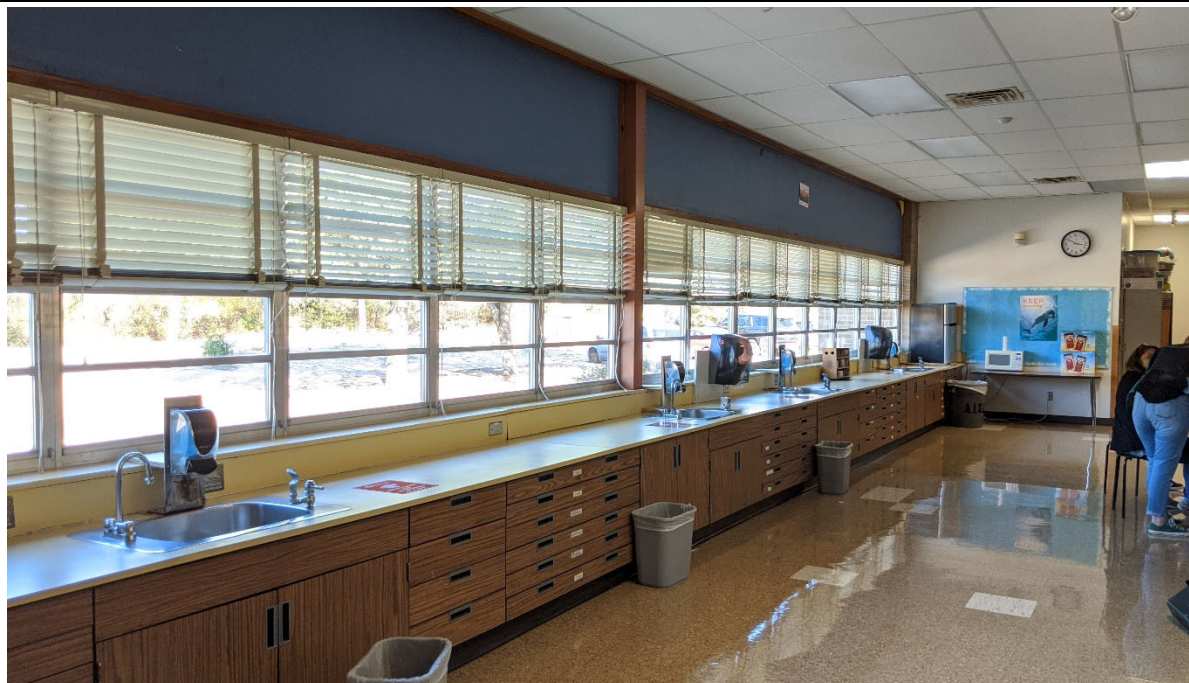
Environmental Quality: Most daylight comes from large areas of sinks at both ends of school.

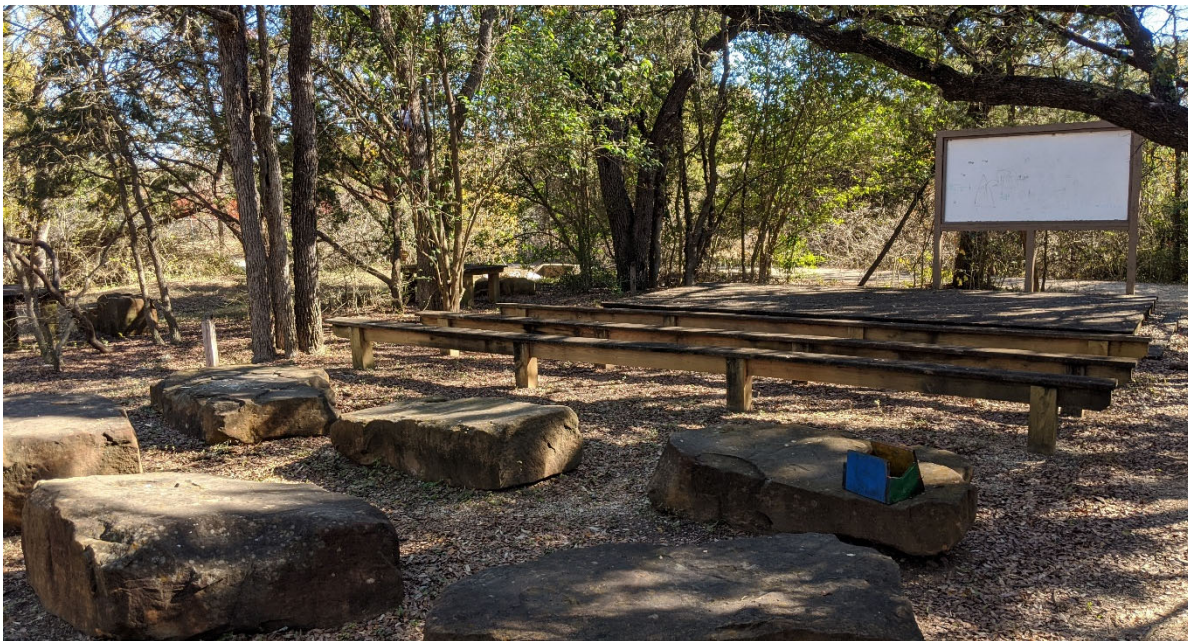
Outdoor Learning: Outdoor classroom could be very well used if the mosquito problem is solved.

2.1	Are outdoor studios and support spaces appropriately configured per the ed spec?			3				Comments	1.00 3.00
1	Very unsatisfactory - No dedicated outdoor studios							Single outdoor studio. It has a variety of seating, but mosquito issues make it difficult to use.	
2	Unsatisfactory - Too small, poor condition, disconnected from learning spaces, no flexibility, no shade provided								
3	Average - Adequate size, adequate condition, needs some renovations or updates to function well, 50% or less shade coverage over studio area								
4	Satisfactory - Good size, good condition, connected to learning spaces, good flexibility, more than 50% shade coverage over studio area								
5	Very satisfactory - Generous size, excellent condition, connected to learning spaces, excellent flexibility, full shade coverage over studio area								
N/A	Does not apply

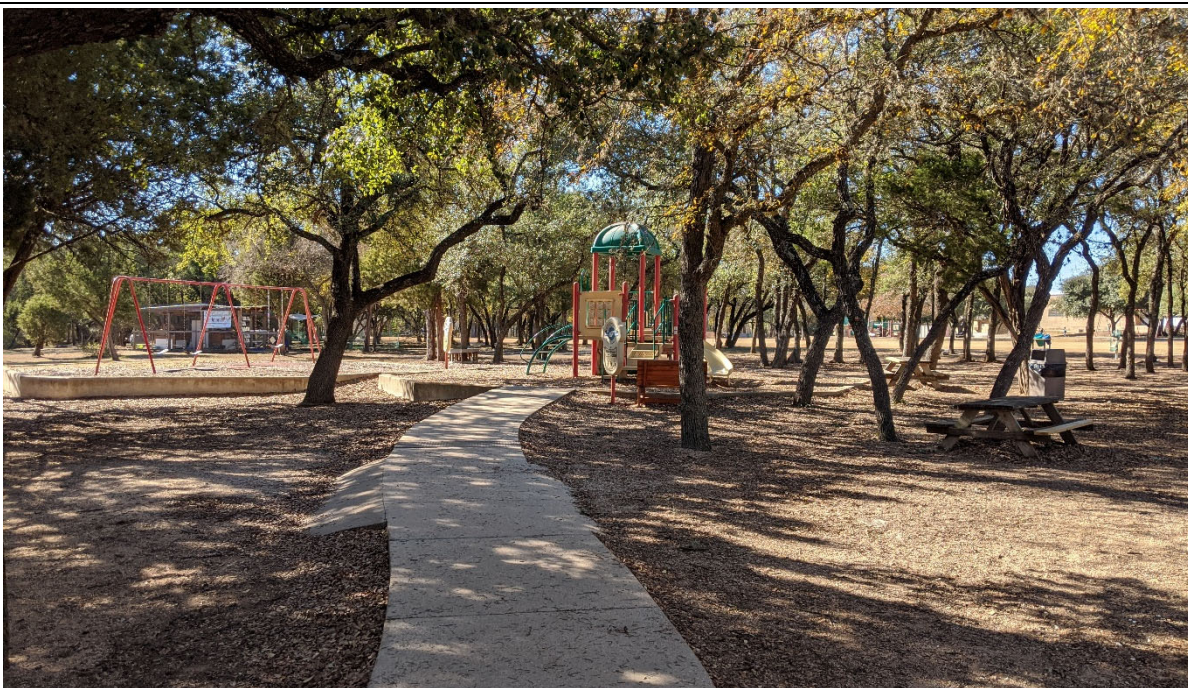
Outdoor Learning: One of the two playgrounds set in large grove of trees.

2.2	Are active playgrounds (elementary only) and support spaces configured per the ed spec?				4			Comments	1.00 4.00
1	Very unsatisfactory - No dedicated active playground							Numerous playgrounds and play areas. Only the basketball court is covered, but trees provide some shade.	
2	Unsatisfactory - Too small, poor condition, no shade provided								
3	Average - Adequate size, adequate condition, needs some renovations or updates to function well, 50% or less shade coverage over play structure								
4	Satisfactory - Good size, good condition, more than 50% shade coverage over play structure								
5	Very satisfactory - Generous size, excellent condition, full shade coverage over play structure								
N/A	Does not apply

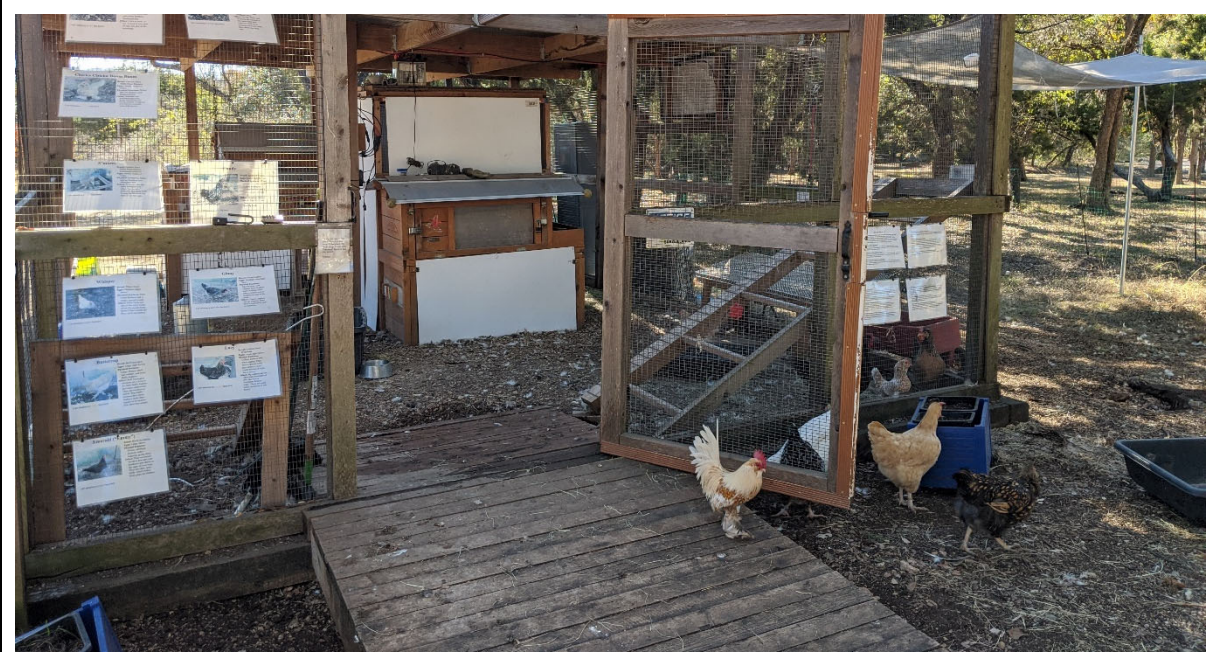
Outdoor Learning: Large chicken coop and fenced area.

2.5	Does the school have animal husbandry? (optional)					5			Comments	0.00	0.00	
1	No								Has a chicken coop			
5	Yes											
2.6	Does the school have nature loop trails? (optional)					5			Comments	0.00	0.00	
1	No											
5	Yes

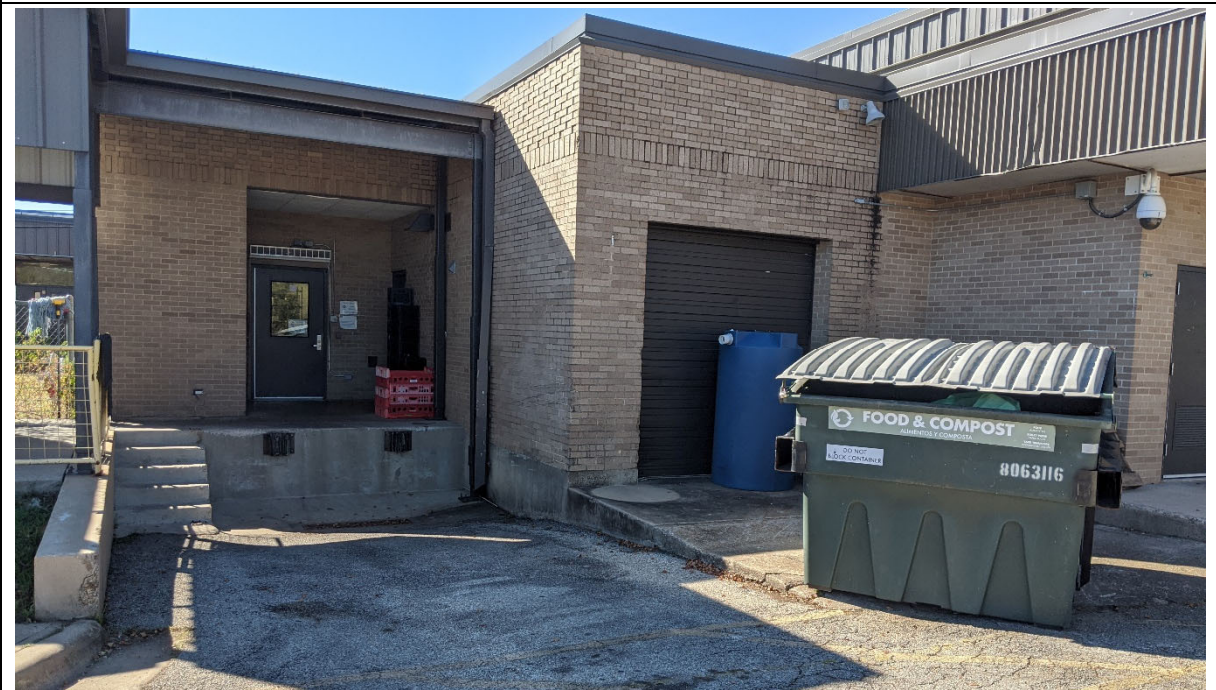
Loading dock but no accessible route for trash and compost.

1 - Exterior (cont.)		1	2	3	4	5	N/A		
1.3	Is the dumpster accessible for trash / compost disposal?		2					Comments	0.50 1.00
1	Very unsatisfactory - No compost present, route has obstacles (stairs, curbs, barriers) to dumpster							No ramp from loading dock	
2	Unsatisfactory - Compost is present. Route has obstacles to dumpster								
3	Average - Compost is present (<100' to cafeteria), Route to dumpster is free and clear but the two are not directly adjacent.								
4	Satisfactory - Compost and dumpster are directly adjacent and route is barrier free								
5	Very Satisfactory - Compost and dumpster are directly adjacent and route is barrier free. Dumpster are shaped / positioned so people of all heights can access it.								
N/A	Does not apply								
2 - Outdoor Learning and Activity		1	2	3	4	5	N/A
