Educational Suitability Summary Report

Overton Elementary School

Date: 12/15/2020

Score 74% Satisfactory

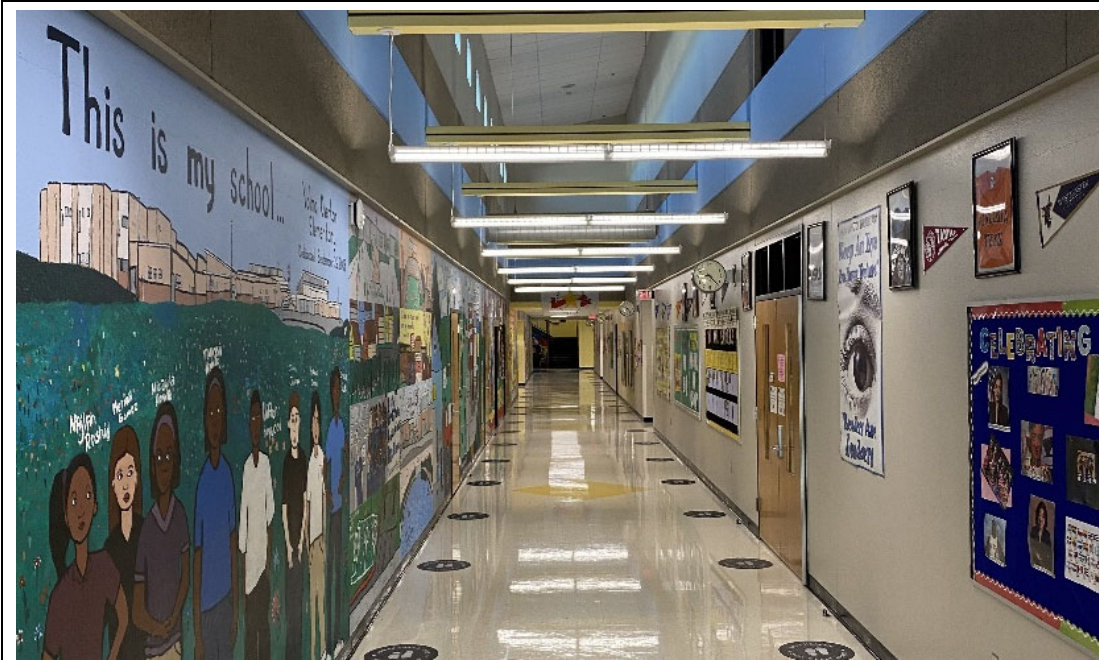
Hallways have ample width. Main hallway conveys school pride with murals and memorabilia on walls.

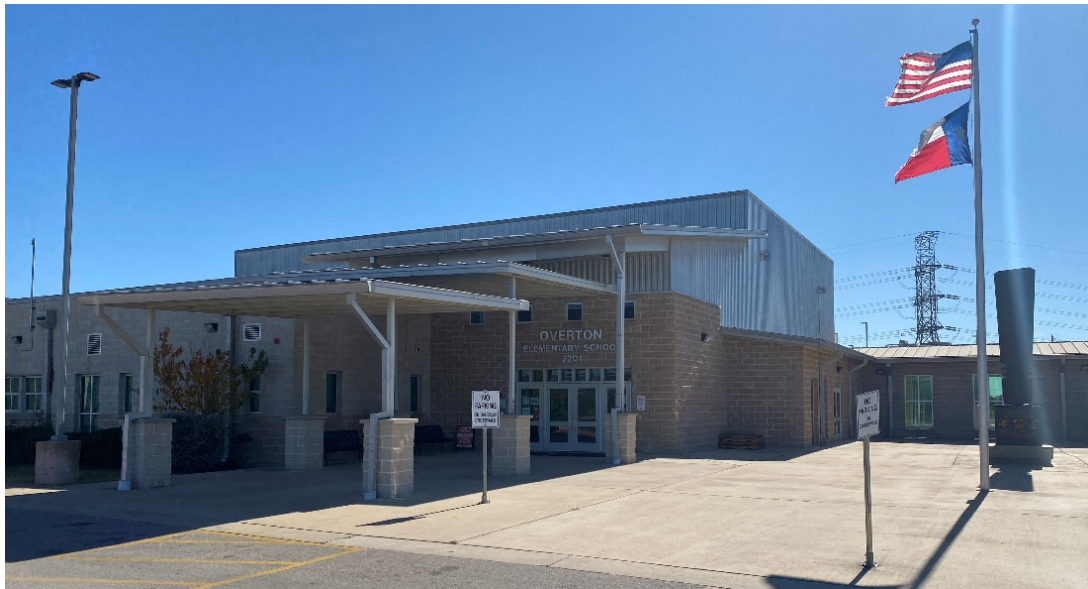
The exterior of the building is in good condition. A monument to community civil rights leaders is a primary feature of the entry courtyard.

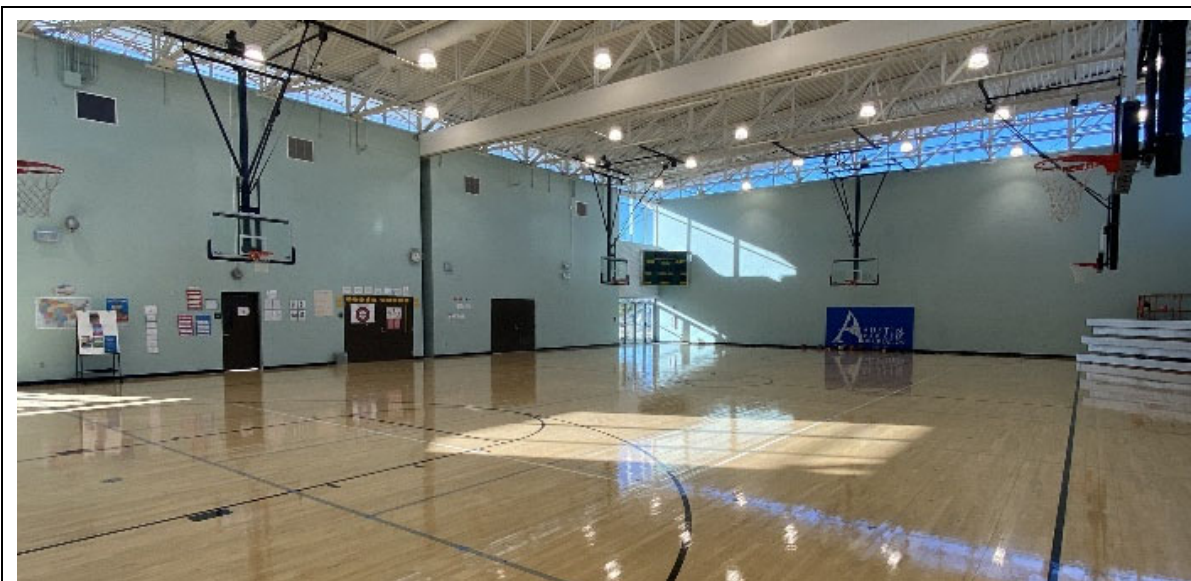
Gym photo prior to damage sustained from the winter storm in Feb. 2021. Gym is in particularly good condition (outside of some minor bleacher issues) and provides good quality of light and space. Gym is shared with community center and faculty mentioned this is a mutually beneficial relationship.

Gym is of good size and in good condition. Adequate storage available but bleachers do not function well and need some updates. After site assessment visit, gym was damaged by flooding due to winter storm in February 2021. No timeline has been given to its reopening by the City of Austin.

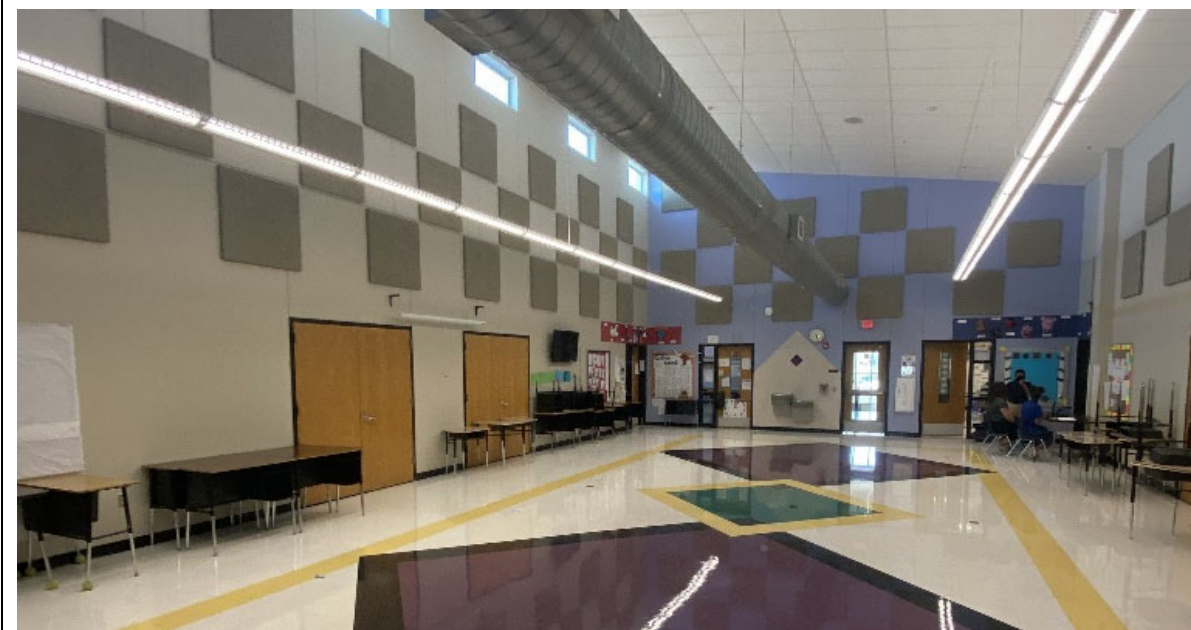
Multipurpose halls in some studio wings provide ample space for collaborative and group breakout learning and gathering of larger groups.

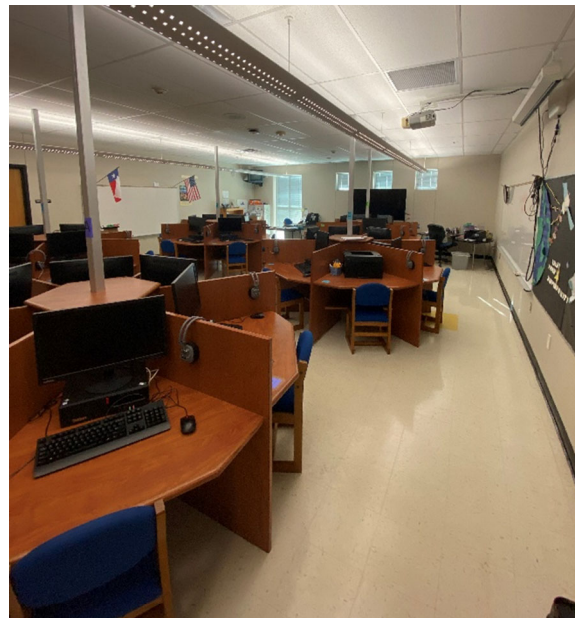
Computer lab and technology learning space needs updates. Power/data poles are being pulled from the ceiling; furniture is dated.

Furniture is not new, but it is sturdy and clean. Studios have a mixture of furniture types and some is newer and more flexible. Furniture in computer lab needs updates. The library could have a larger variety of furniture.

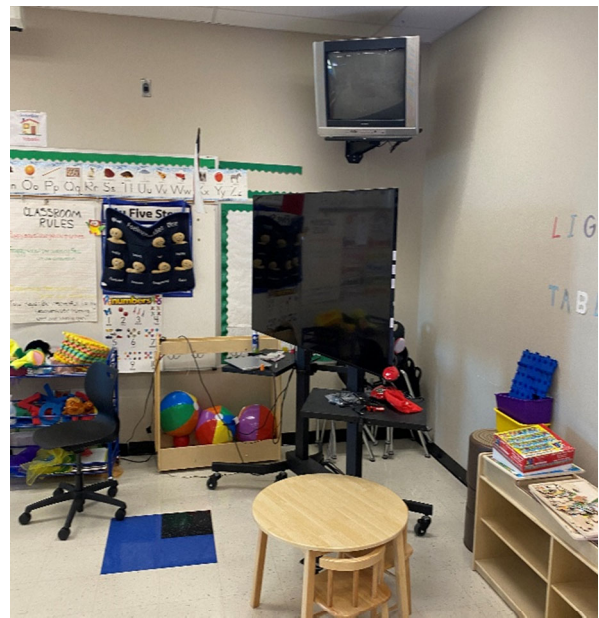
Hardwired technology in studios is out-of-date and mostly unused. Portable screens are preferred.

Multiple types of technology were observed, and studios had out of date wall mounted televisions. More power outlets are needed throughout school. AV in cafeteria appeared adequate. Gym AV was not evaluated since it is shared with the Recreation Center.

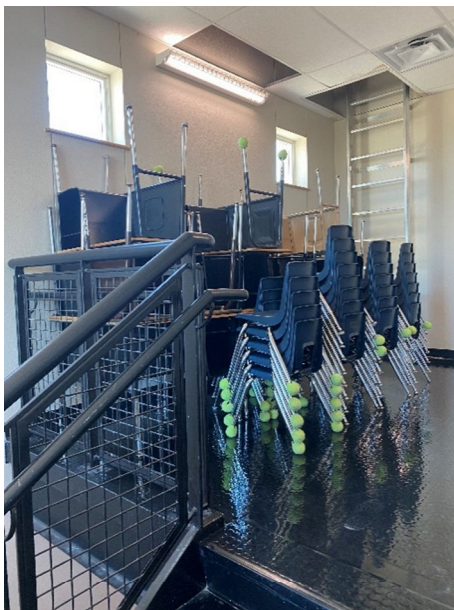
Storage issues are prevalent throughout and may be a function of Covid protocols. Cafeteria storage is also being used for storage.

The cafeteria is adequately sized per Ed Spec for the school's capacity. The kitchen is slightly undersized, and there is only one serving line. Both stage and cafeteria storage are provided, but currently, the back of the stage is also being used as additional storage.

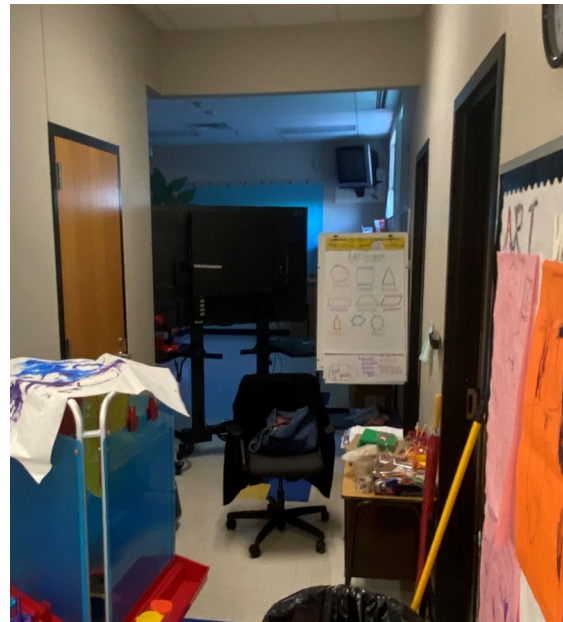
All studios are directly connected to an adjacent studio. They share restrooms and storage, but there is no acoustic separation.

Studio spaces are good size and establishes connection with other studios and shared learning spaces. The main issue for the studio spaces was acoustics. The shared restroom between two studios caused sound to travel between rooms.

Acoustics are inadequate in studios because of the shared restroom layout. Artificial and natural light

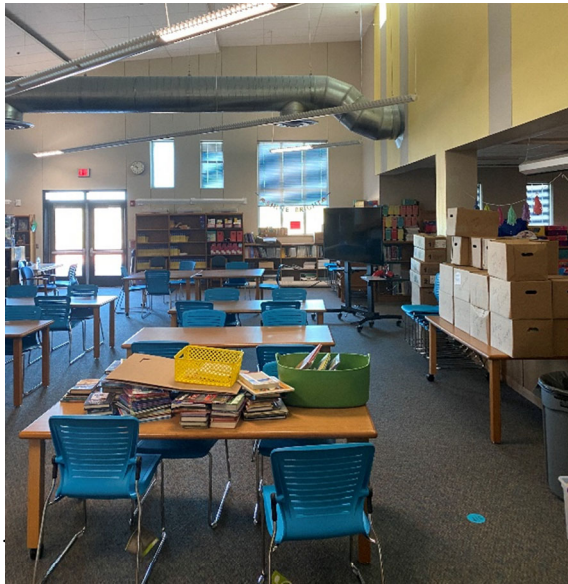
Media Center is in good condition/large size and has a door to the exterior. Currently not in use due to Covid protocols.

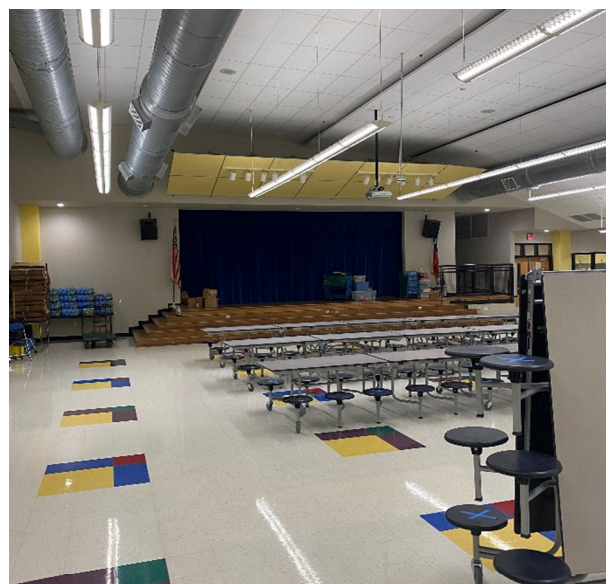
Dining commons is adequately sized. Only provides one type of seating, but in general, finishes and furniture are in good condition.

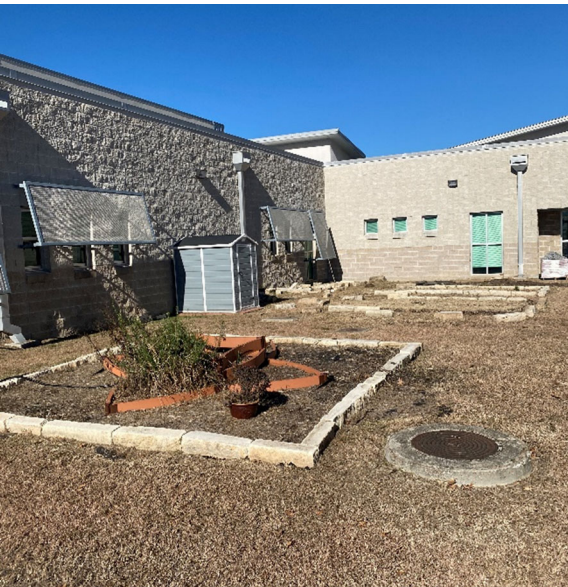
Outdoor gardens and outdoor learning spaces require some updates to function well.

Outdoor learning spaces are adequate but needs some reconfiguration and updates to function better. Shade is not provided for the outdoor spaces and play areas.

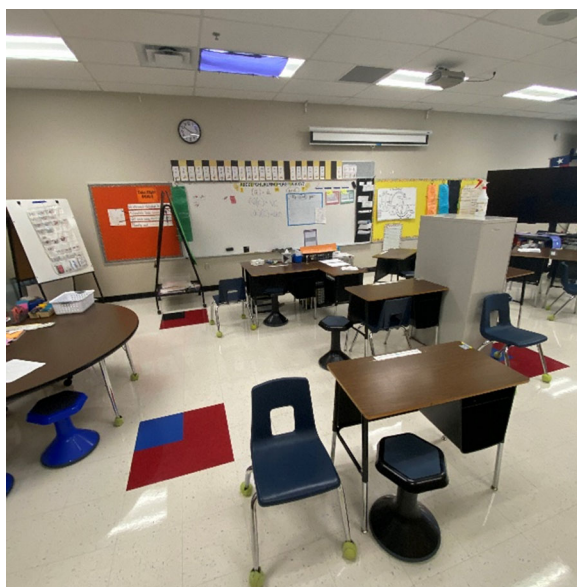
Studios have a mixture of furniture types. Some is updated and flexible while some is not as easily movable and reconfigurable.
