Educational Suitability Summary Report

Reilly Elementary School

Date: 02/05/2021

Score 54% Average

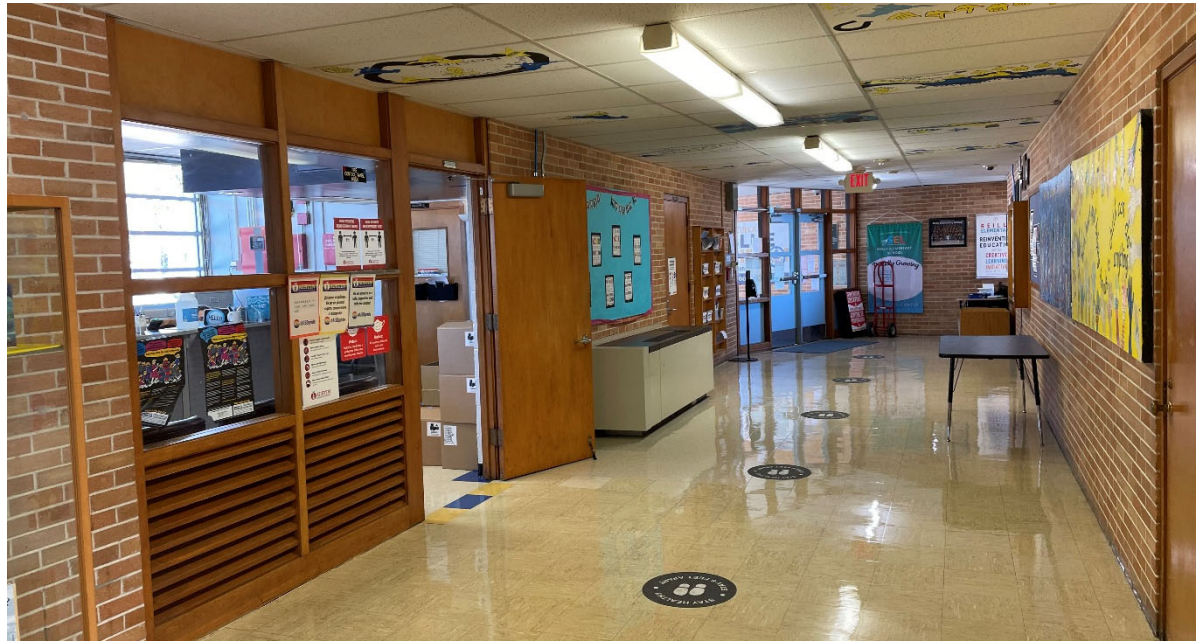
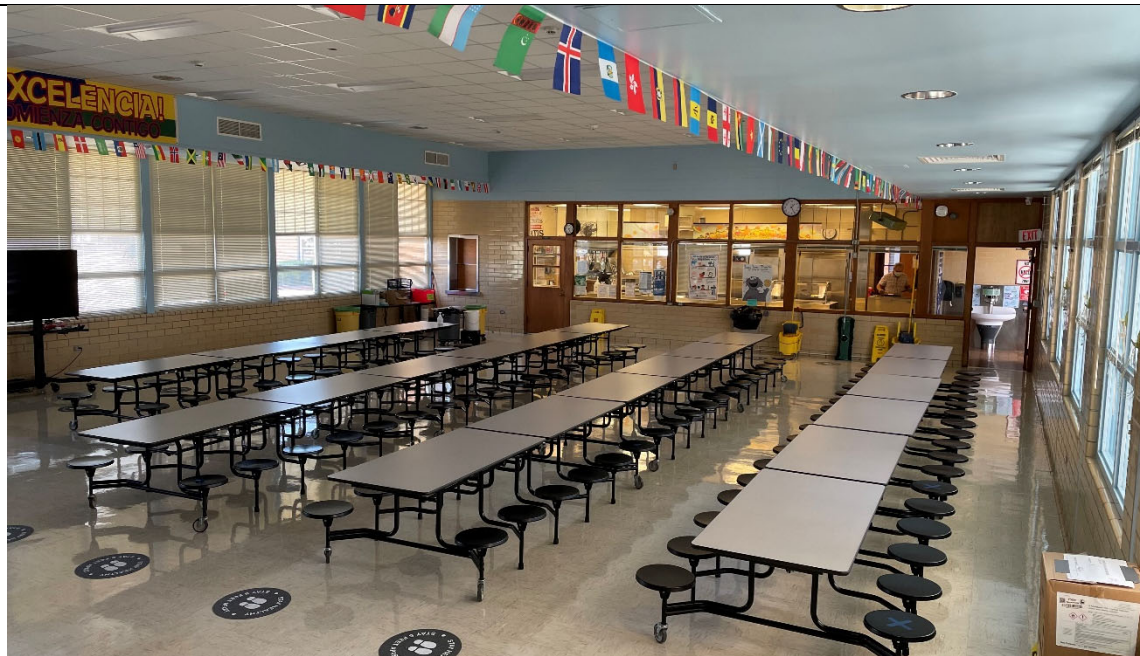
Food Services: The cafeteria is adequately sized for capacity per Ed Spec but does not meet the needs of the school. It is too small for accommodating the entire enrollment at once or hosting large events. The kitchen is very undersized.

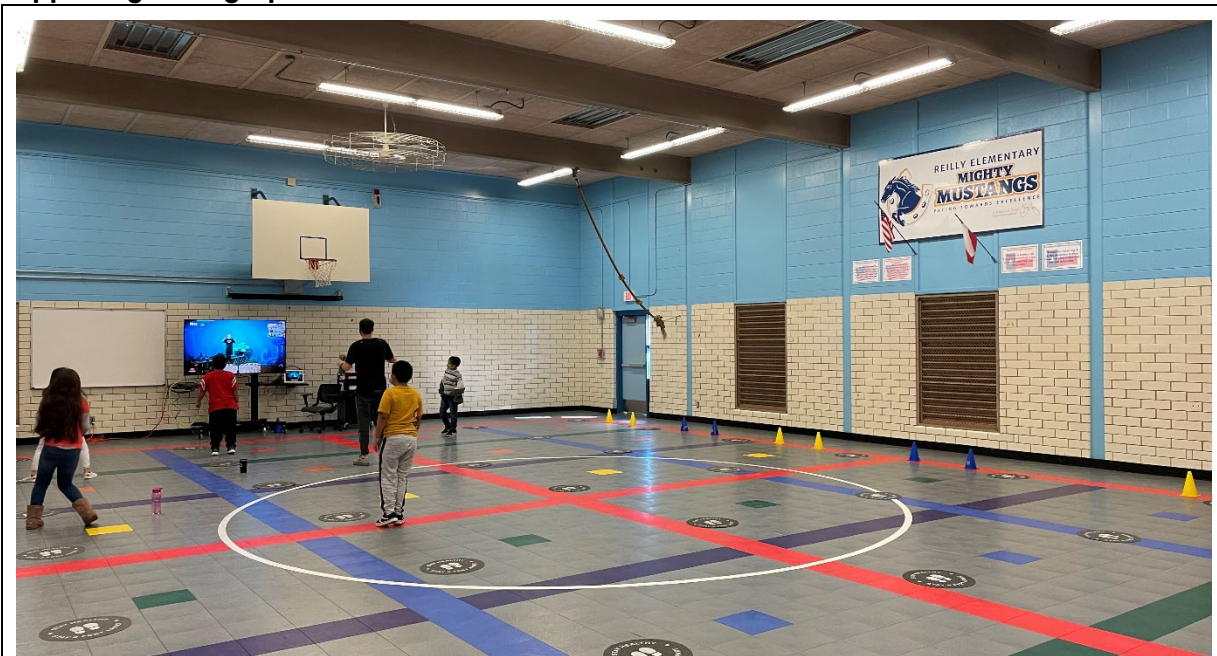
PE and Wellness: The gym is undersized, and finishes are outdated.

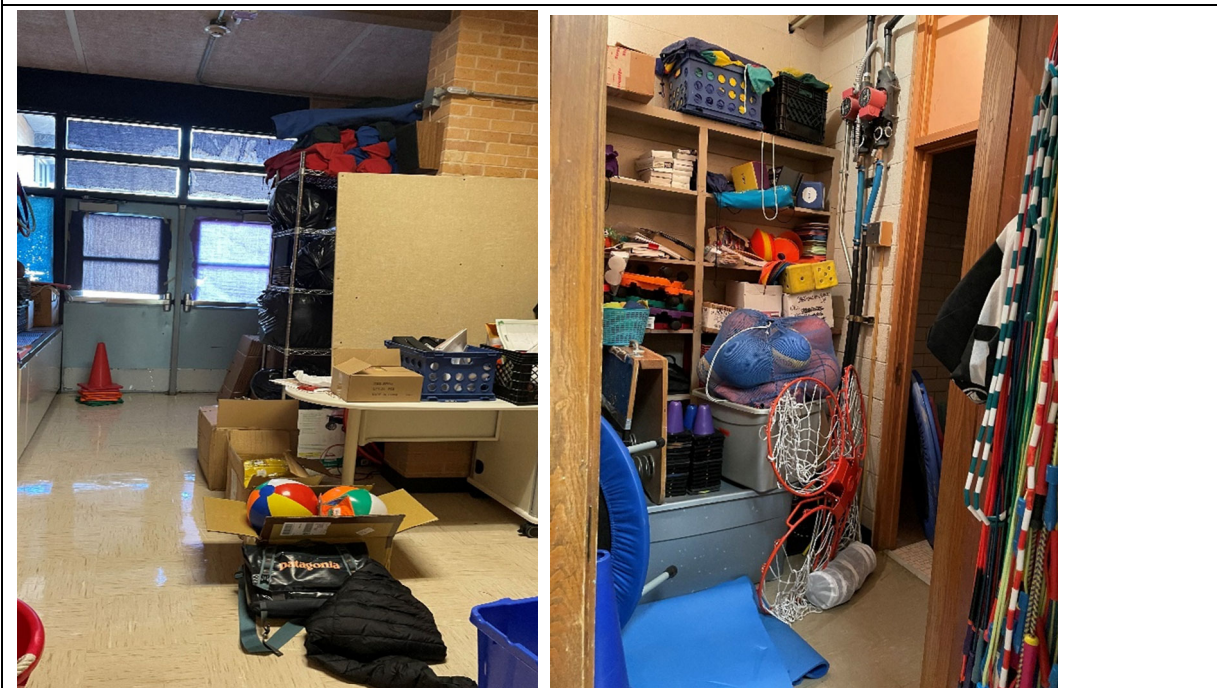
PE and Wellness: The gym storage is detached from the main gym area in what used to be a school entry and restrooms.

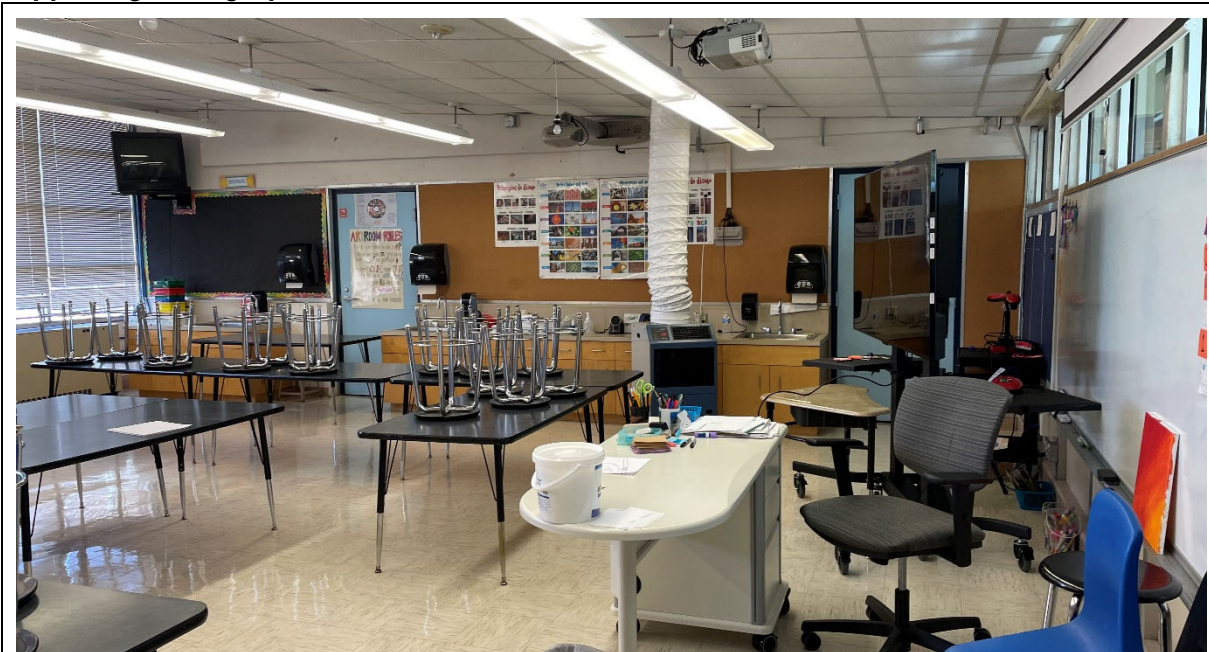
Visual and Performing Arts: Art room is slightly undersized at 900 square feet but has adequate number of sinks. There is a kiln, but storage is limited.

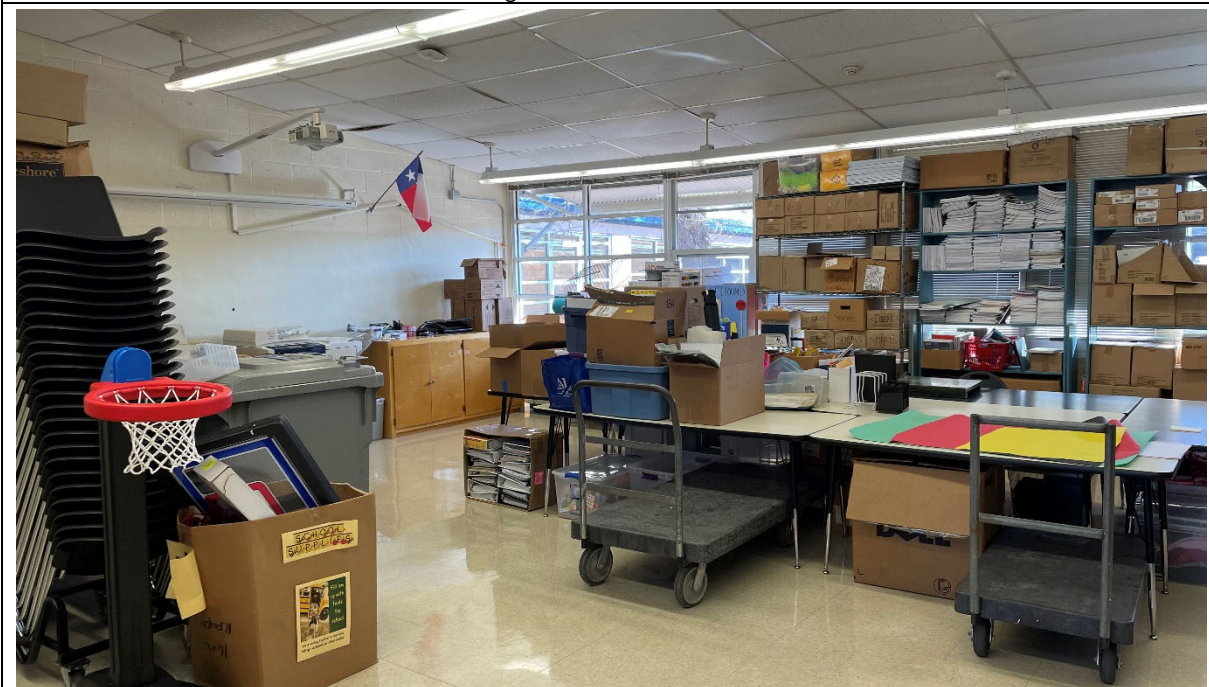
Administration Spaces: The faculty workroom is in a converted studio.

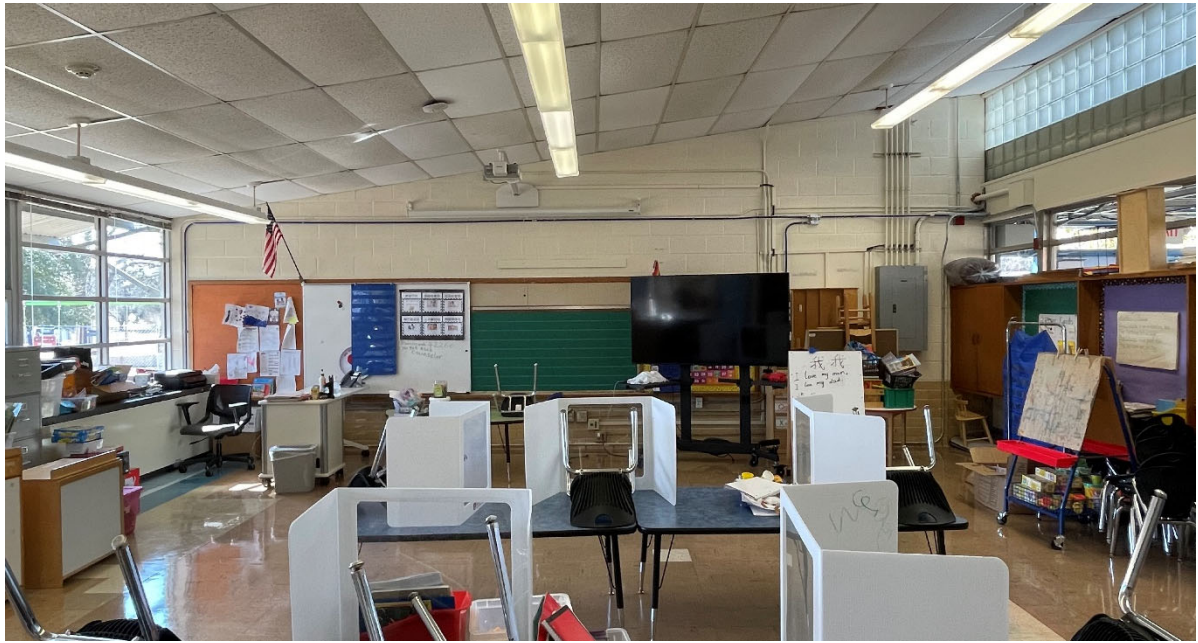
Academics and Learning: Studios are well lit and have great views to the outside. Storage is limited and lighting is outdated.

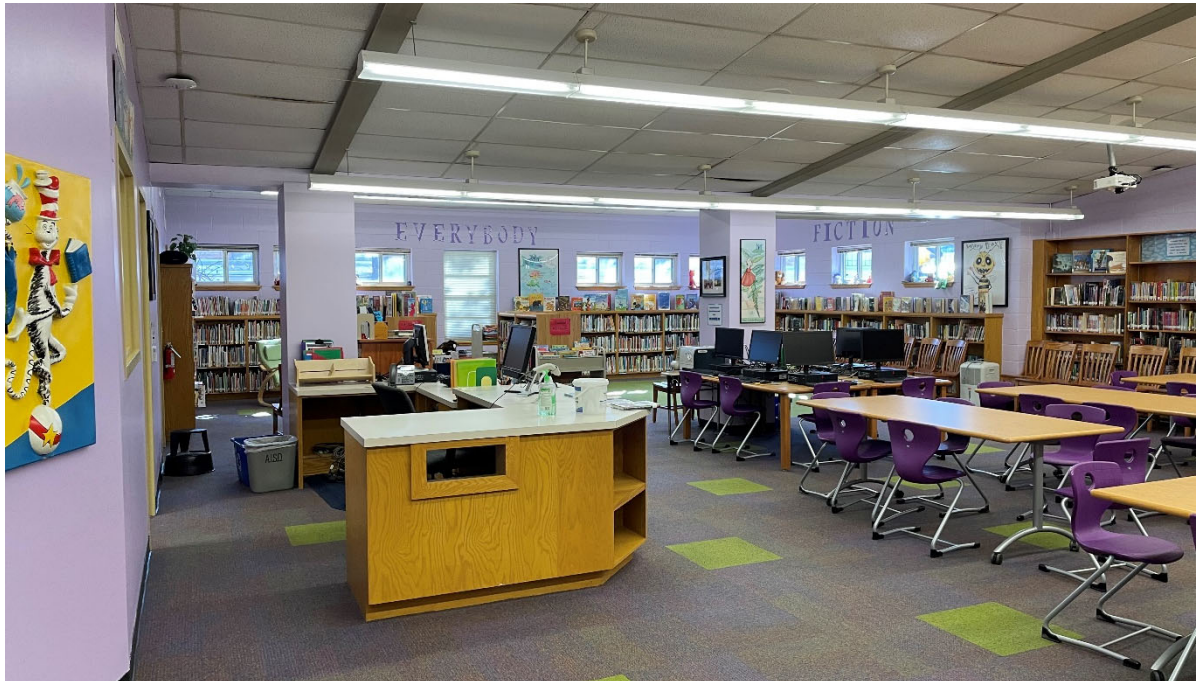
Media Resources: The library seems to have had some recent updates, including flooring and furniture. There is a projector but no screen. There is no access to the outdoors.

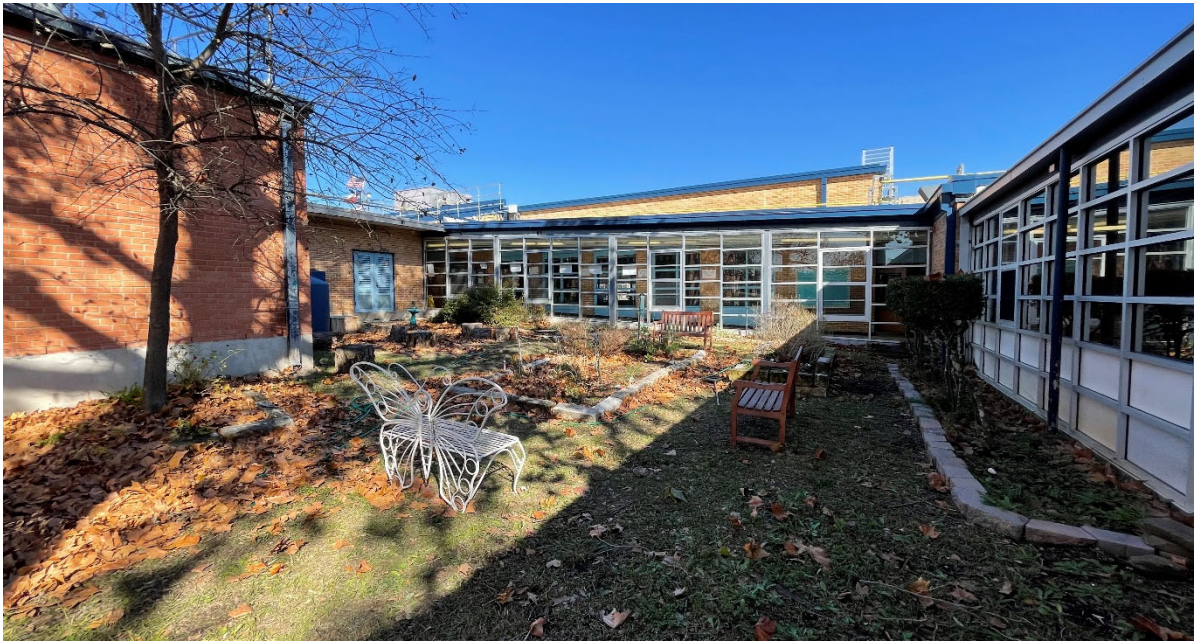
Outdoor Learning and Activity: The school is proud of the new sensory gardens. They are optimally located between studio wings and have access to a water supply.

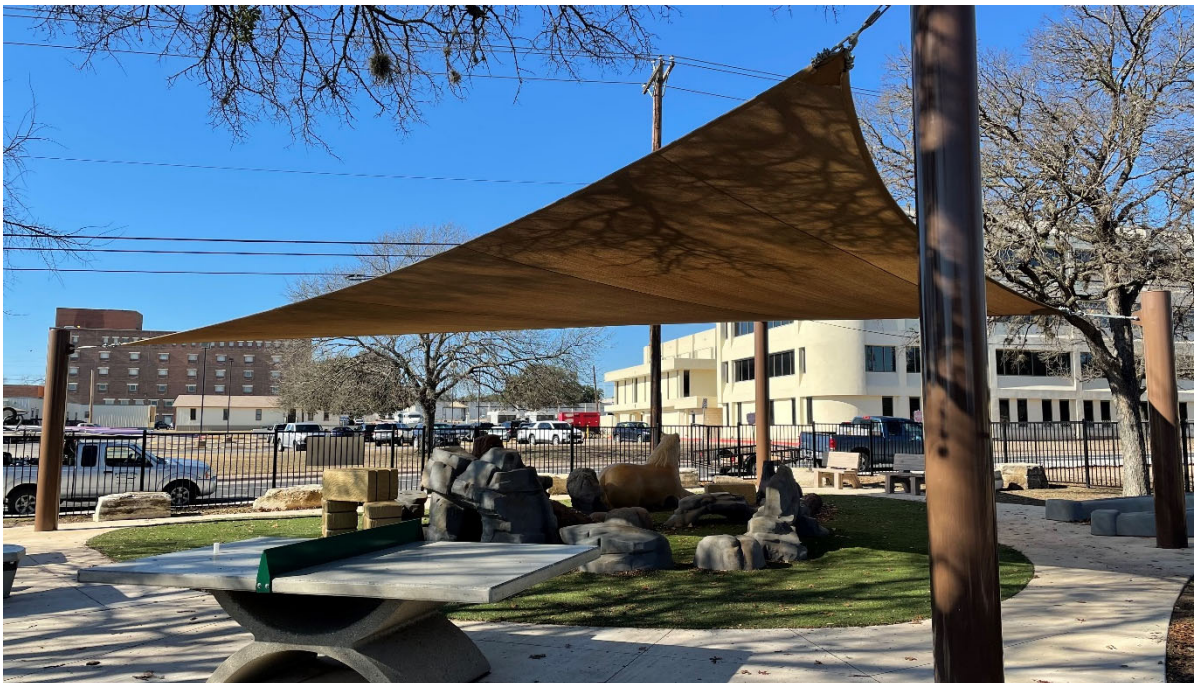
Outdoor Learning and Activity: The school recently added a new playscape. The exterior portion of the campus is quite large due to the adjacency to Reilly School Park. There is a large walking path present as well.
