Educational Suitability Summary Report

TA Brown Elementary School

Date: 01/25/2021

Perkins&Will

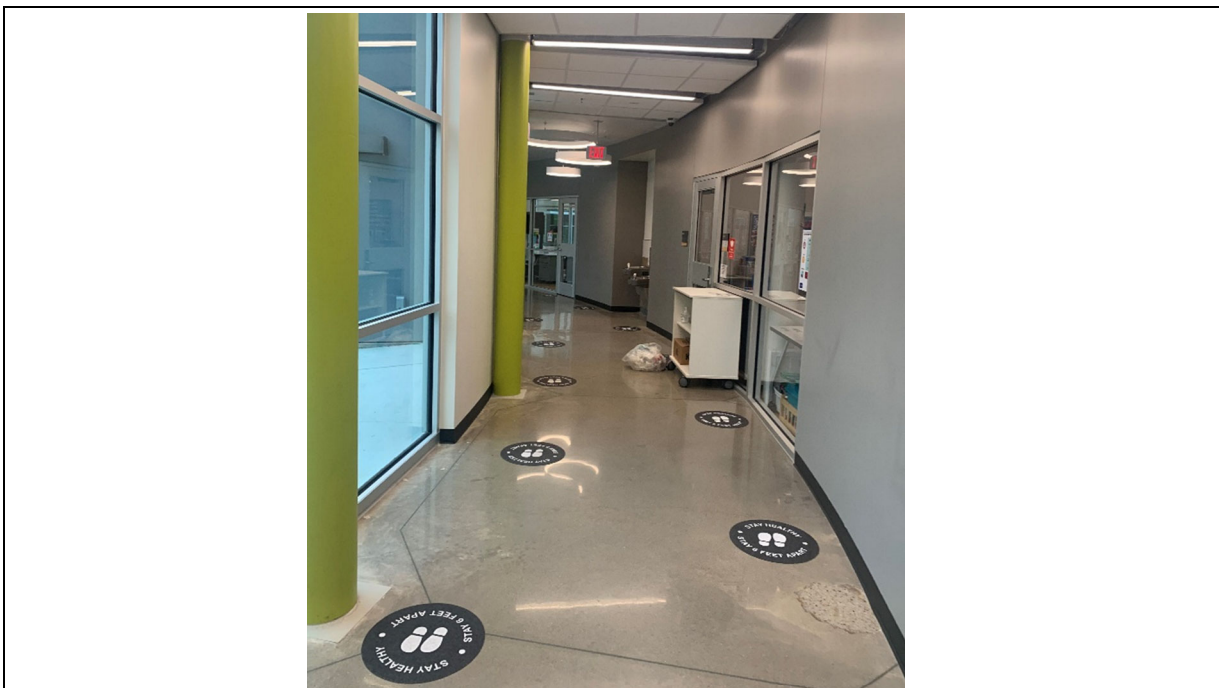
Hallways: Primary corridors are wide, but some secondary corridors are tight. Furniture and column protruding create narrower feel of some corridors.

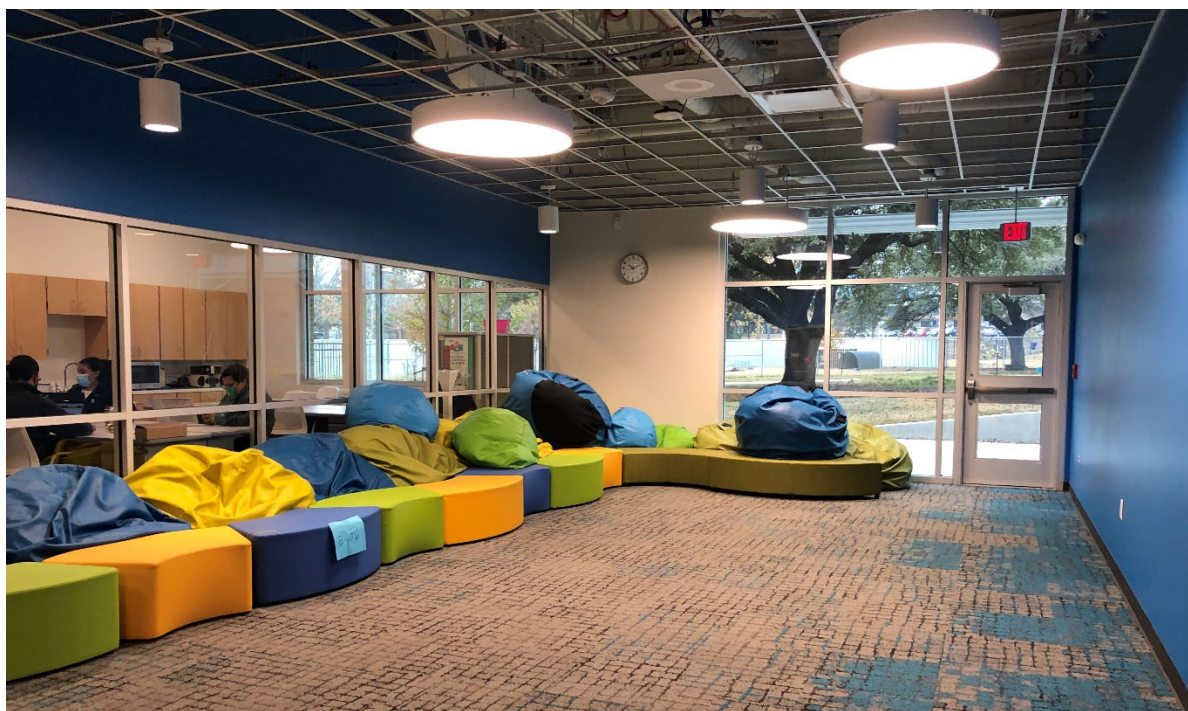
Breakout Space: Breakout spaces are spread across the building adjacent to the main circulation and allow for extra collaboration and learning spaces.

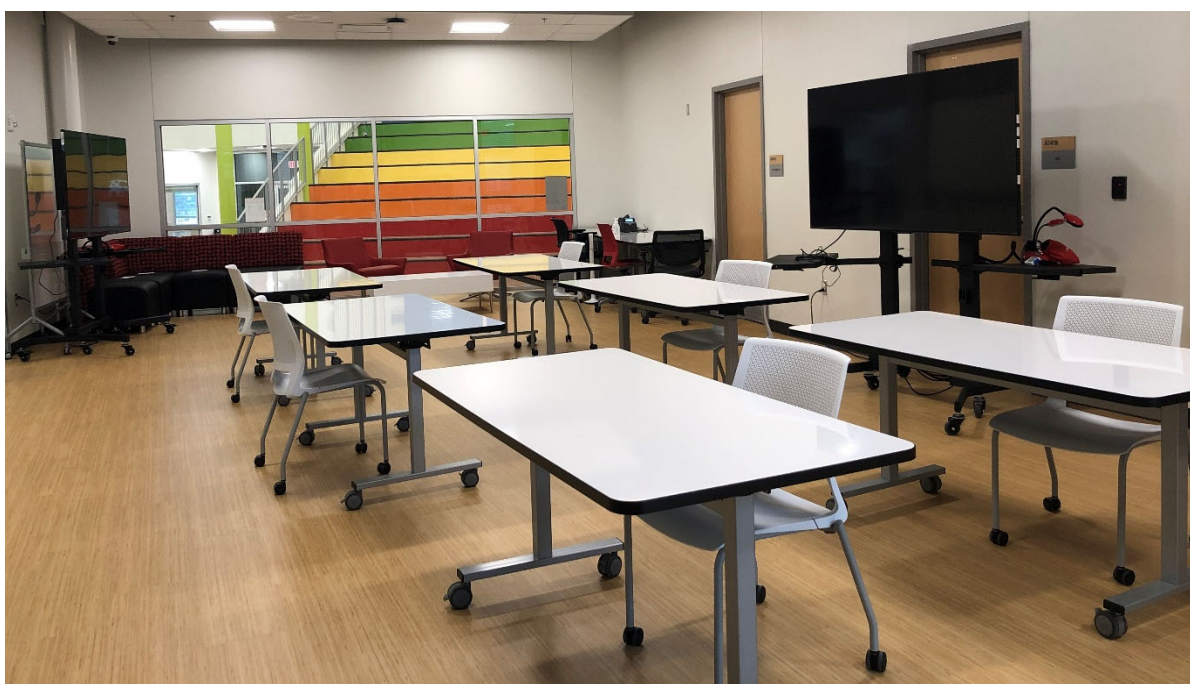
Community Room: Secured separation from the learning areas and afterhours access for a variety of uses

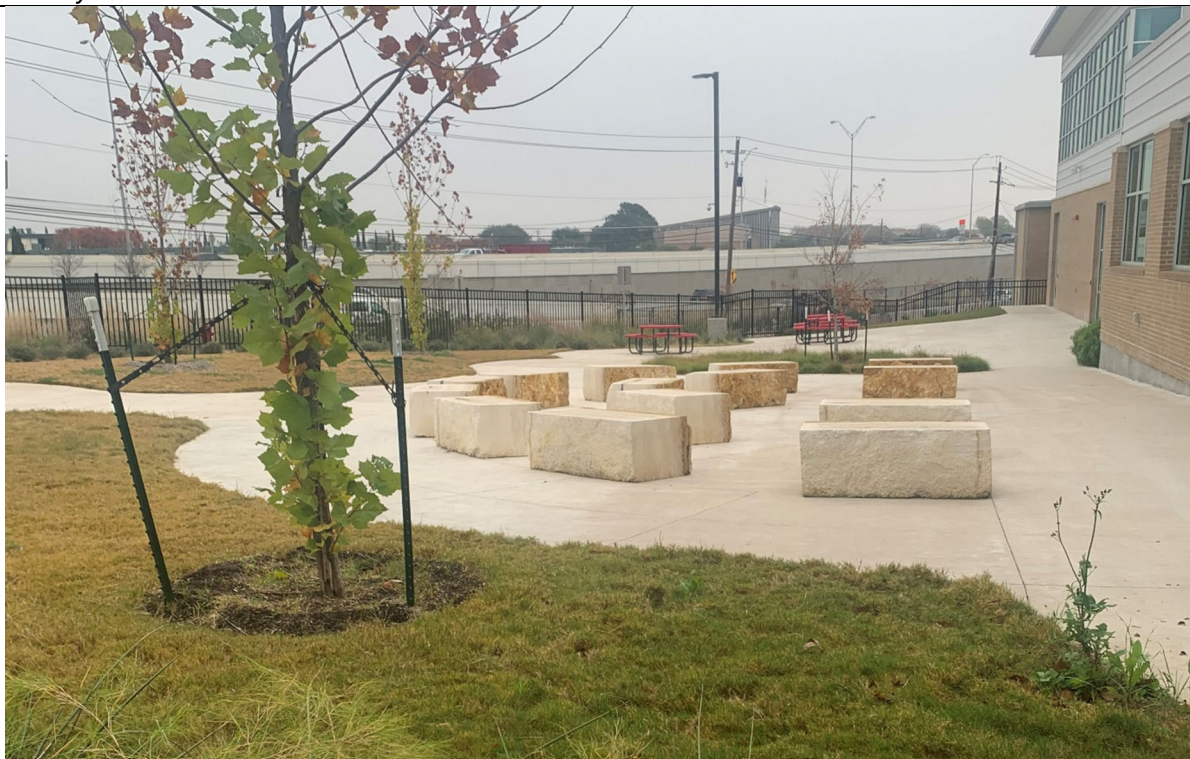
Exterior learning areas are planned with several settings, no shade coverings at most locations.

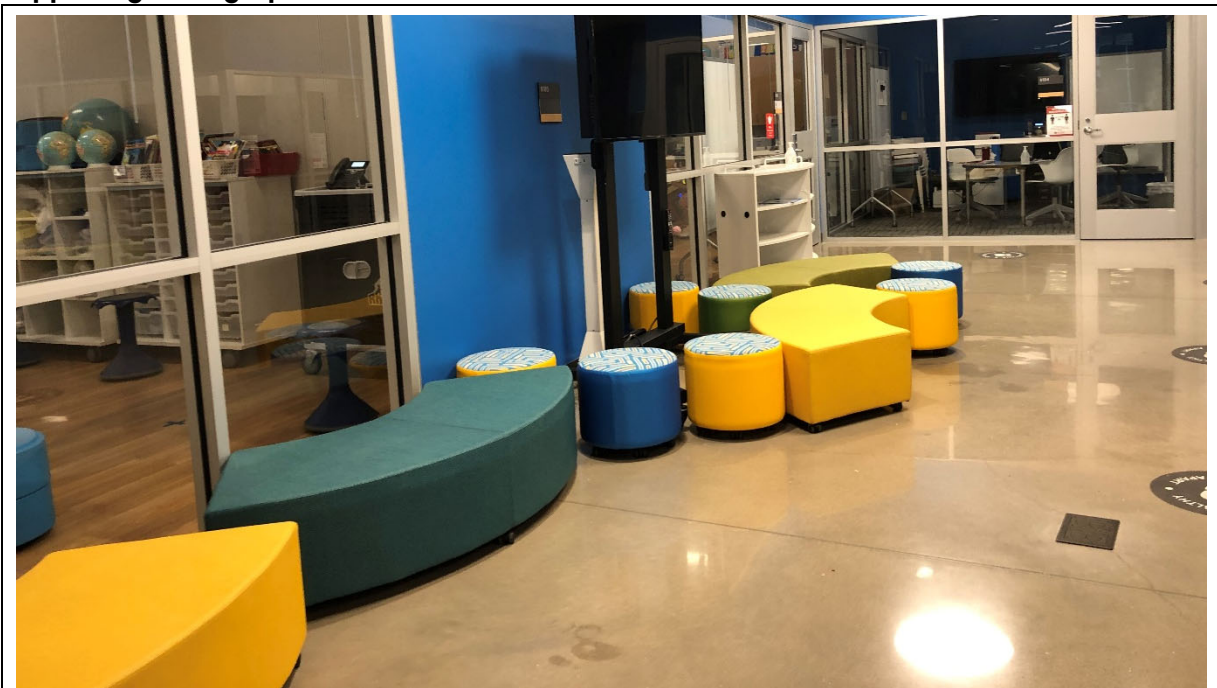
Flexible Space/Hallways: Breakout spaces in the hallways, good transparency into the learning spaces and promotes social interaction.

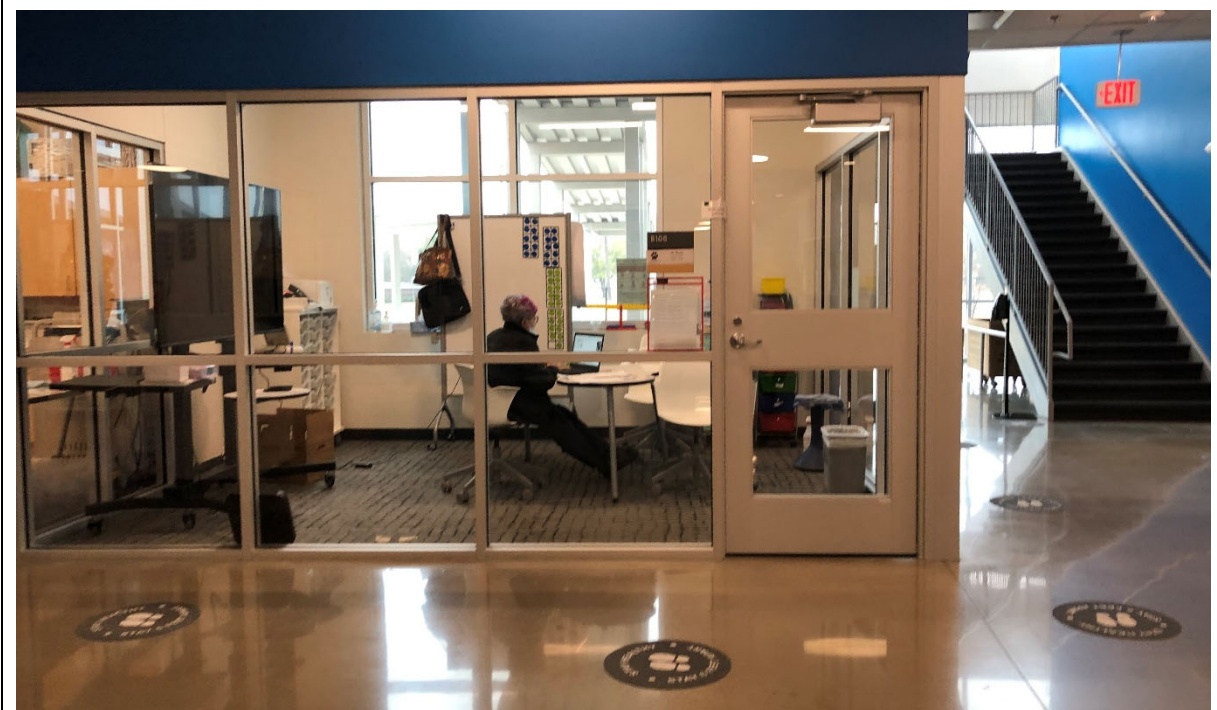
Small Group Space: Good natural light and adequate size.

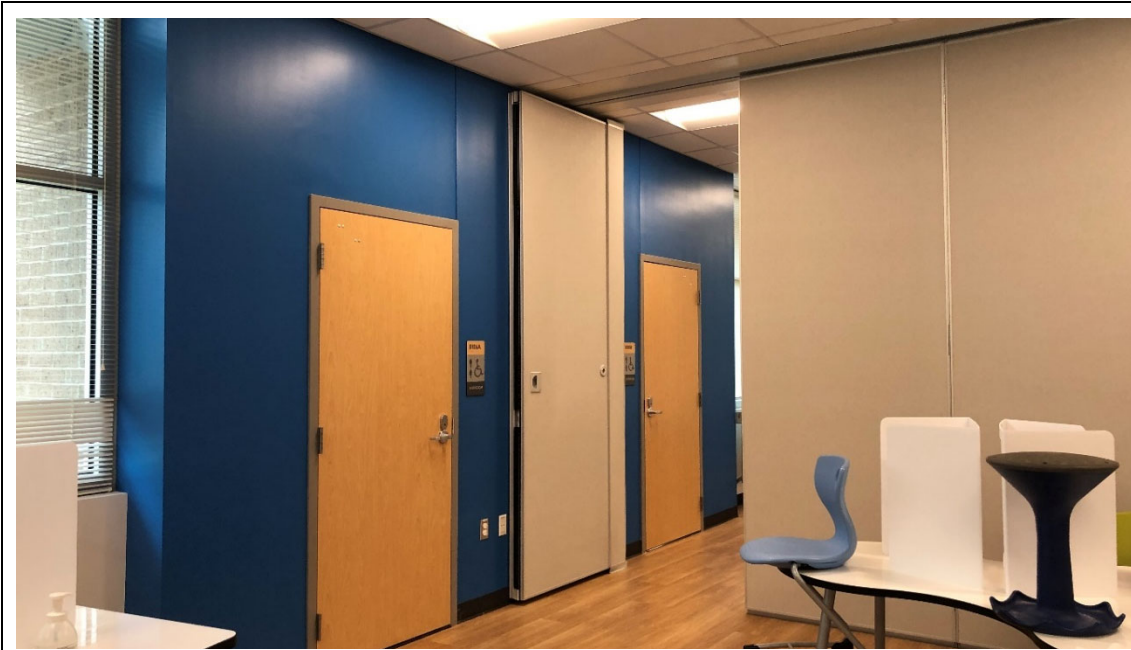
Studio: Movable partition, allows for flexibility and use of restrooms between studios without sacrificing acoustical privacy when needed.

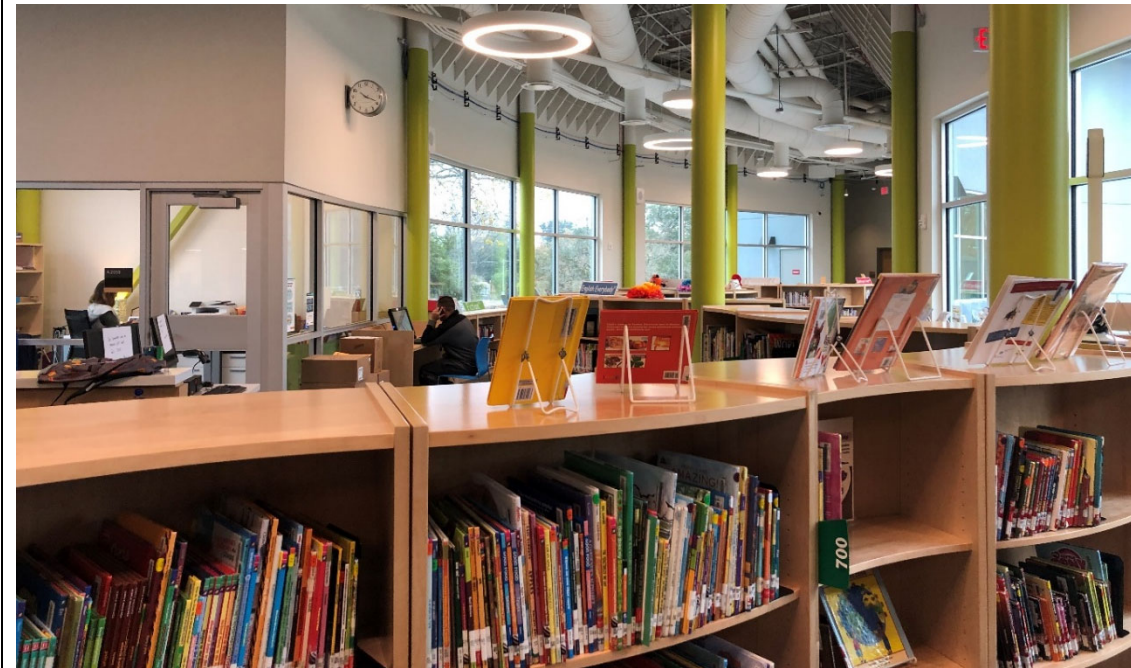
Library: Good natural light in the space. Areas for quiet study are not available. The library is relatively close to the entrance but is on second floor. Outdoor balcony is directly accessed from library.

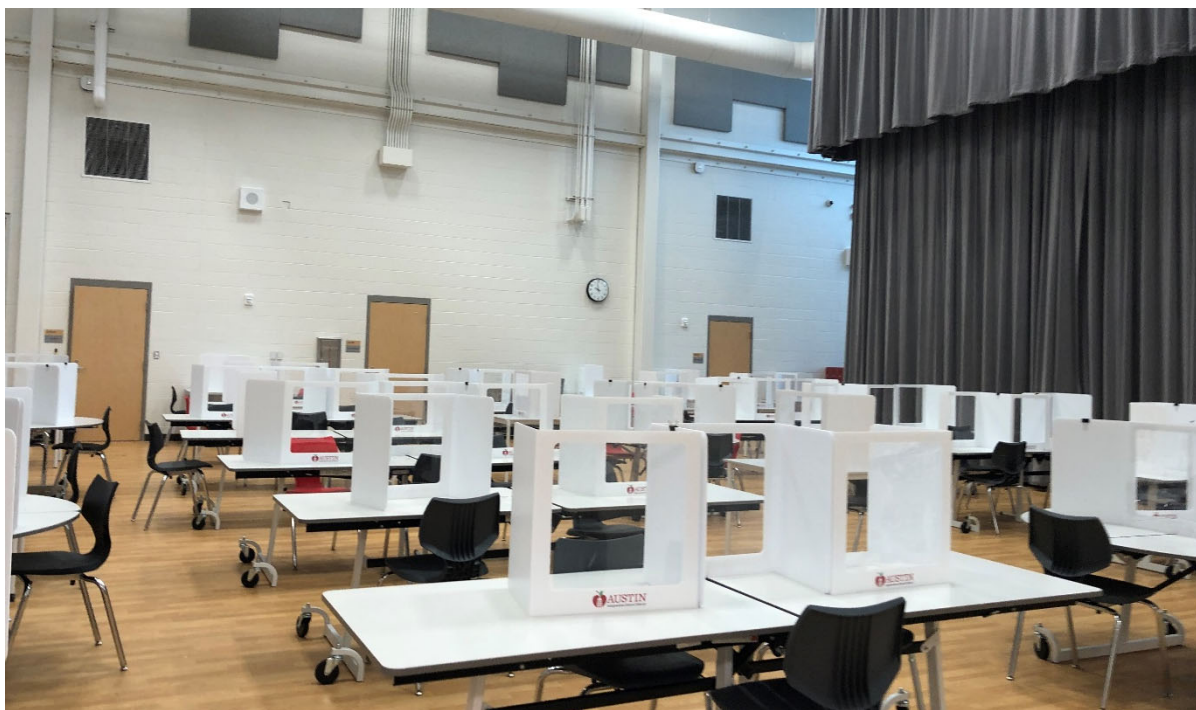
Dining Hall and Stage: Provides multi-use space with operable wall between gym and cafeteria.

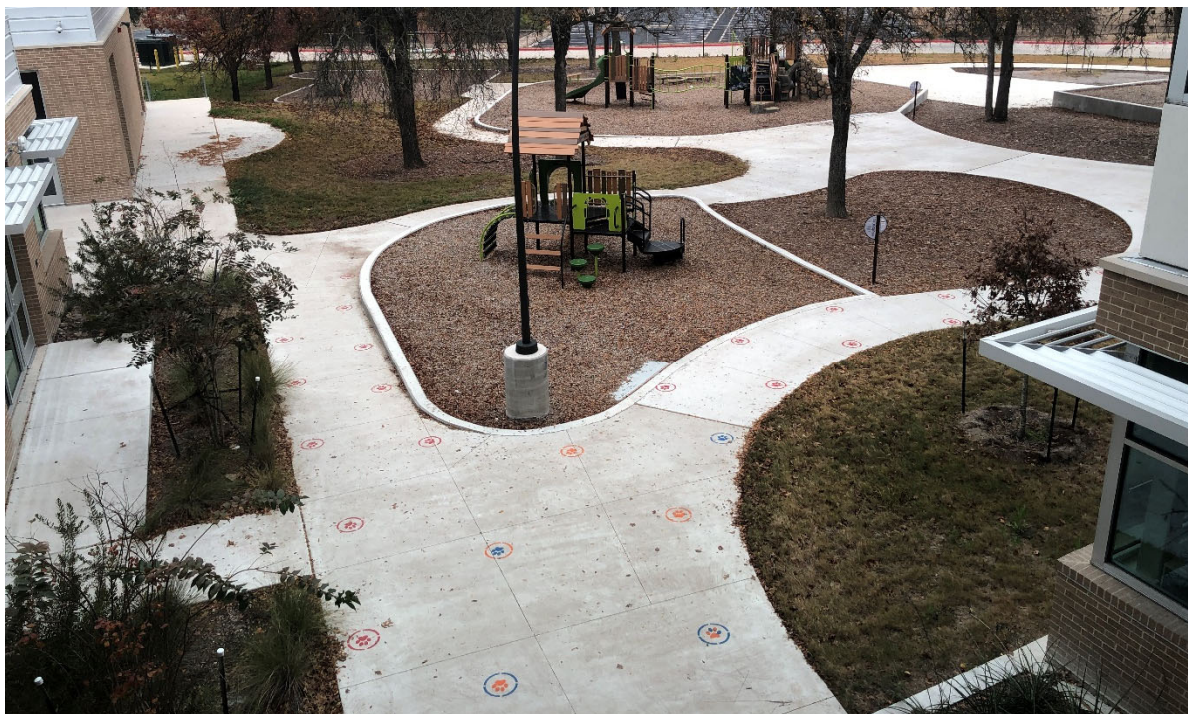
Playscapes: 50% of play areas shaded by tree canopies only.
