Educational Suitability Summary Report

Walnut Creek Elementary School

Date: 01/05/2021

Score 54% Average

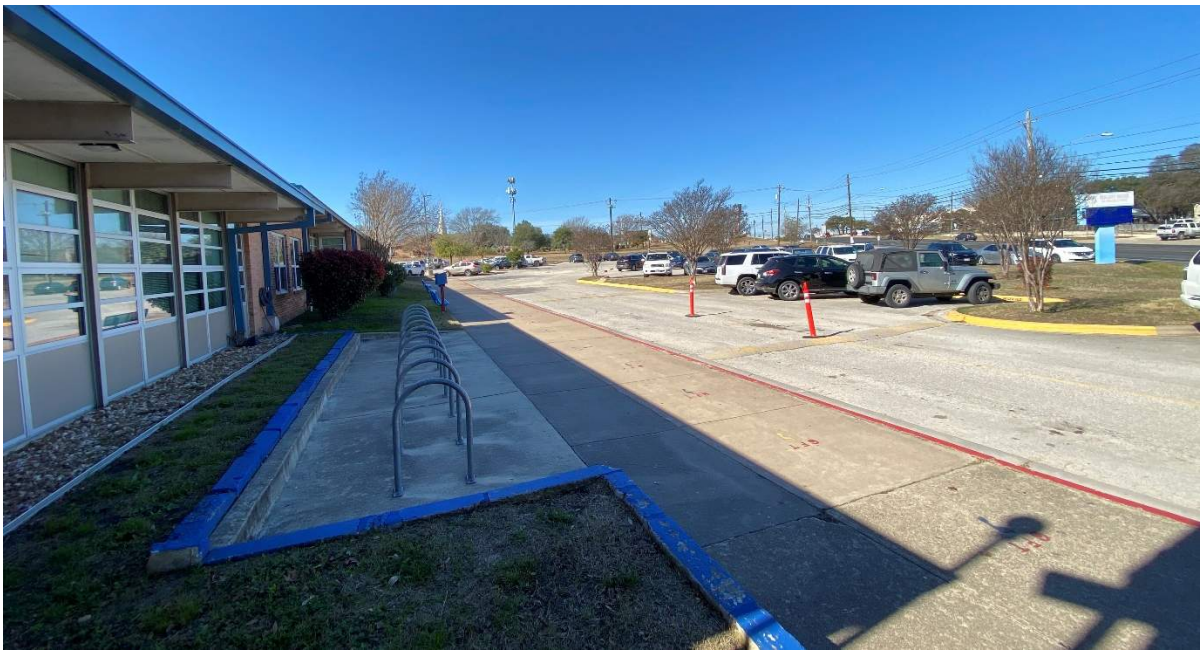
The drop-off at the main entrance doesn't have an overhang and does not separate bus traffic or pedestrian foot traffic through the parking lot.

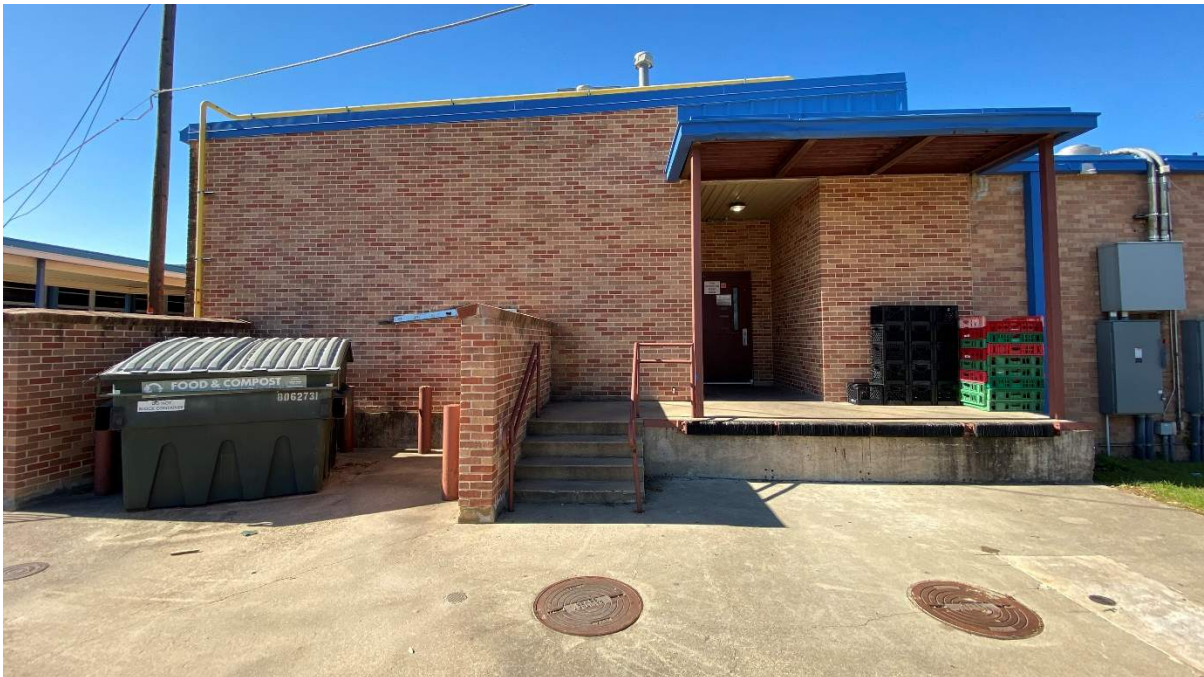
Dumpsters are not on accessible path. Compost is adjacent to exit; however, trash and recycling are 100+ feet away at the edge of the parking lot.

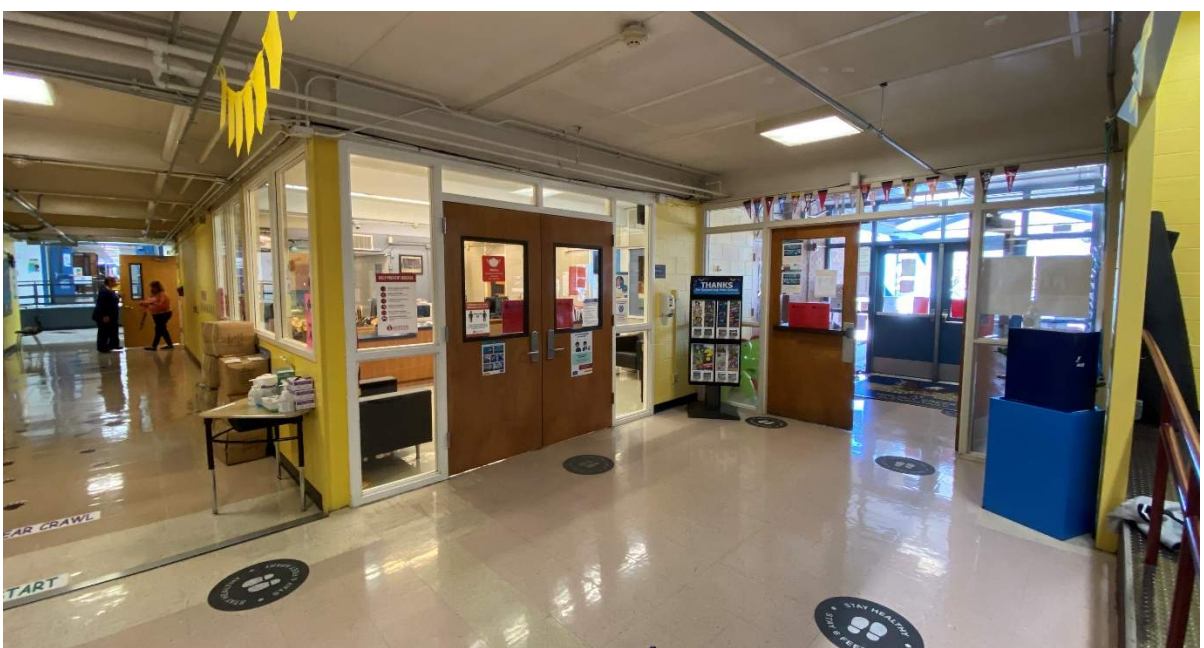
Reception doors were locked during school hours at the time of the assessment.

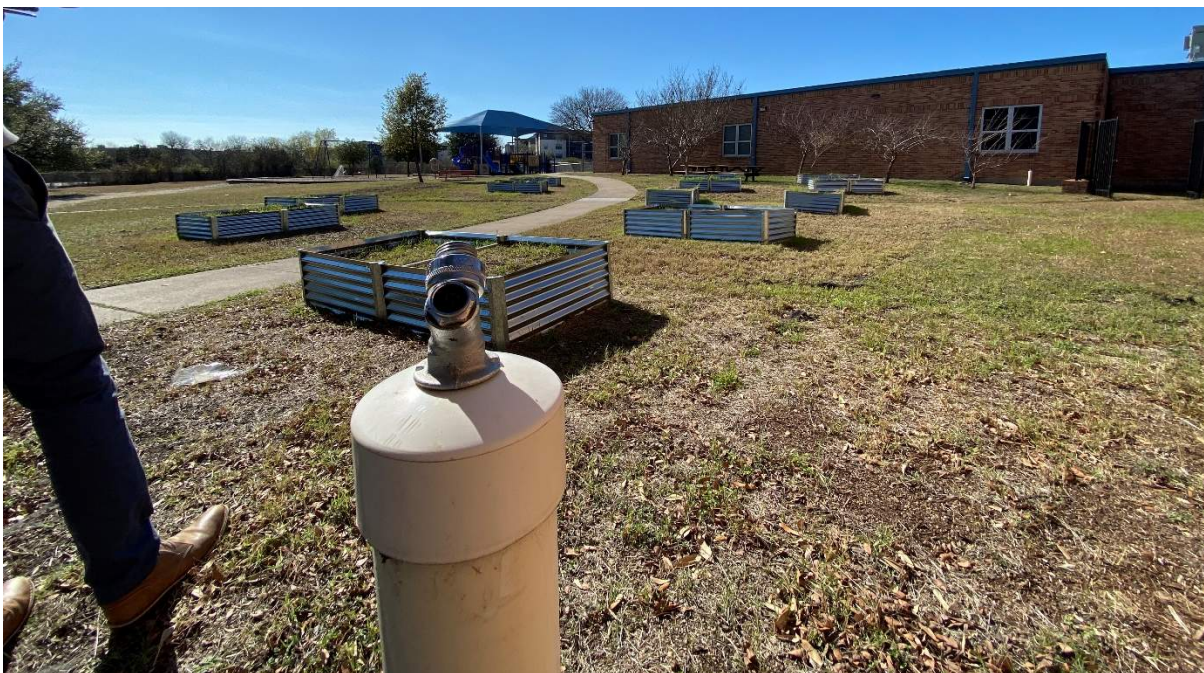
Outdoor gardens are in good condition. There is one hose bib nearby and no support shed. They are on the edge of campus, disconnected from a majority of learning spaces.

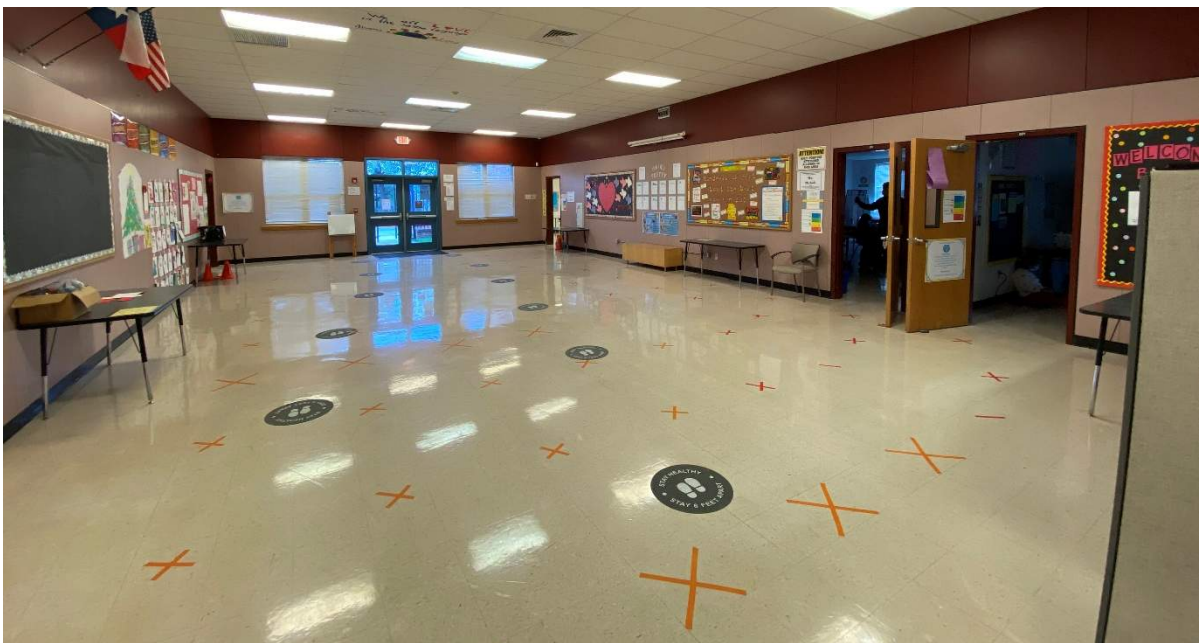
Learning pod and collaboration space in the center of studios in the new portion of the building.

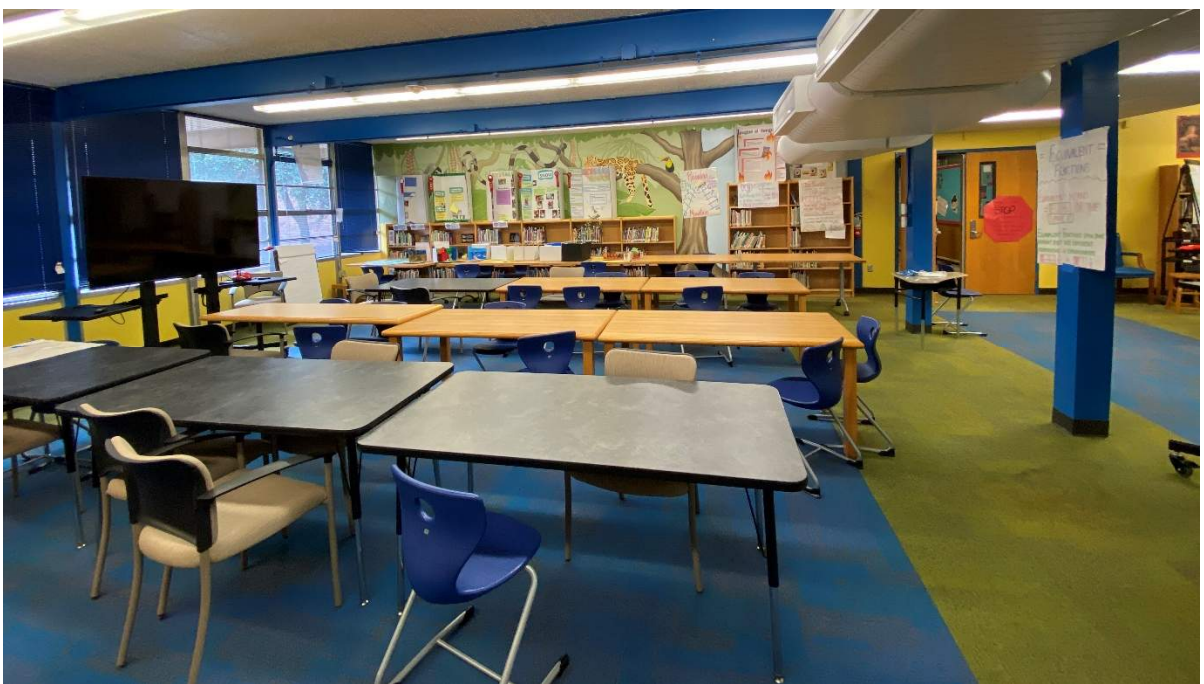
Media center large group area has a mixture of furniture and can be configured for different lessons but lacks acoustic separation.

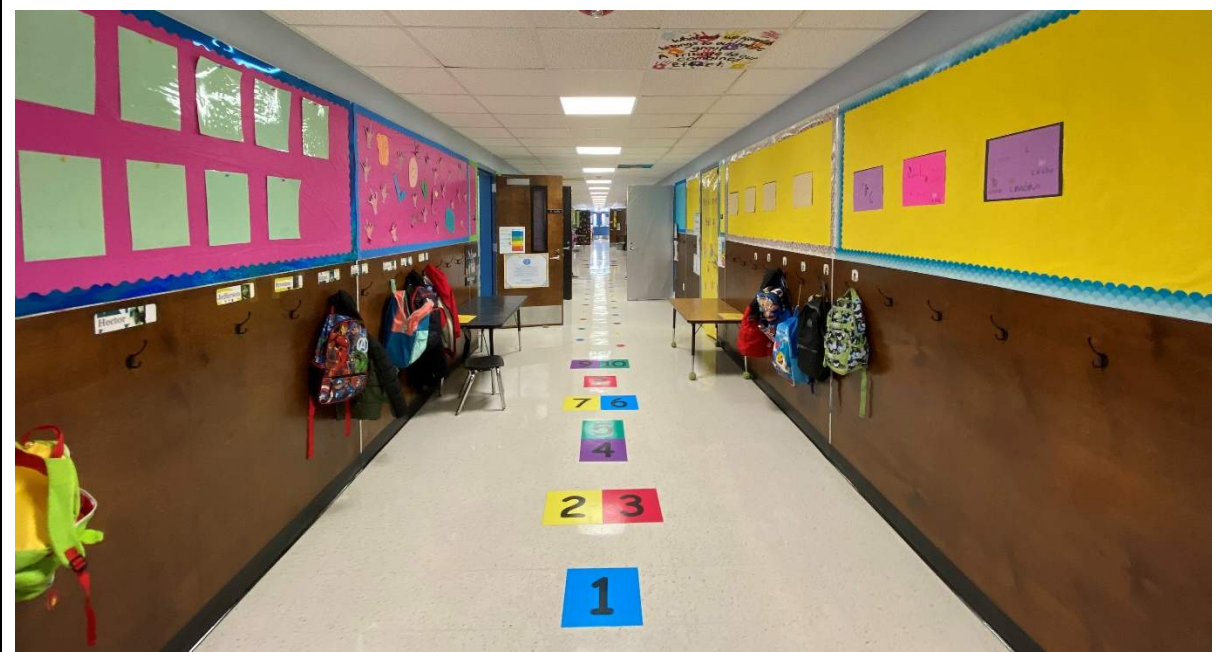
Corridor in the older portion of the building has ample tackable space but lacks transparency into learning spaces.

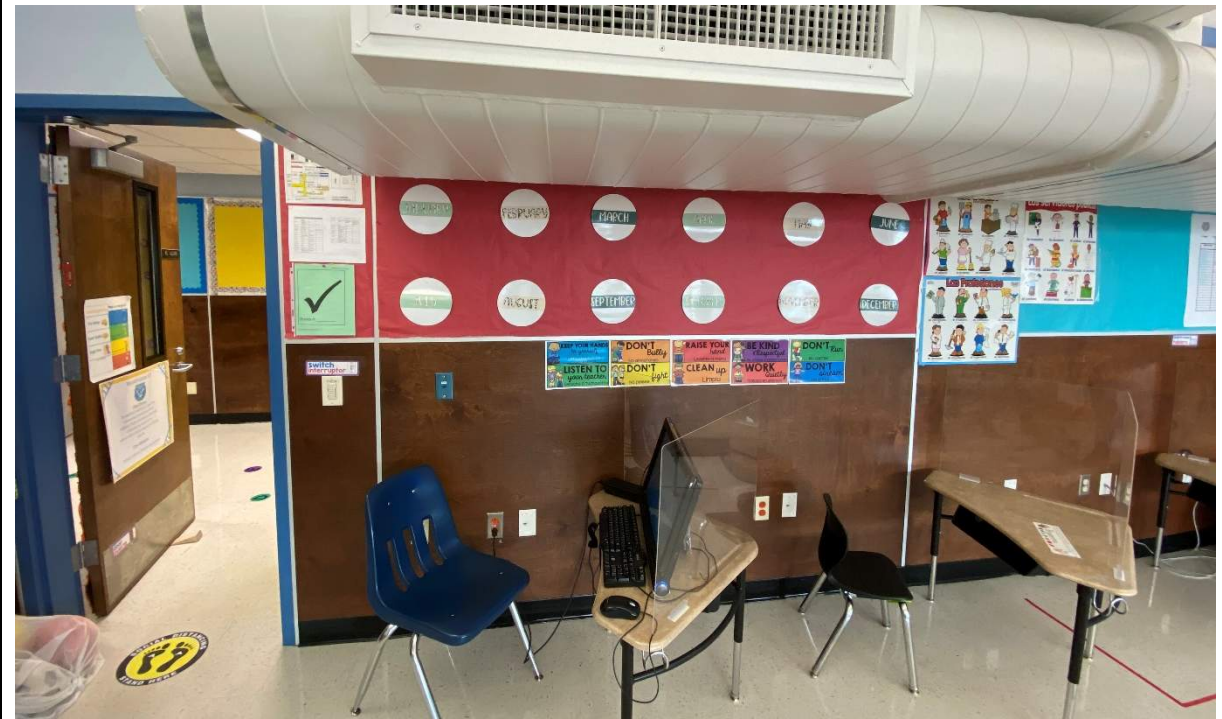
the recent HVAC system in the studios that hangs low below the ceiling and is a hazard for staff and students. The overall aesthetic of the school, both interior and exterior, was something brought up multiple times. The staff and community would like to see this updated.

Relatively new HVAC duct hangs below acceptable head height in the older wing studios.

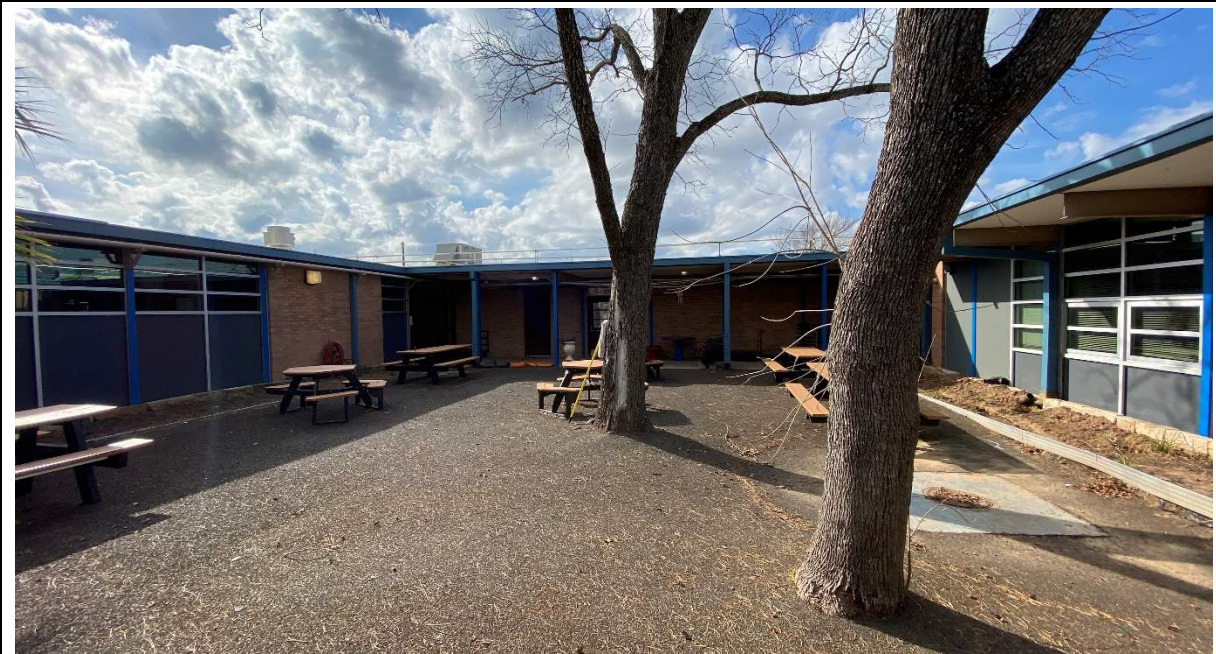
The interior courtyard just off the main entrance provides a secure outdoor space with seating.

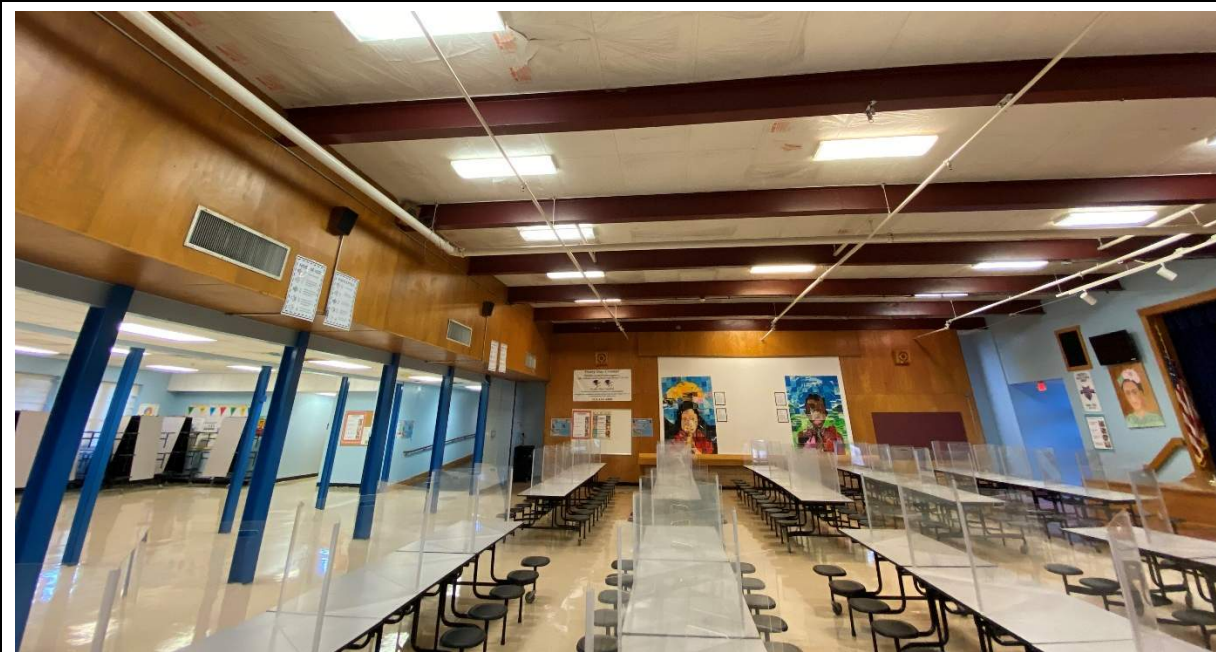
Dining commons is undersized and lacks daylight. The old stage (in front of view) was renovated for the teacher workroom and the new stage (to the right) is disconnected from music studio. The ceiling finish requires maintenance and has been secured with temporary plastic.

11.1	Is the Dining Commons appropriately configured per the ed spec?		2					Comments	1.00 2.00
	1 Very unsatisfactory - Too small, missing program spaces 2 Unsatisfactory - Too small, poor condition, only one option for eating space provided, inadequate circulation 3 Average - Adequate size and condition, needs updates or renovations to function well 4 Satisfactory - Good size and condition, good circulation, multiple options for eating space (ex: connection to outdoor eating space) 5 Very Satisfactory - Generous size, excellent condition and circulation, multiple options for eating space (ex: connection to outdoor eating space) N/A Does not apply	Undersized. Only one area to eat in. Limited natural light. Plastic on ceiling to prevent insulation from falling in food.
