Educational Suitability Summary Report

Widén Elementary School

Date: 10/23/2020

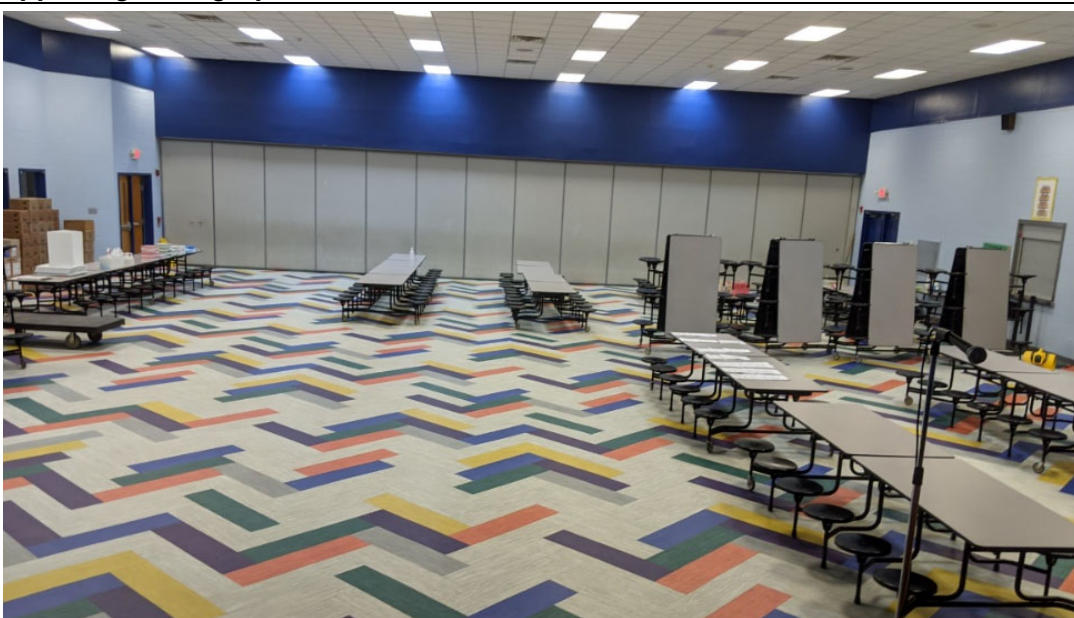
Movable partition between gym and cafeteria creates acoustic issues. No natural daylight in gym or cafeteria. Flooring is in good condition.

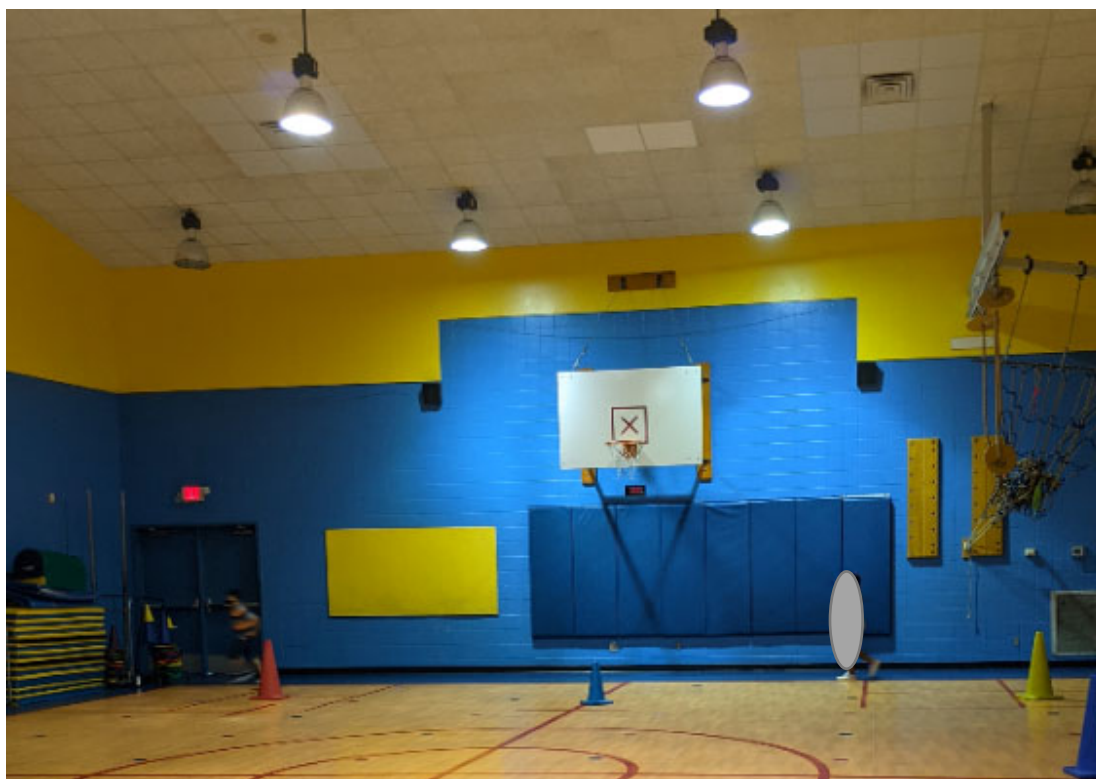
Gym is appropriately sized, but the lighting is inadequate. The equipment is old and in poor condition.

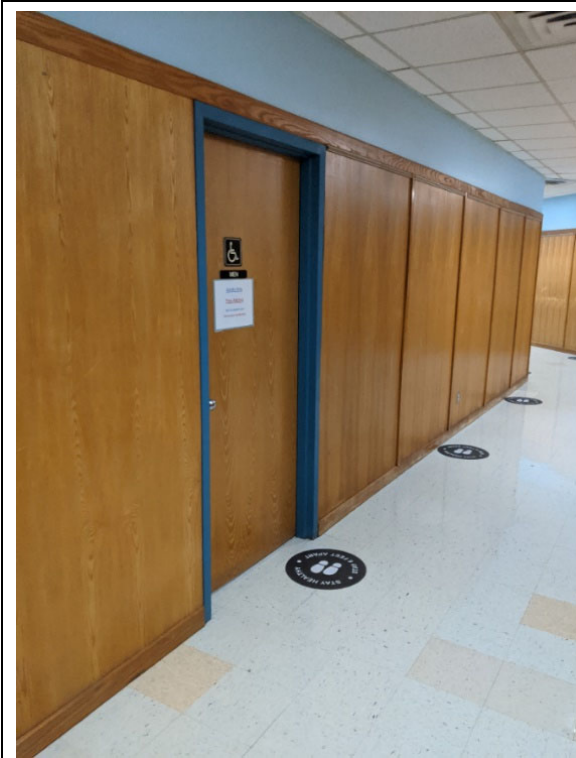
Dark wood paneling is not conducive to an elementary school environment.

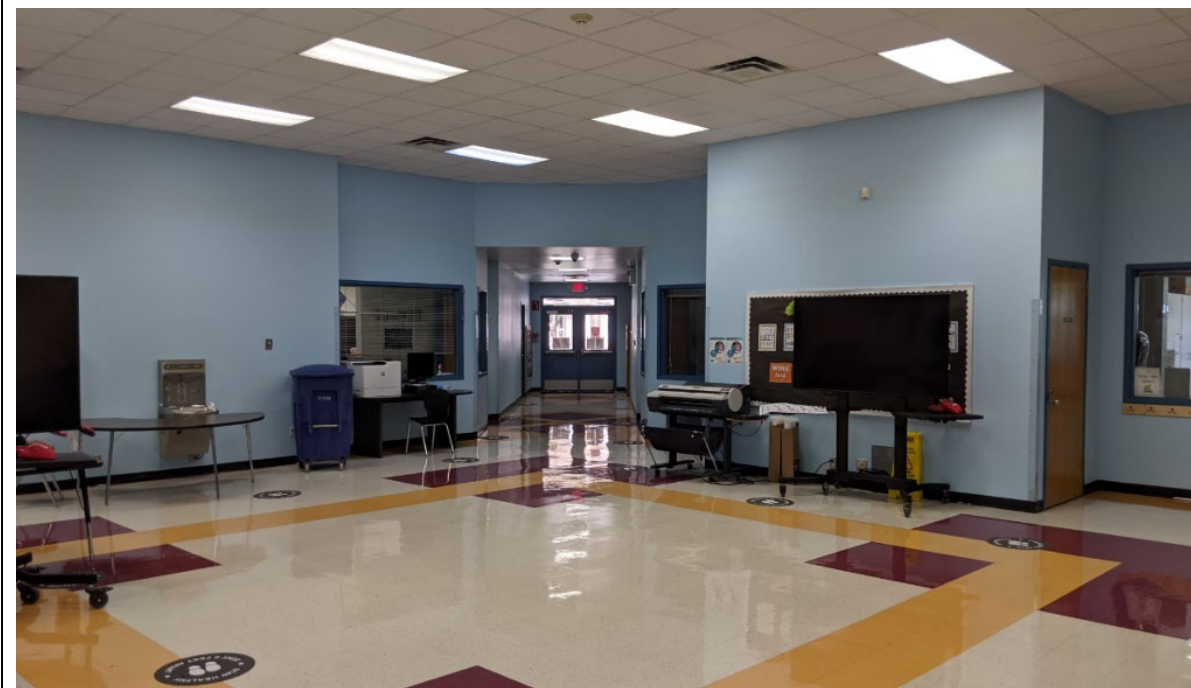
Collaboration space in studio pods. Storage room/restrooms block visibility from studios into collaboration space. These spaces are underutilized due to this issue.

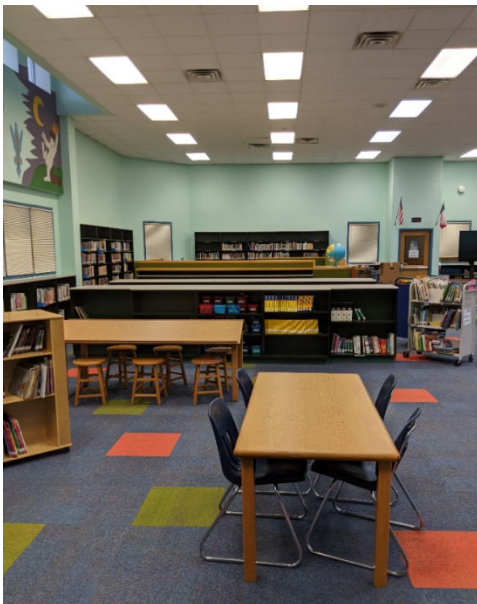
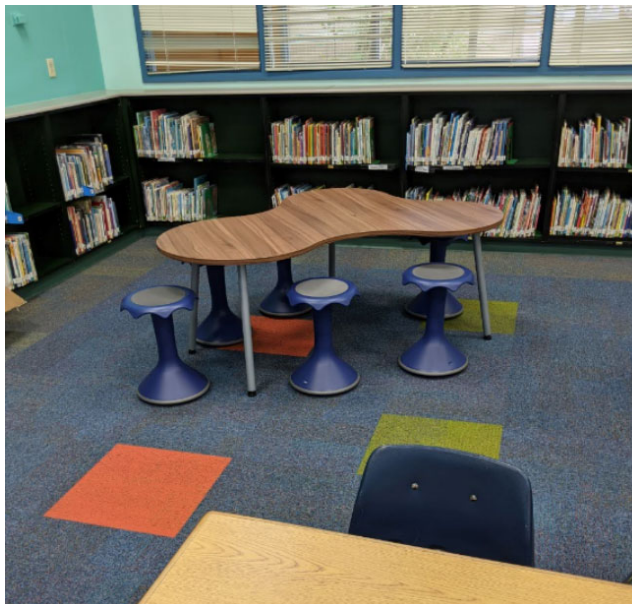
Media Resources: Natural daylight only from overhead. Limited transparency into corridors. Different types of seating provided..

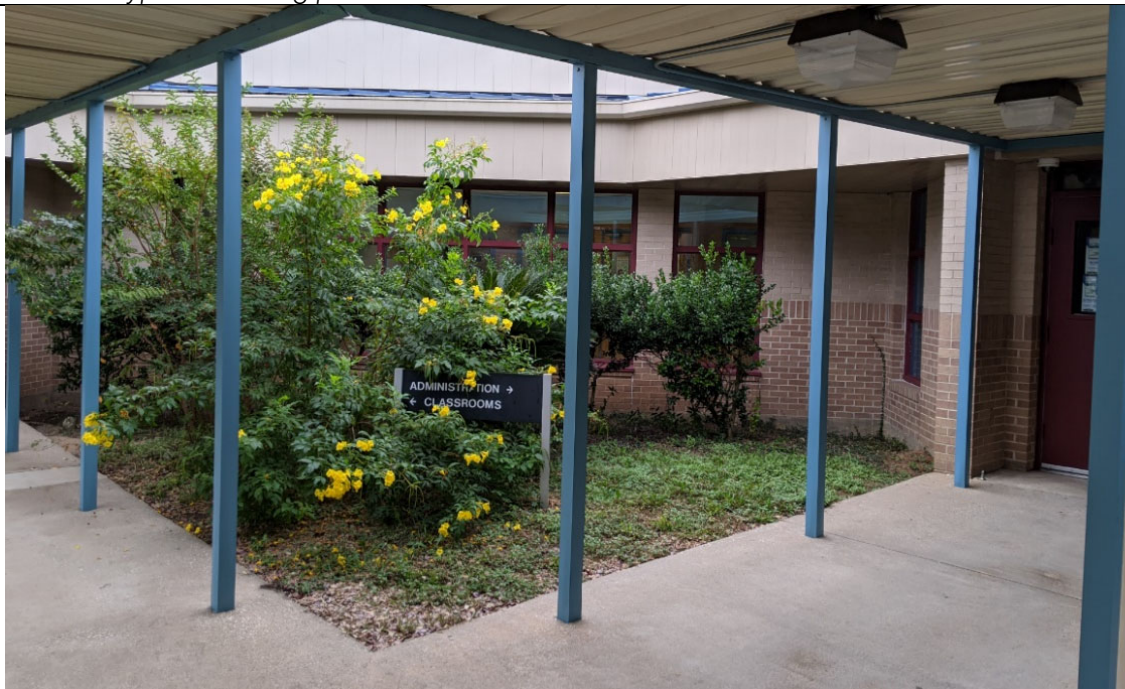
Main entry of school is dark and not welcoming. Signage is obscured, and grounds require maintenance.

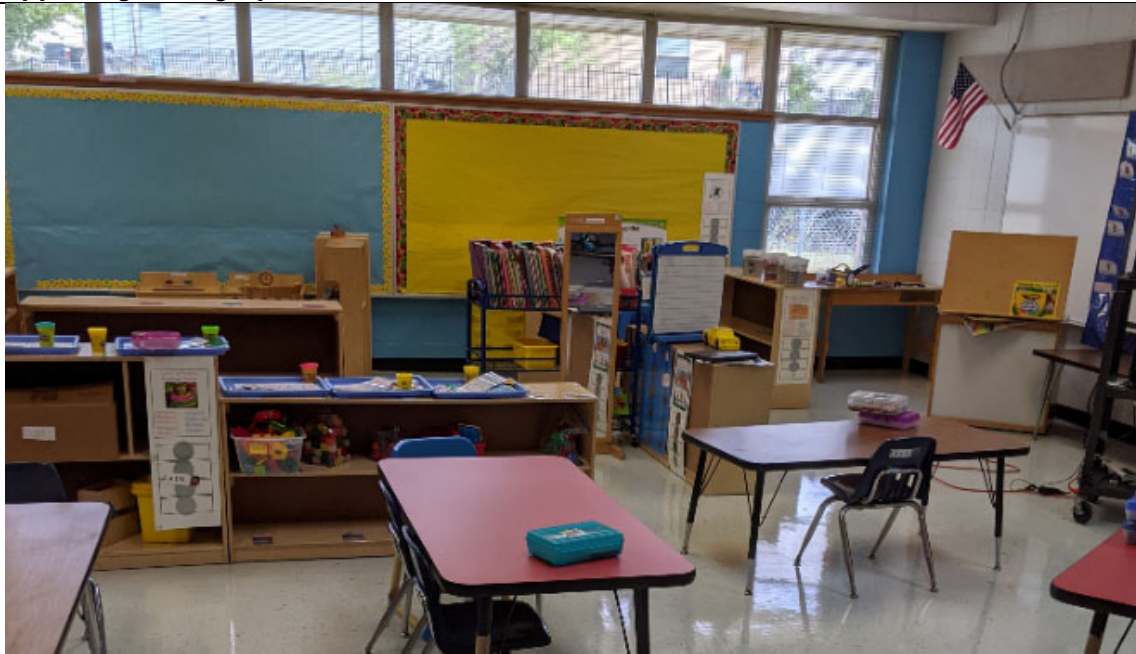
All studios have access to natural daylight. Studios do not meet current SF requirements according to Educational Specifications.

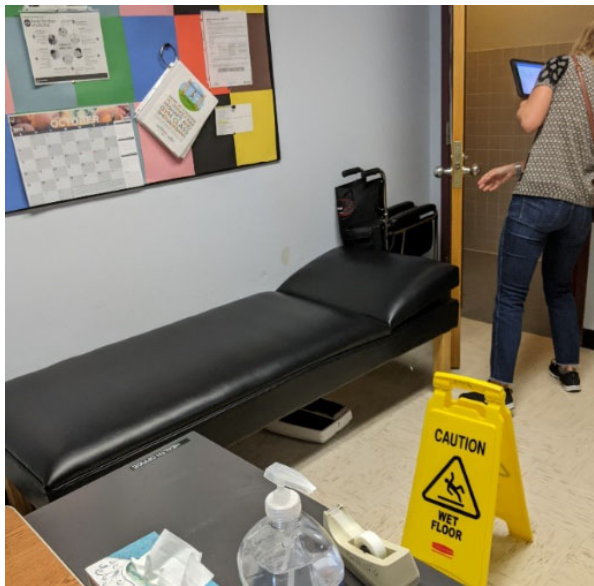
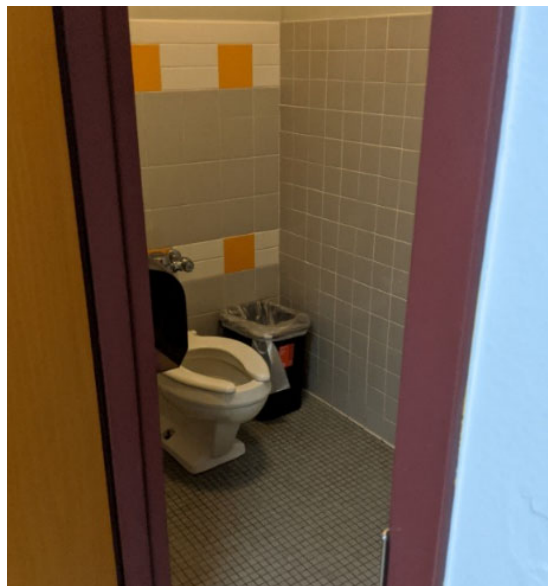
Health services area is inadequate and undersized. Inaccessible toilet and no storage.
